DAHP Level II Mitigation Report

Surrey Building

10777 Main Street
Bellevue, Washington
King County

2018-03-01597

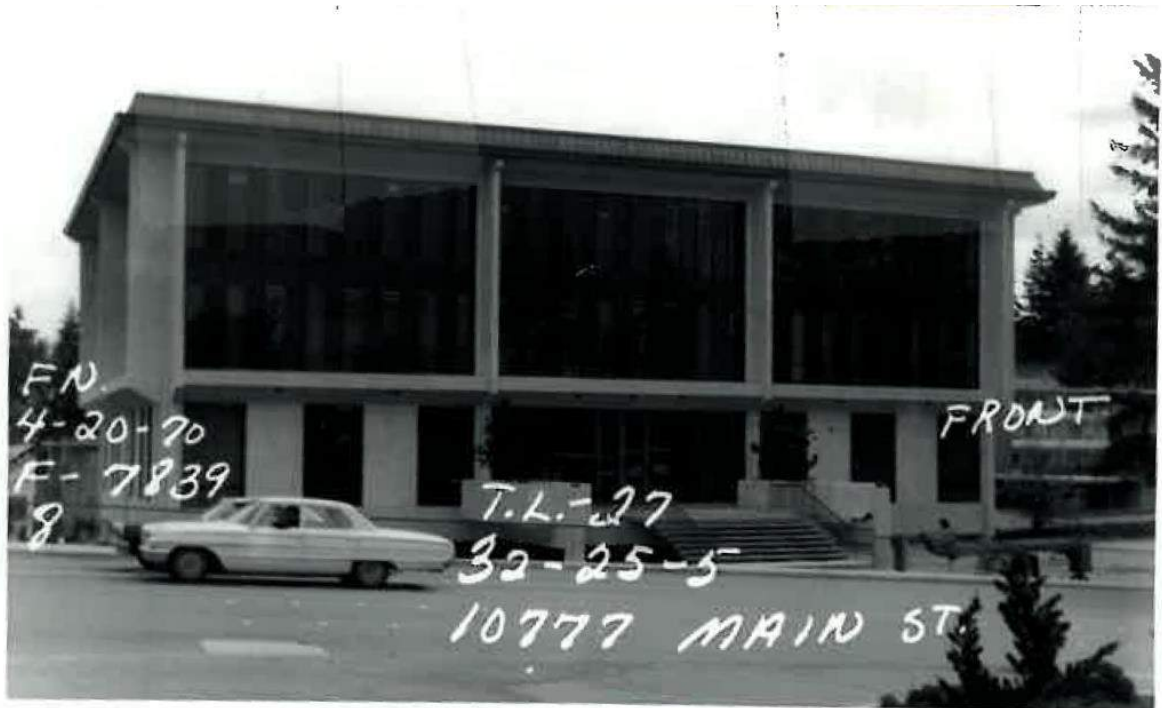
Historic Image 1: Surrey Building, north façade. Camera facing south. April 20, 1970. Source: King Co. Tax Assessor Property Record Card, 1969-70. WA State Archives, Puget Sound Branch.

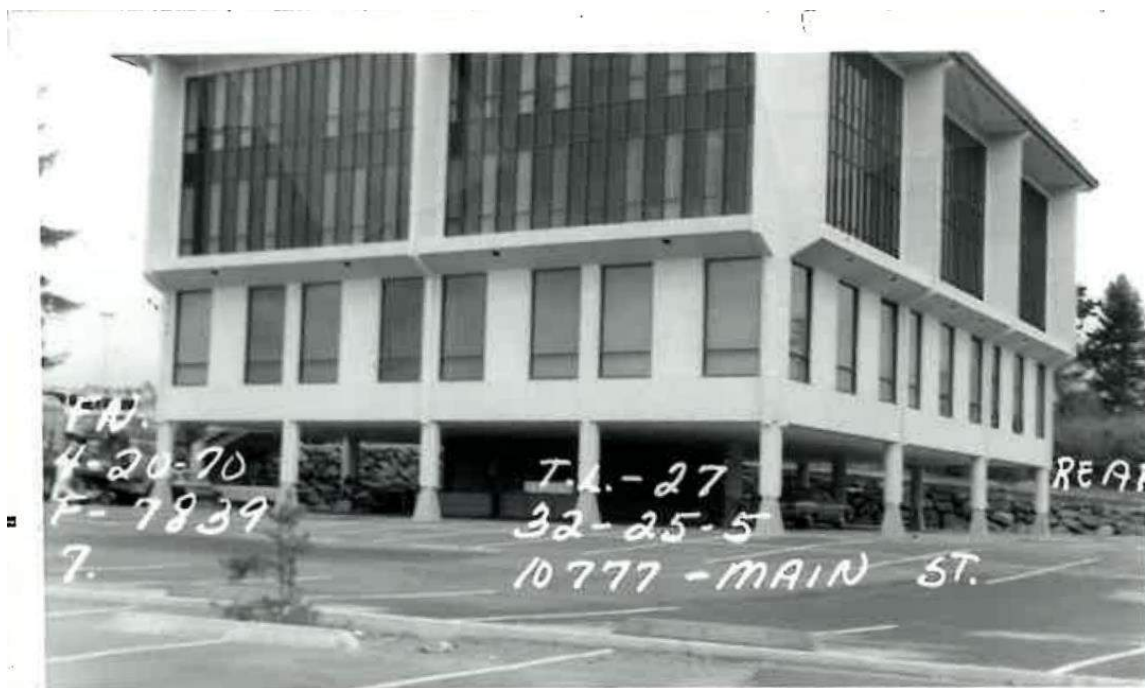
Historic Image 2: Surrey Building, SW corner. April 20, 1970. Camera facing northeast. Source: King Co. Tax Assessor Property Record Card, 1969-70. WA State Archives, Puget Sound Branch.

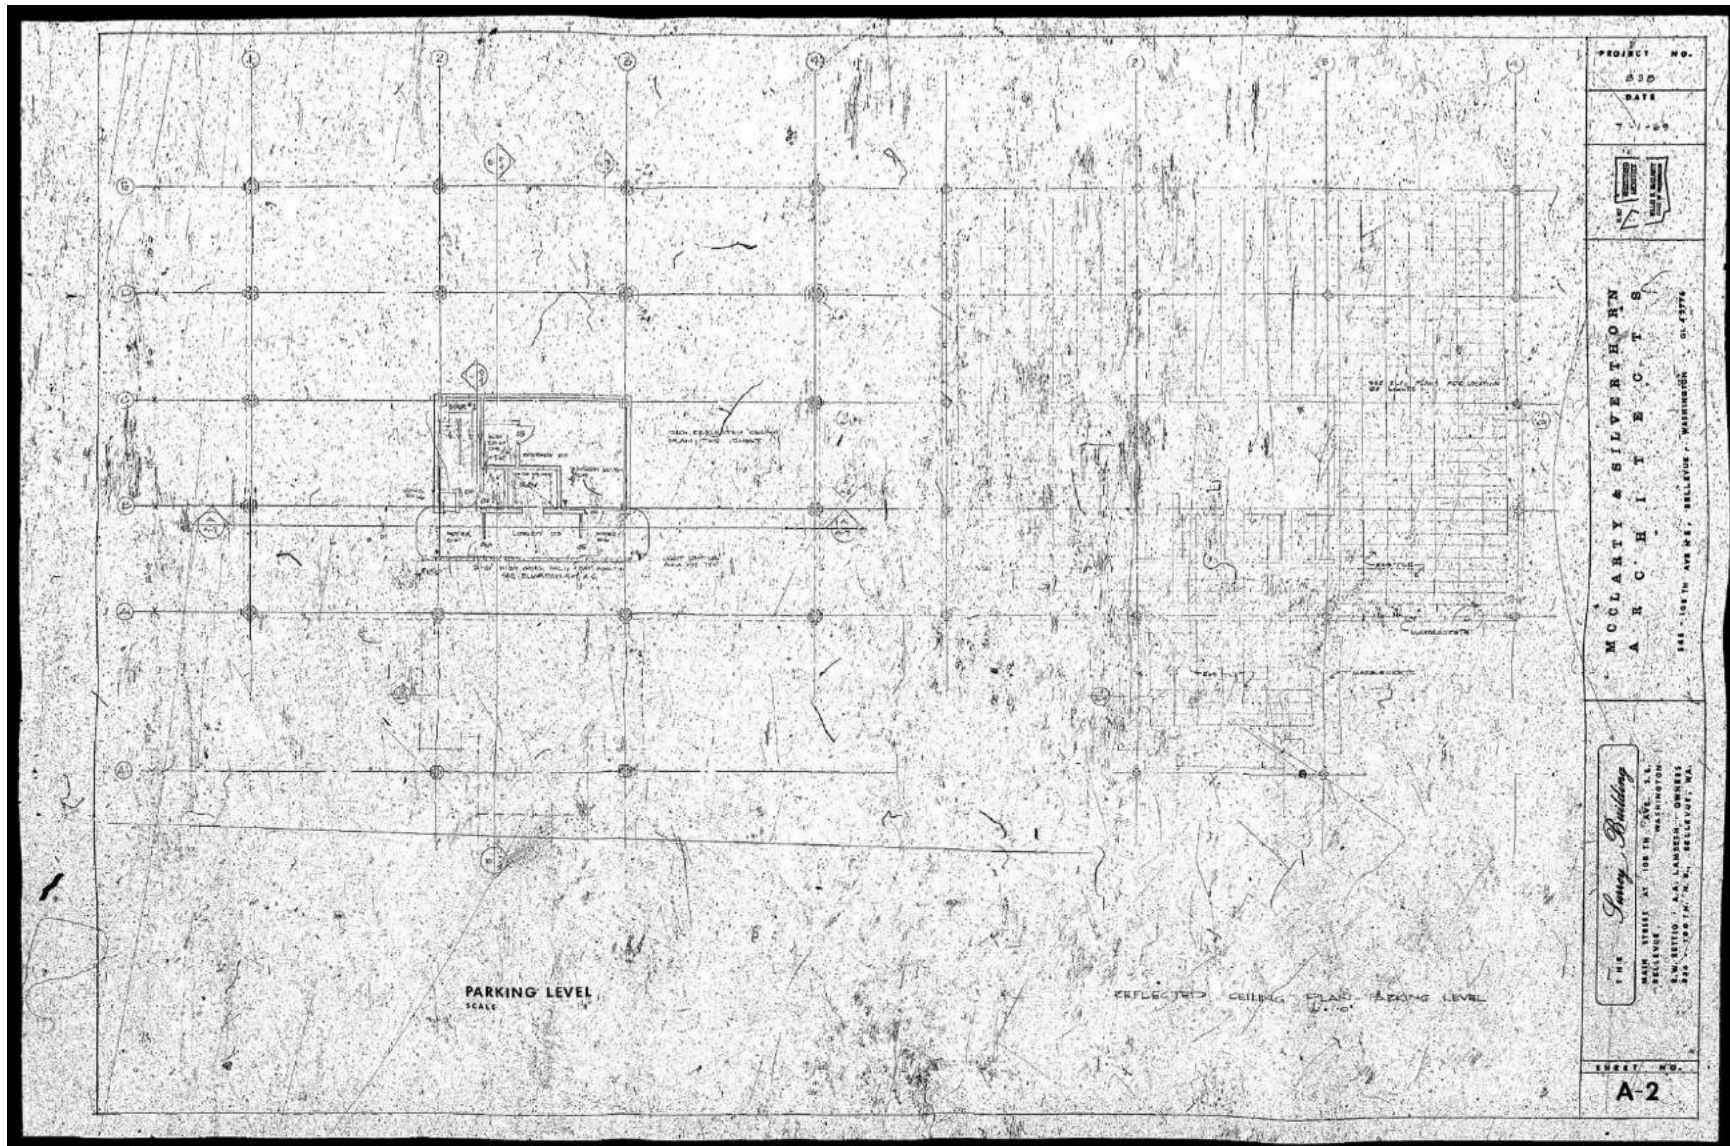
DRAWING 2: McClarty & Silverthorn drawing A2 Parking Plan, Surrey Bldg. July 1, 1969. Source: City of Bellevue, WA.

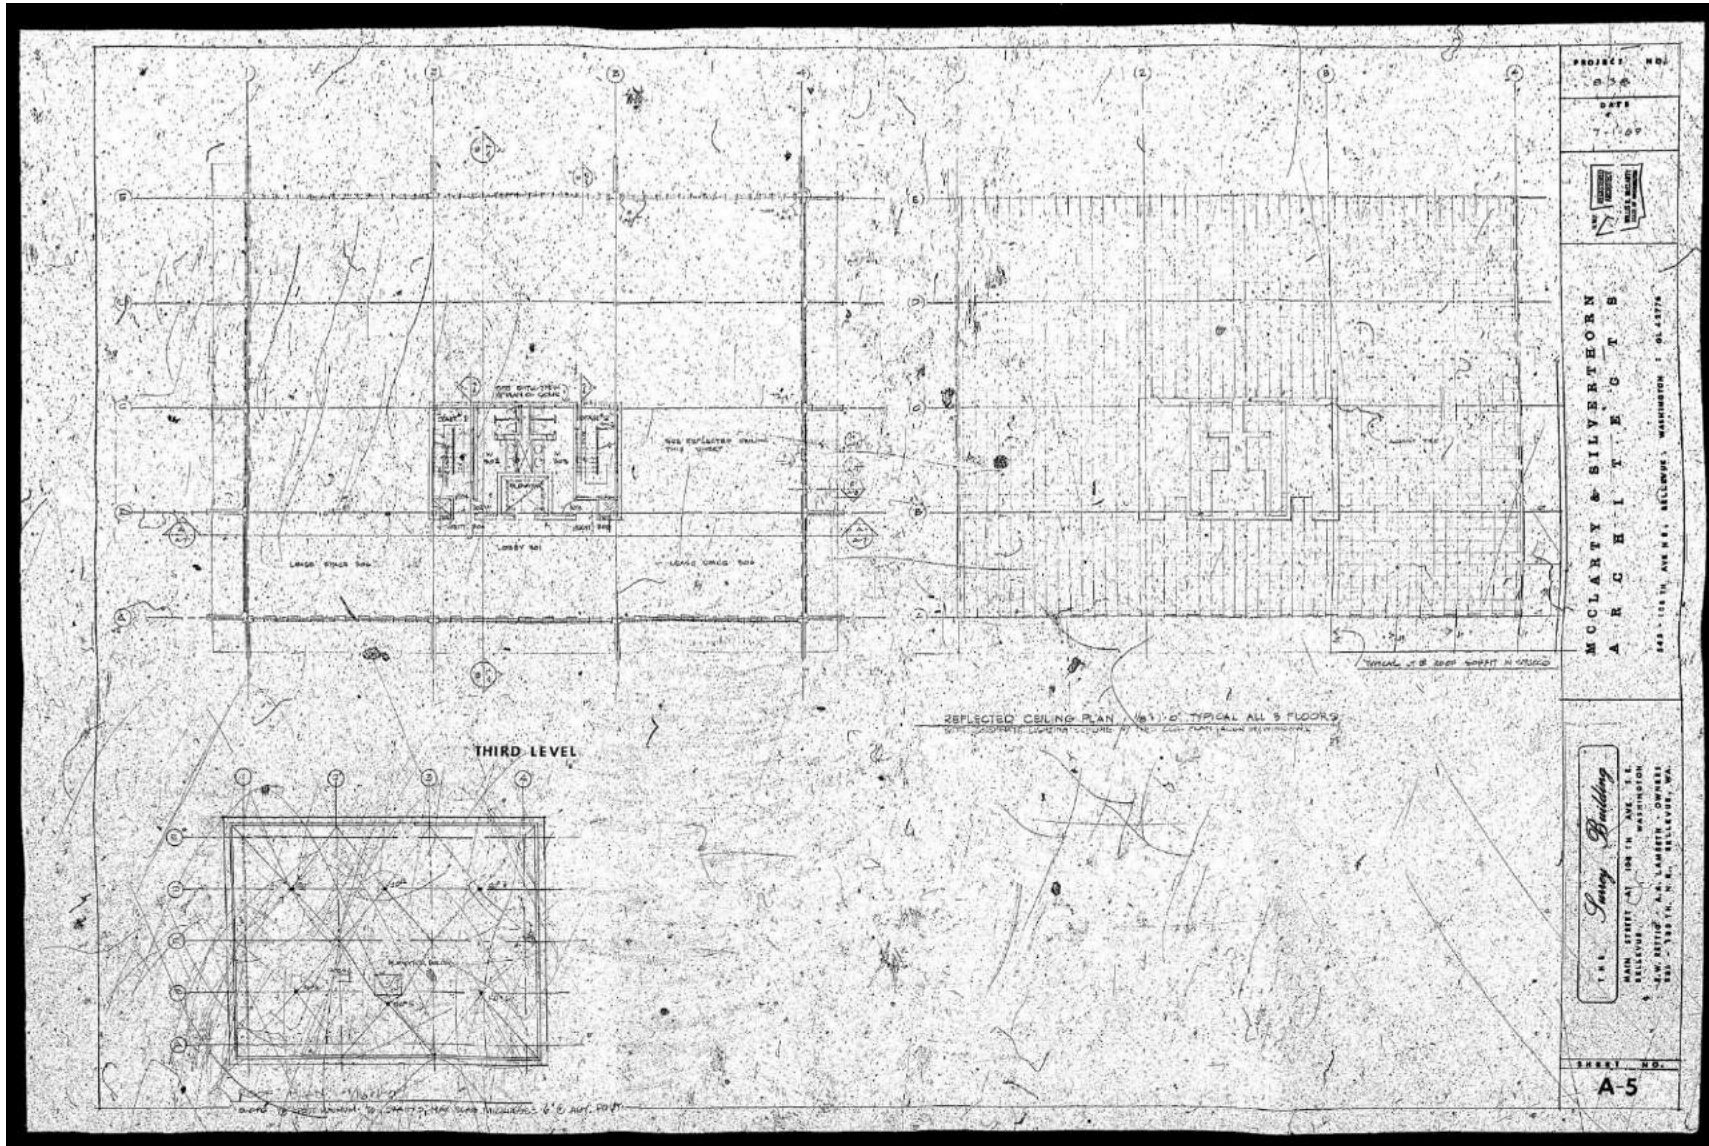
DRAWING 5: McClarty & Silverthorn drawing A5 3rd Level Plan and Ceiling & Roof Plan, Surrey Bldg. July 1, 1969. Source: City of Bellevue, WA.

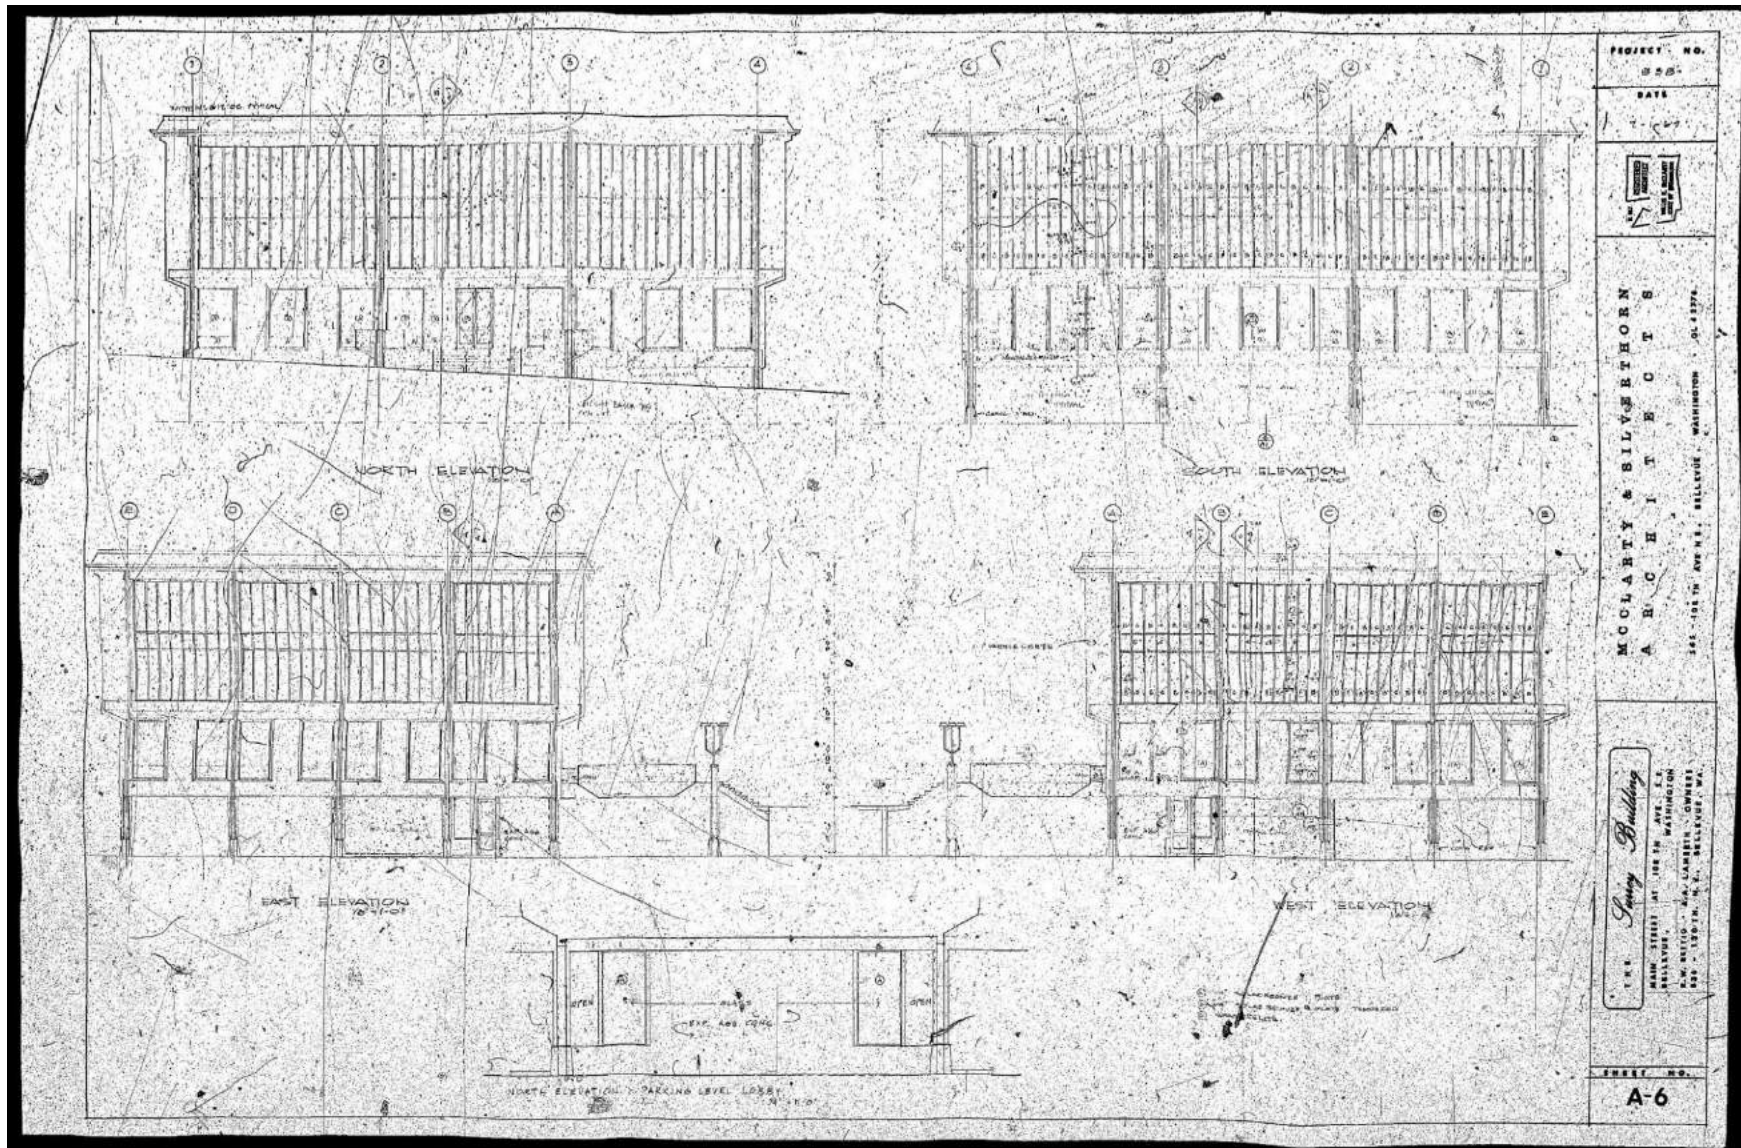
DRAWING 6: McClarty & Silverthorn drawing A5 Exterior Elevations & Glass Schedule, Surrey Bldg. July 1, 1969. Source: City of Bellevue, WA.

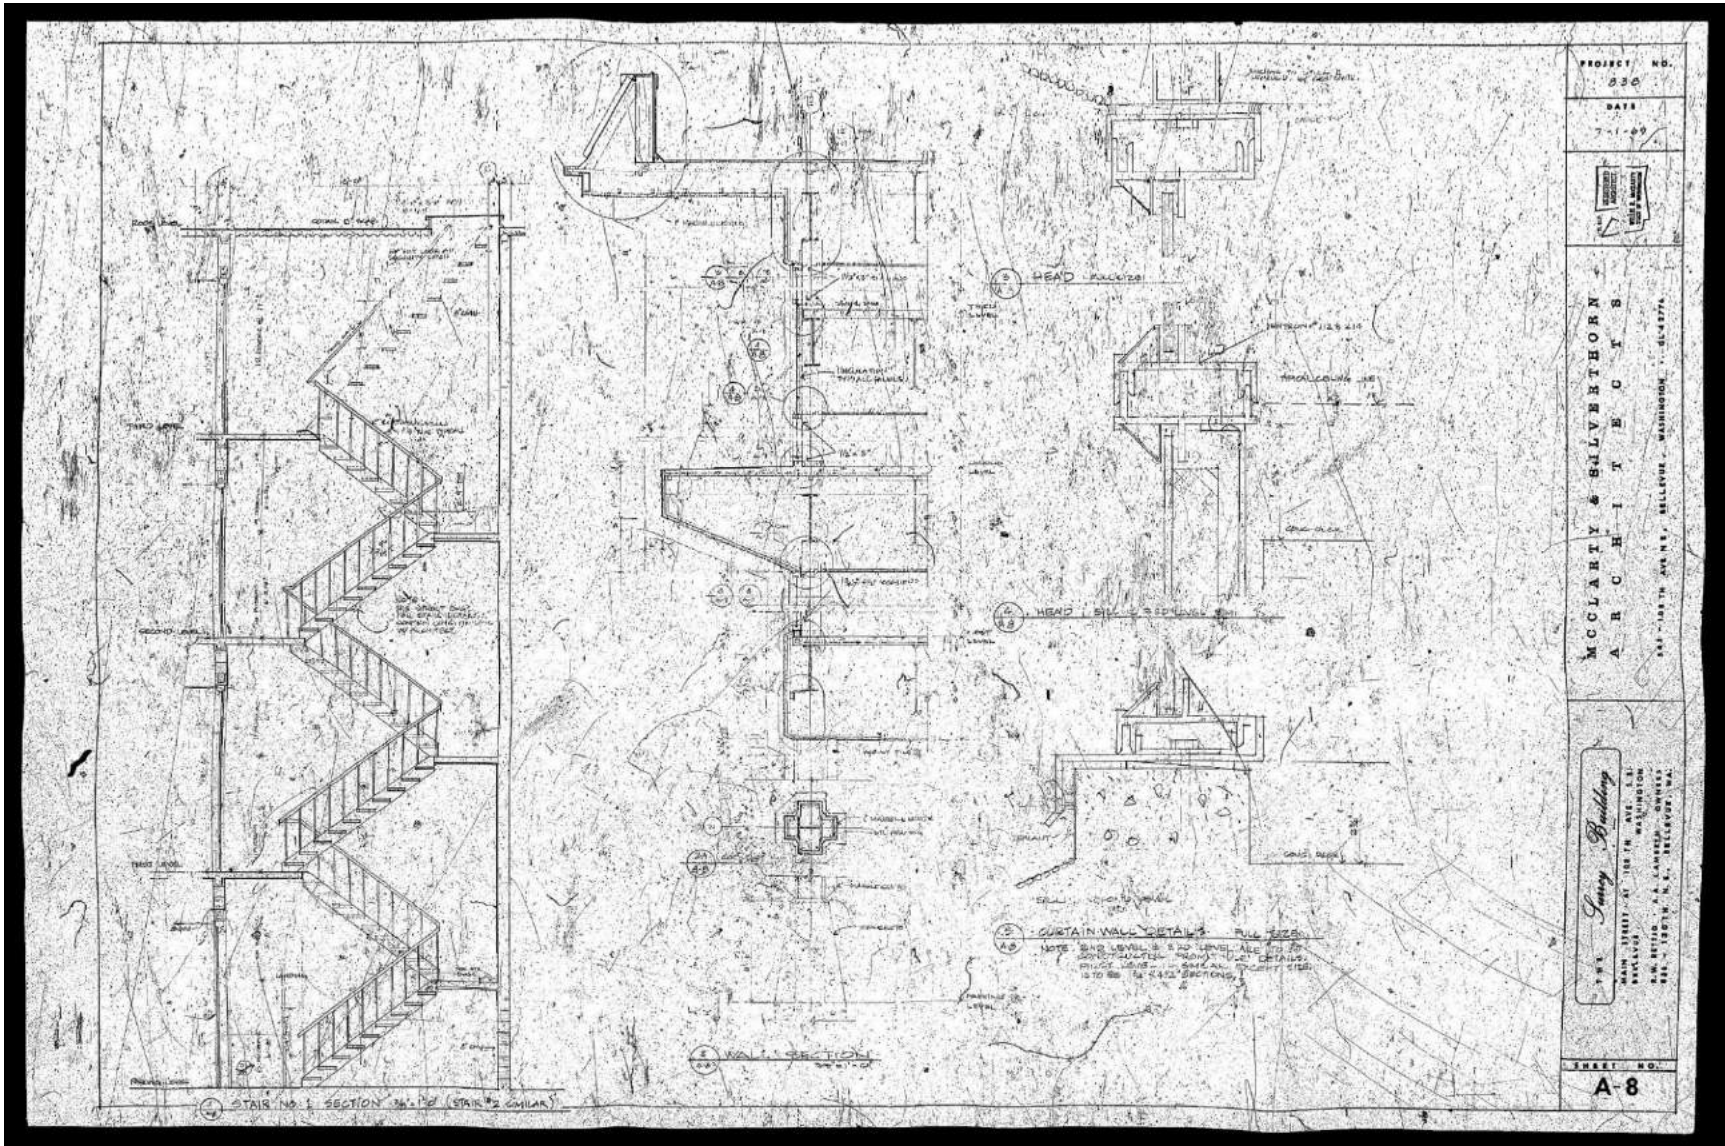
DRAWING 8: McClarty & Silverthorn drawing A8 Stair Section & Wall Sections, Surrey Bldg. July 1, 1969. Source: City of Bellevue, WA.

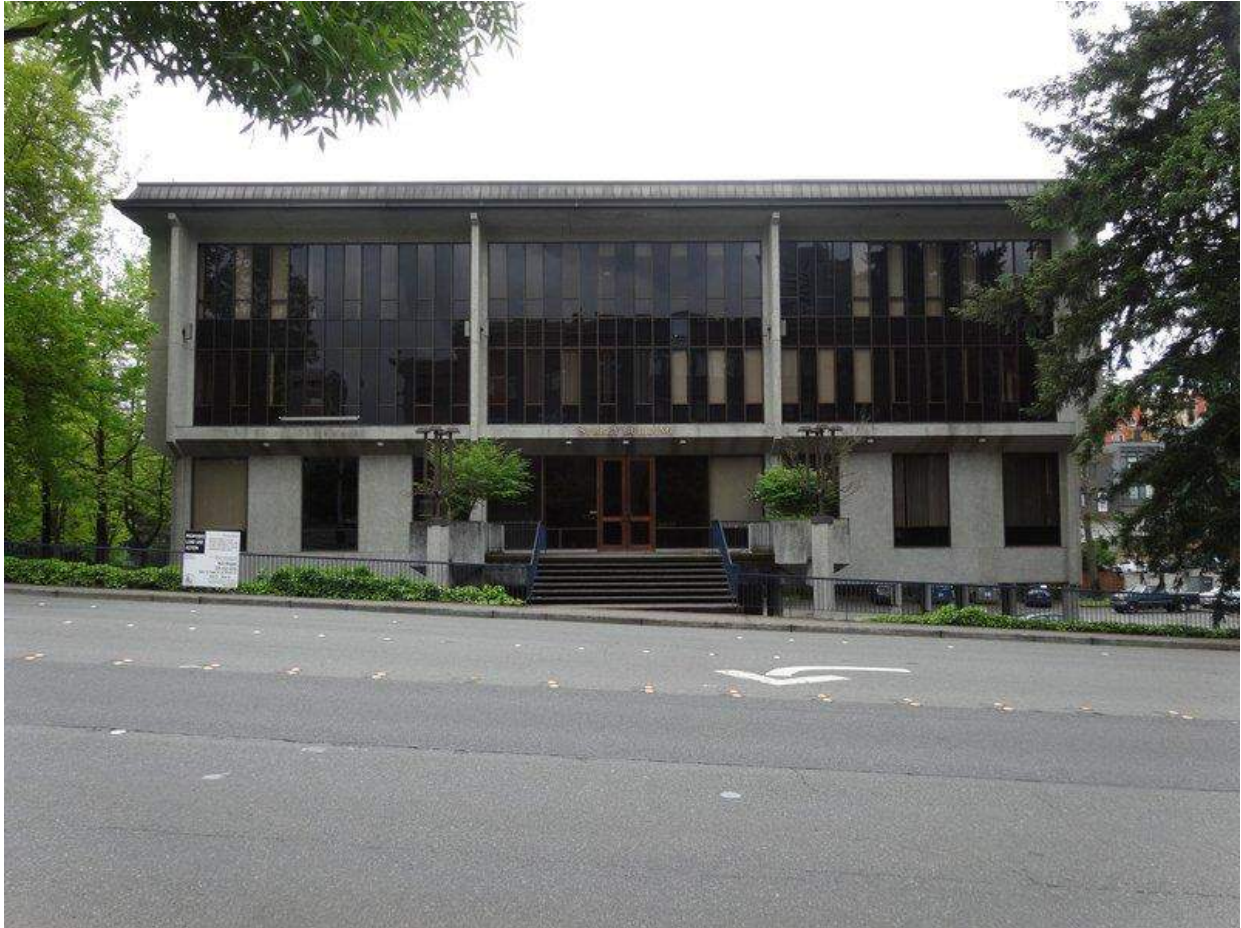
PHOTOGRAPH 1. Surrey Building. North (primary) elevation with Main Street in foreground. Camera facing south.

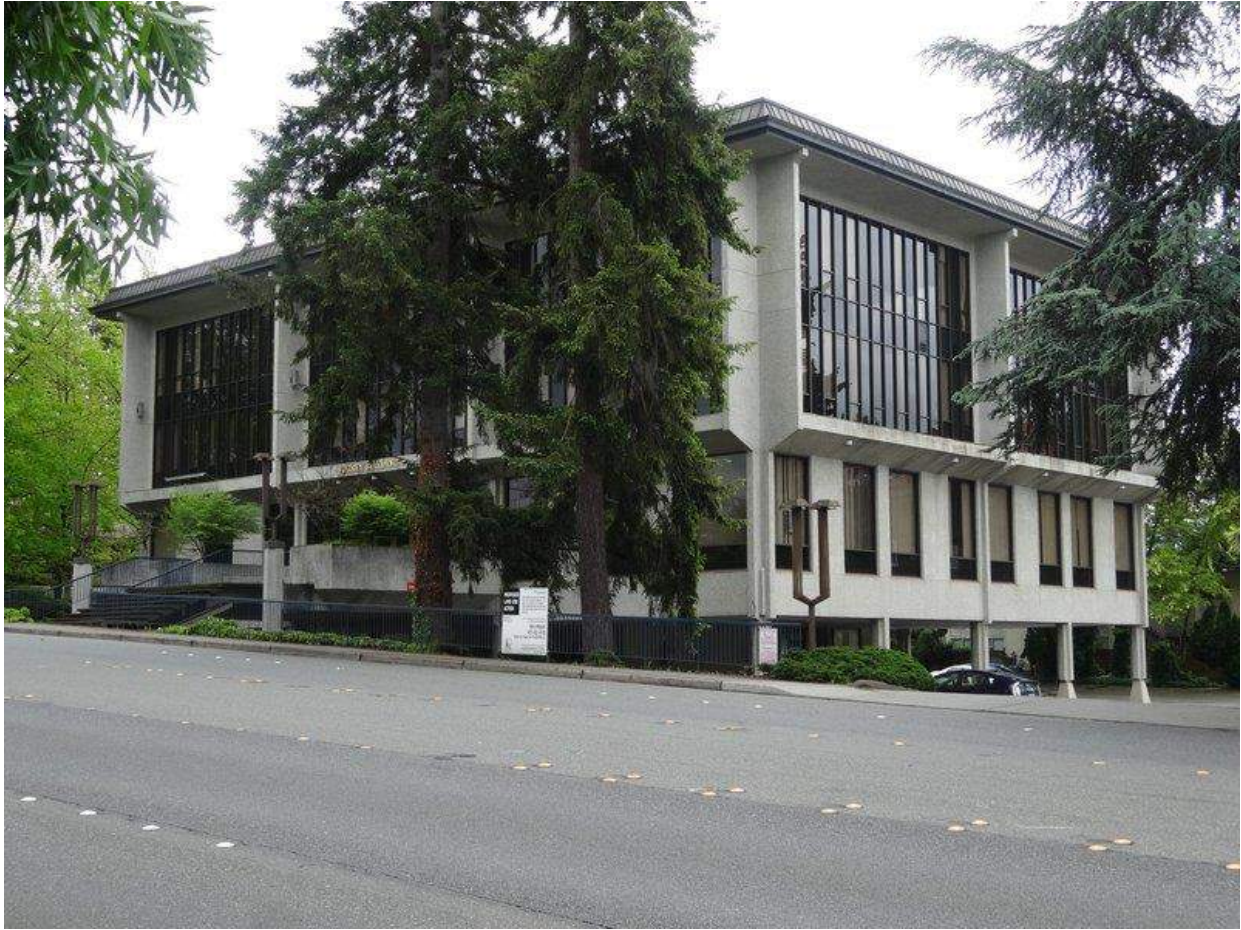
PHOTOGRAPH 2. Surrey Building. Northwest corner of building with Main Street in foreground. Camera facing southeast.

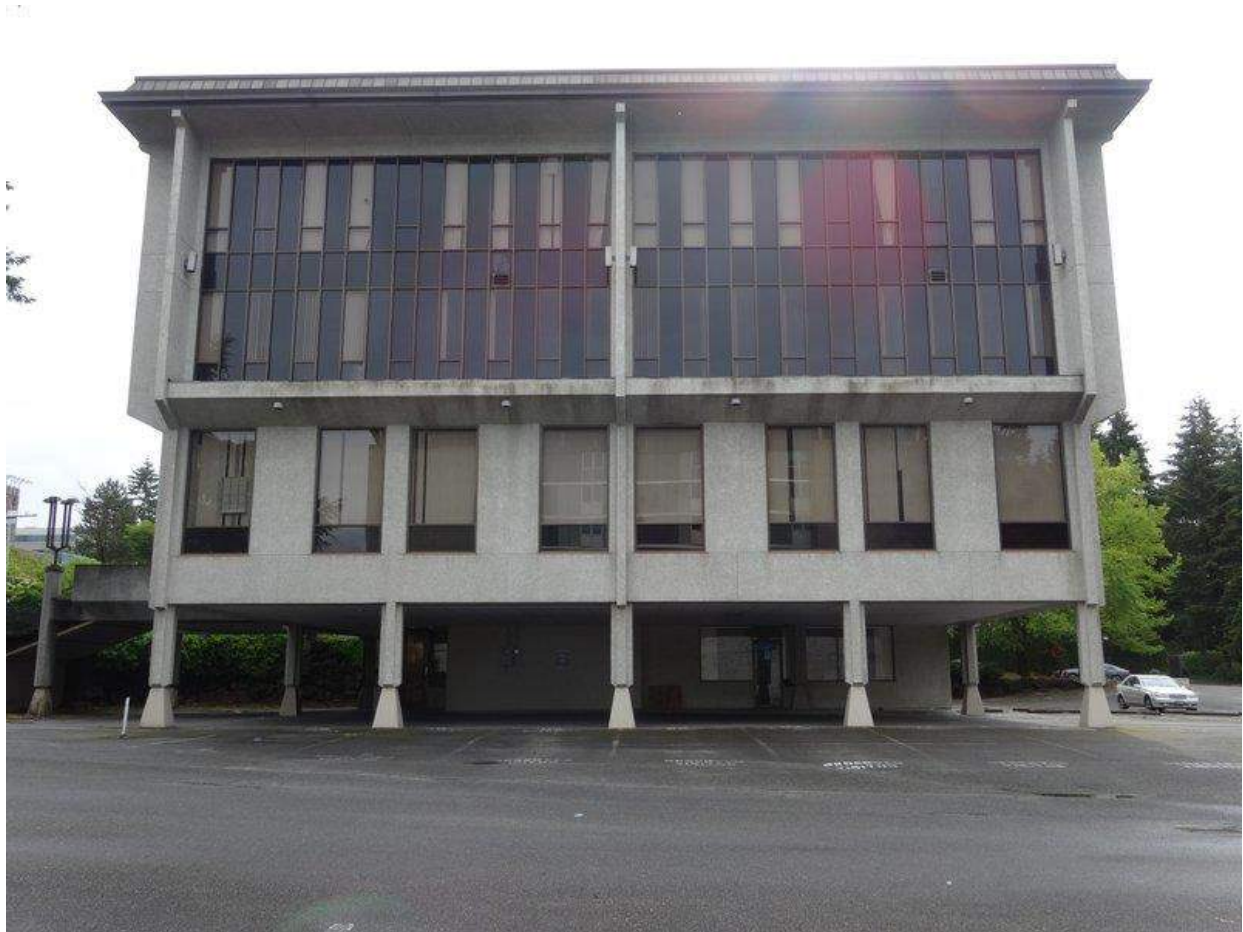
PHOTOGRAPH 3. Surrey Building. West elevation. Camera facing east.

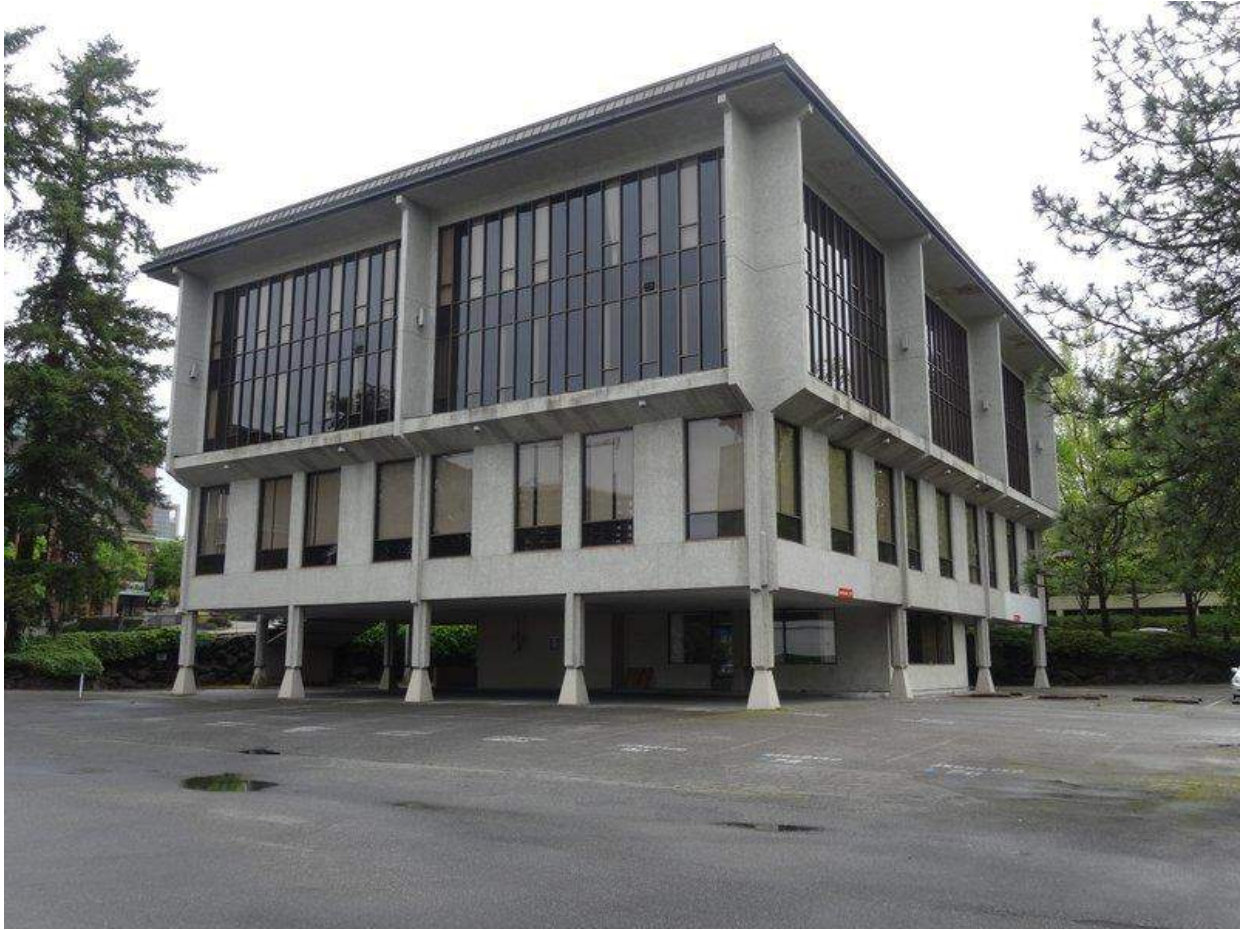
PHOTOGRAPH 4. Surrey Building. Southwest corner of building. Camera facing northeast.

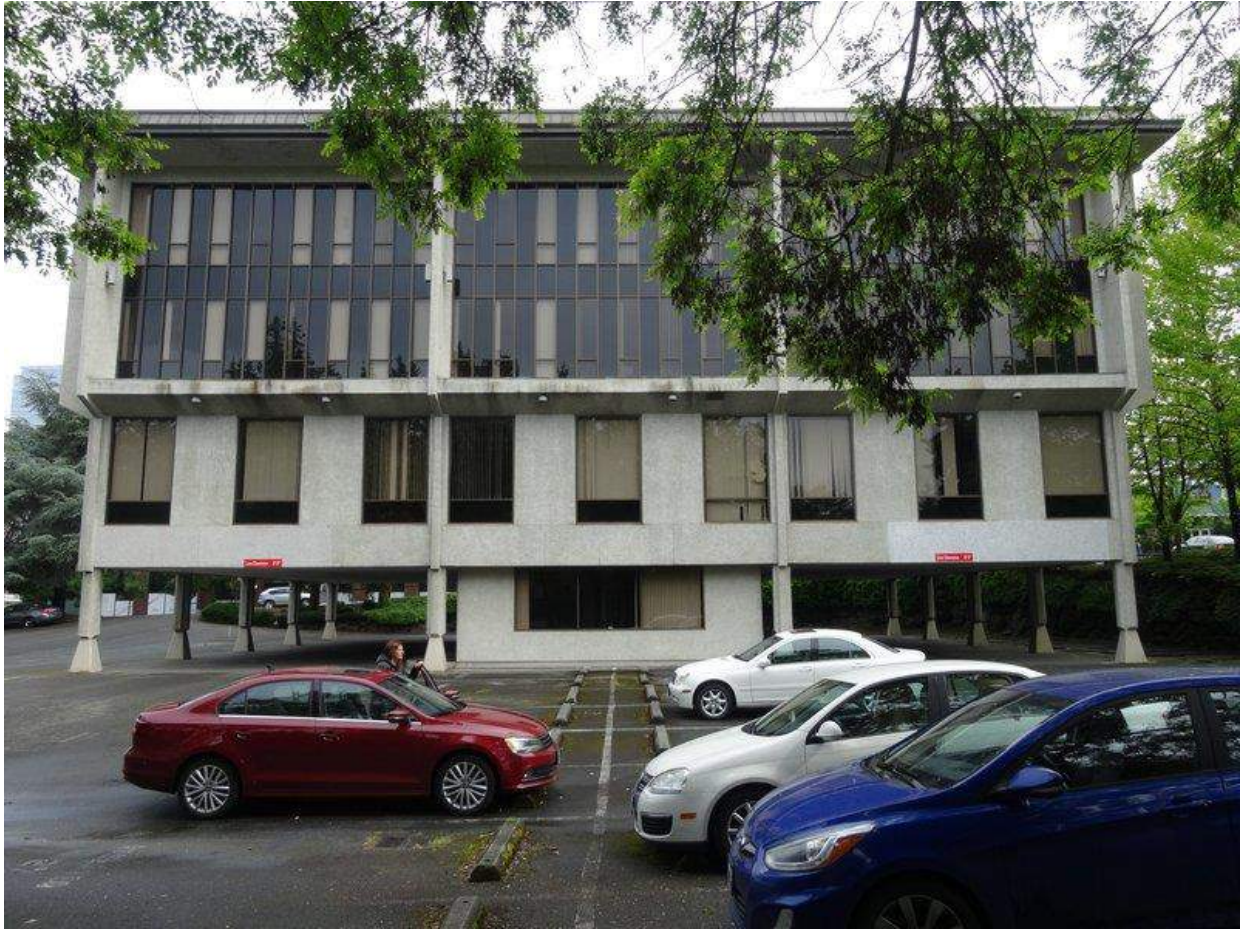
PHOTOGRAPH 5. Surrey Building. South elevation. Camera facing north.

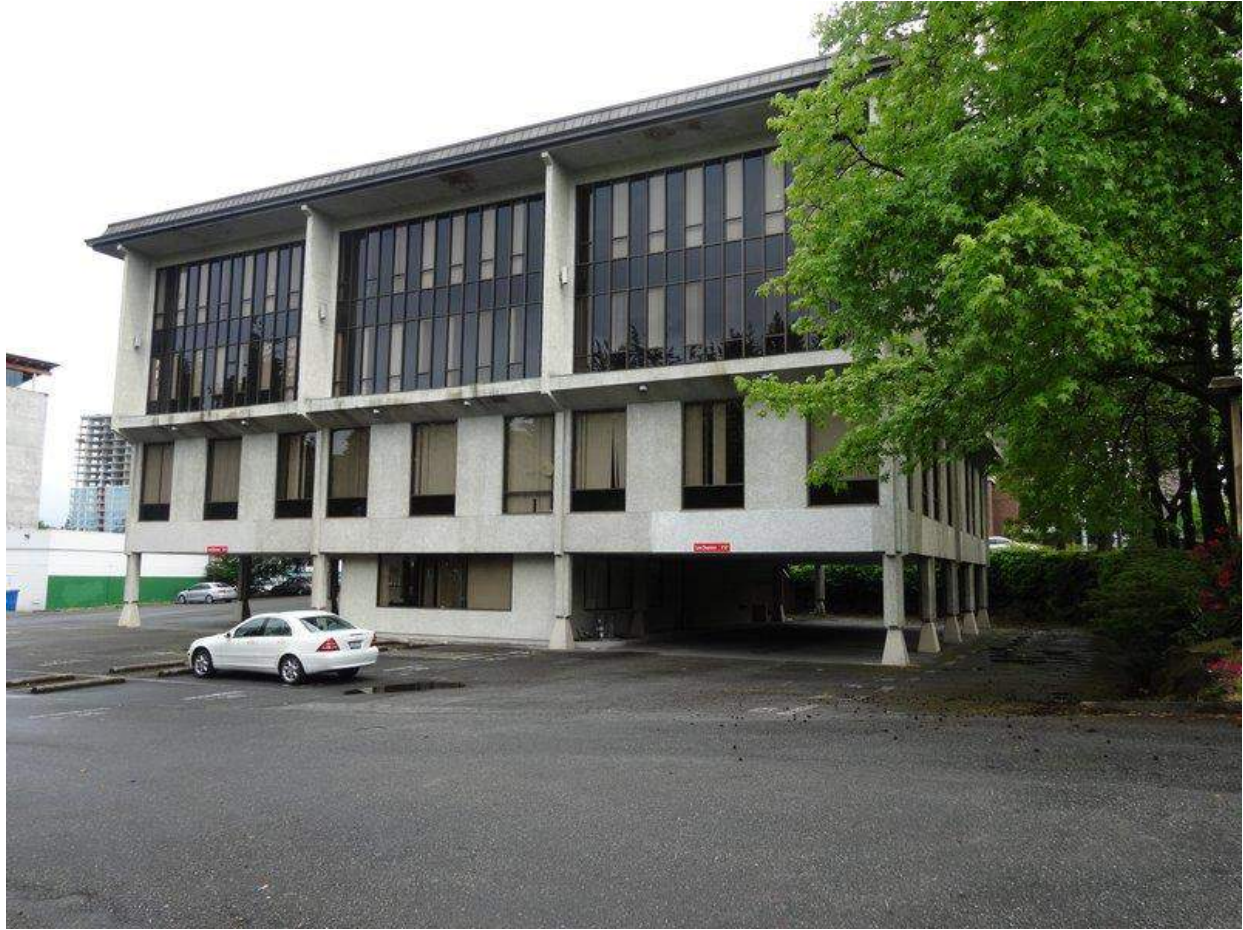
PHOTOGRAPH 6. Surrey Building. Southeast corner of building. Camera facing northwest.

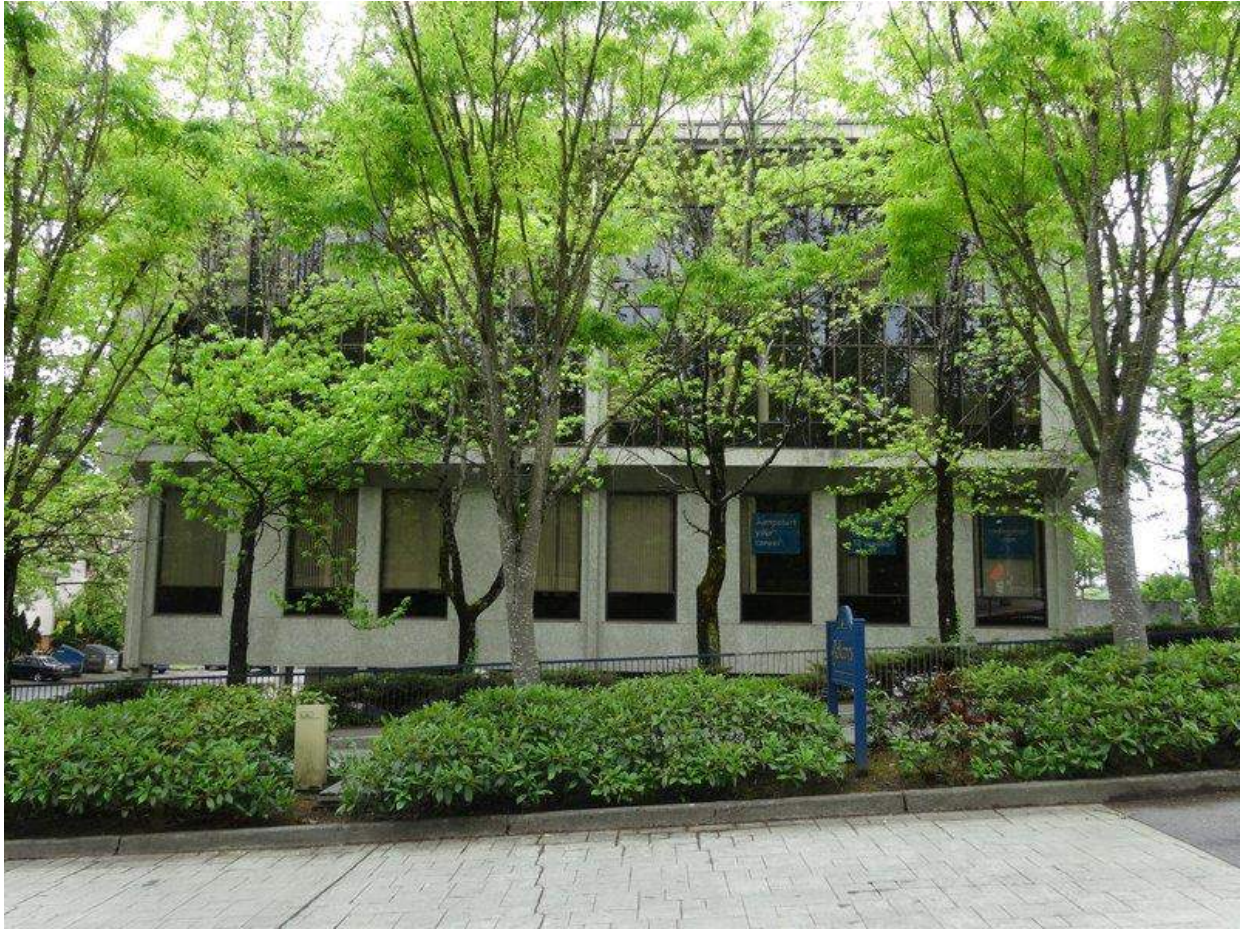
PHOTOGRAPH 7. Surrey Building. East elevation with 108th Avenue SE in foreground. Camera facing west.

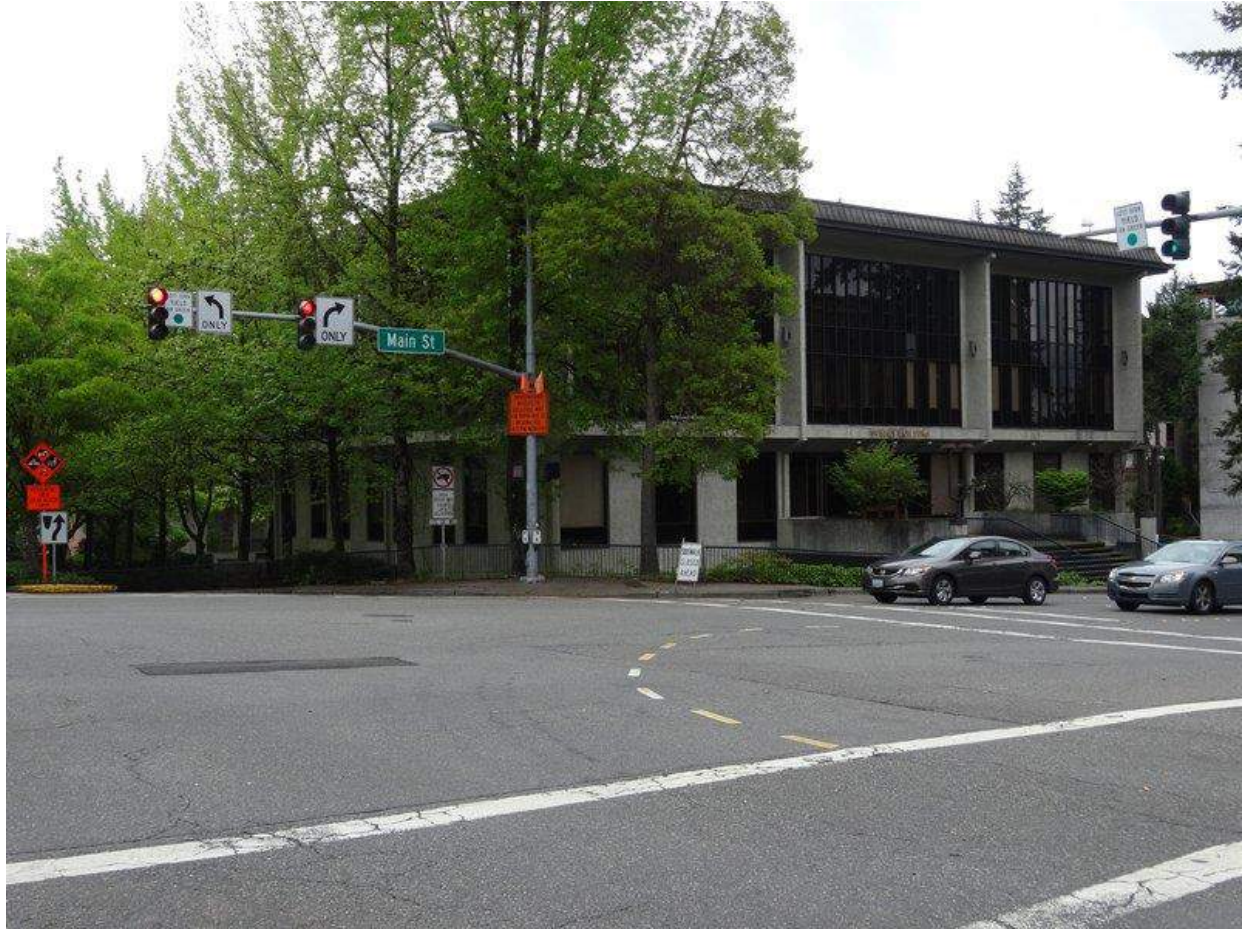
PHOTOGRAPH 8. Surrey Building. Northeast corner of building with intersection of Main Street and 108th Avenue SE in foreground. Camera facing southwest.

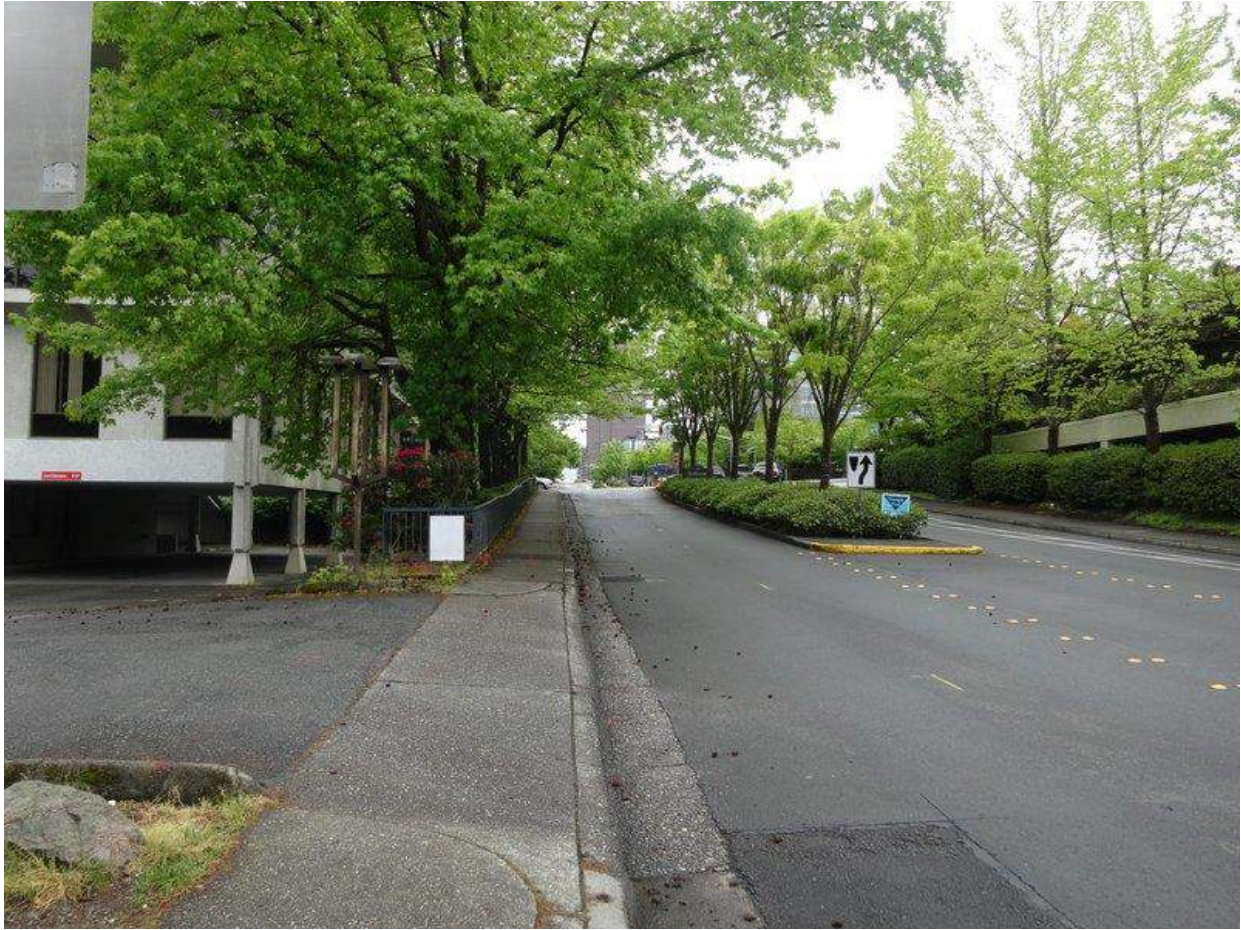
PHOTOGRAPH 9. Surrey Building. East driveway entrance with 108th Avenue SE at right and southeast corner of Surrey Building at left. Camera facing north.

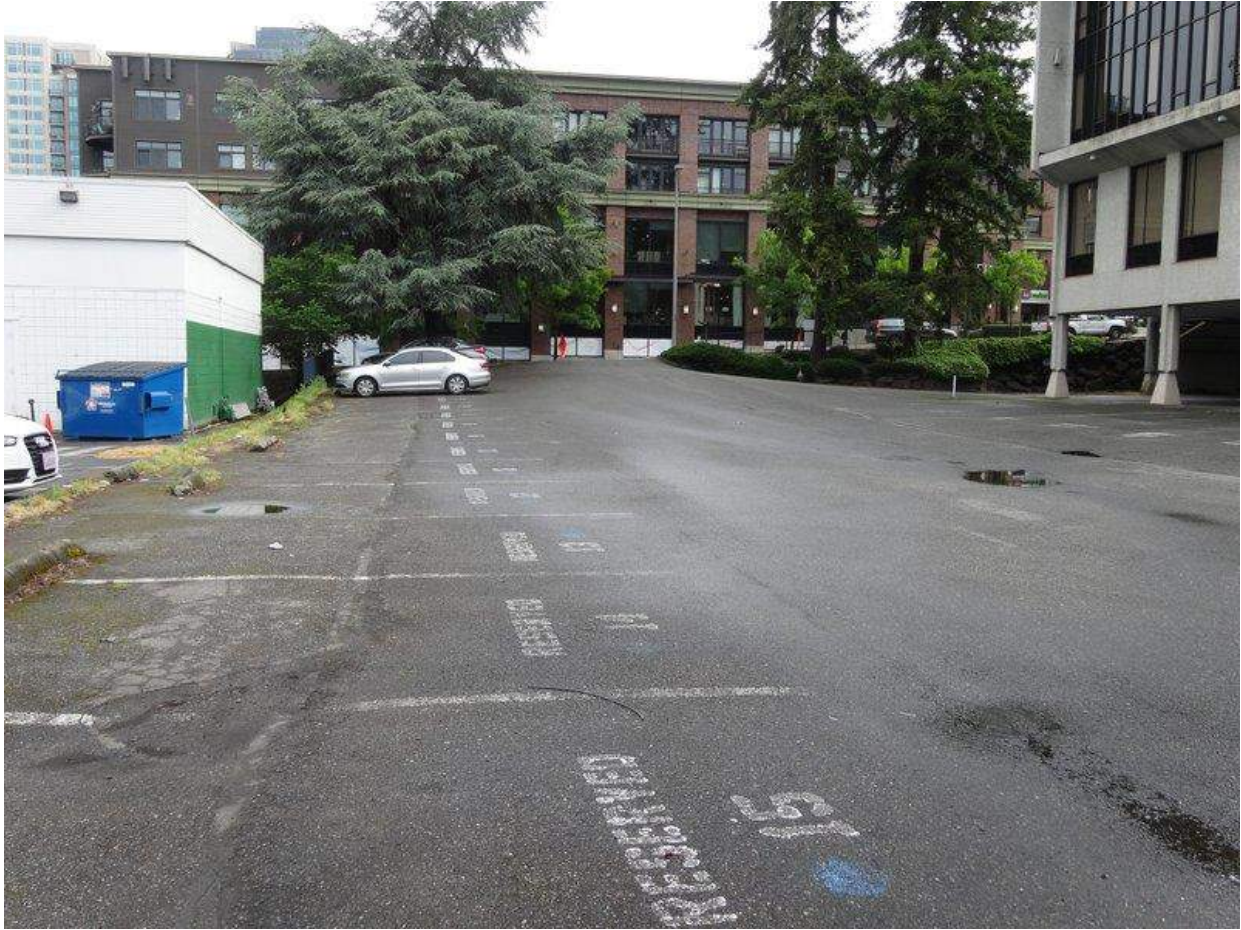
PHOTOGRAPH 13. Surrey Building. Parking area west of building. The five-story red-brick building (center) is addressed 10708 Main Street and was constructed in 2003. The one-story building (left) is addressed 10713 Main Street and was built in 1969. Camera facing north.

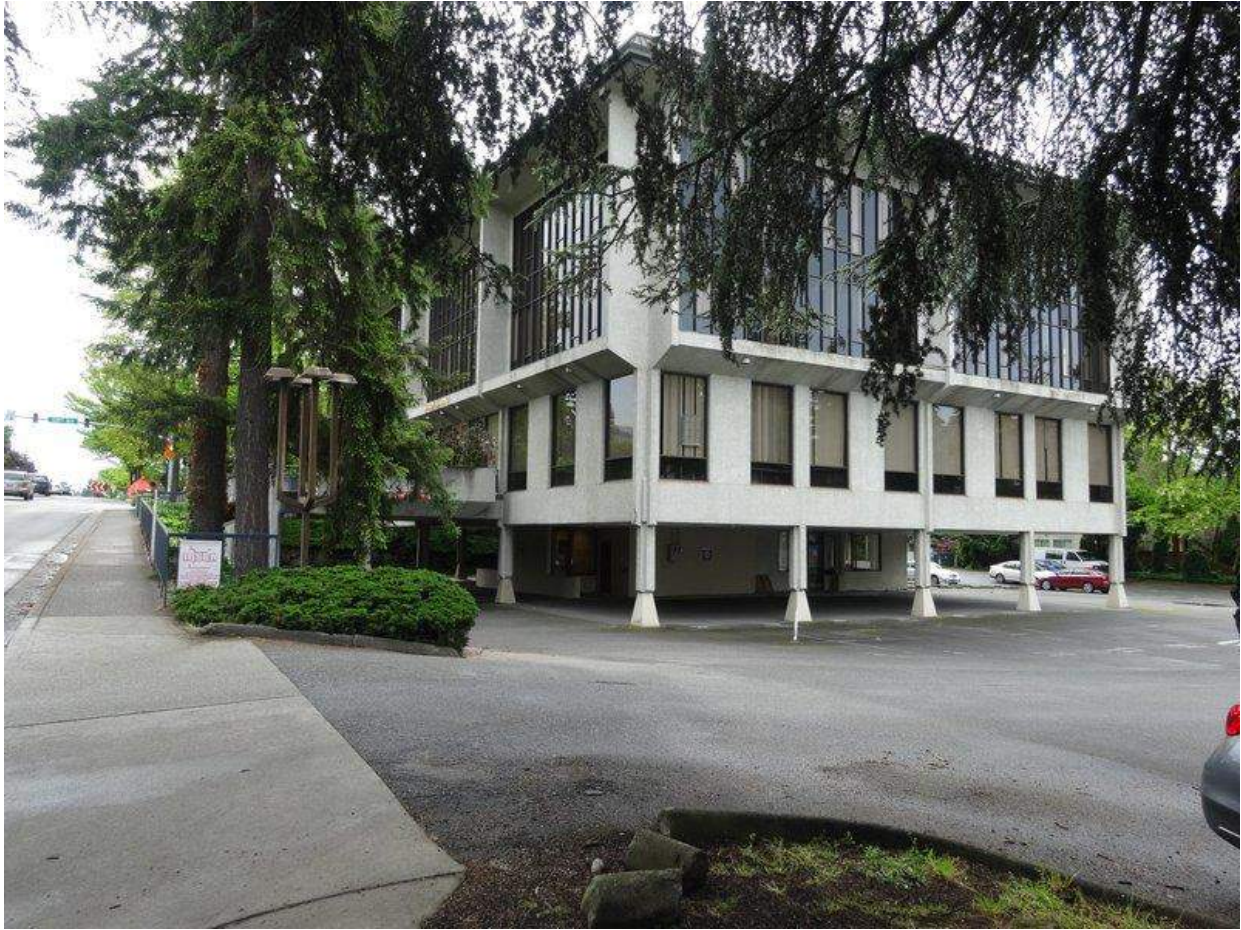
PHOTOGRAPH 15. Surrey Building. North driveway entrance with Main Street at left and the northwest corner of Surrey Building in background. Camera facing east.
