DAHP Level II Mitigation Report

Surrey Building

10777 Main Street
Bellevue, Washington
King County

2018-03-01597

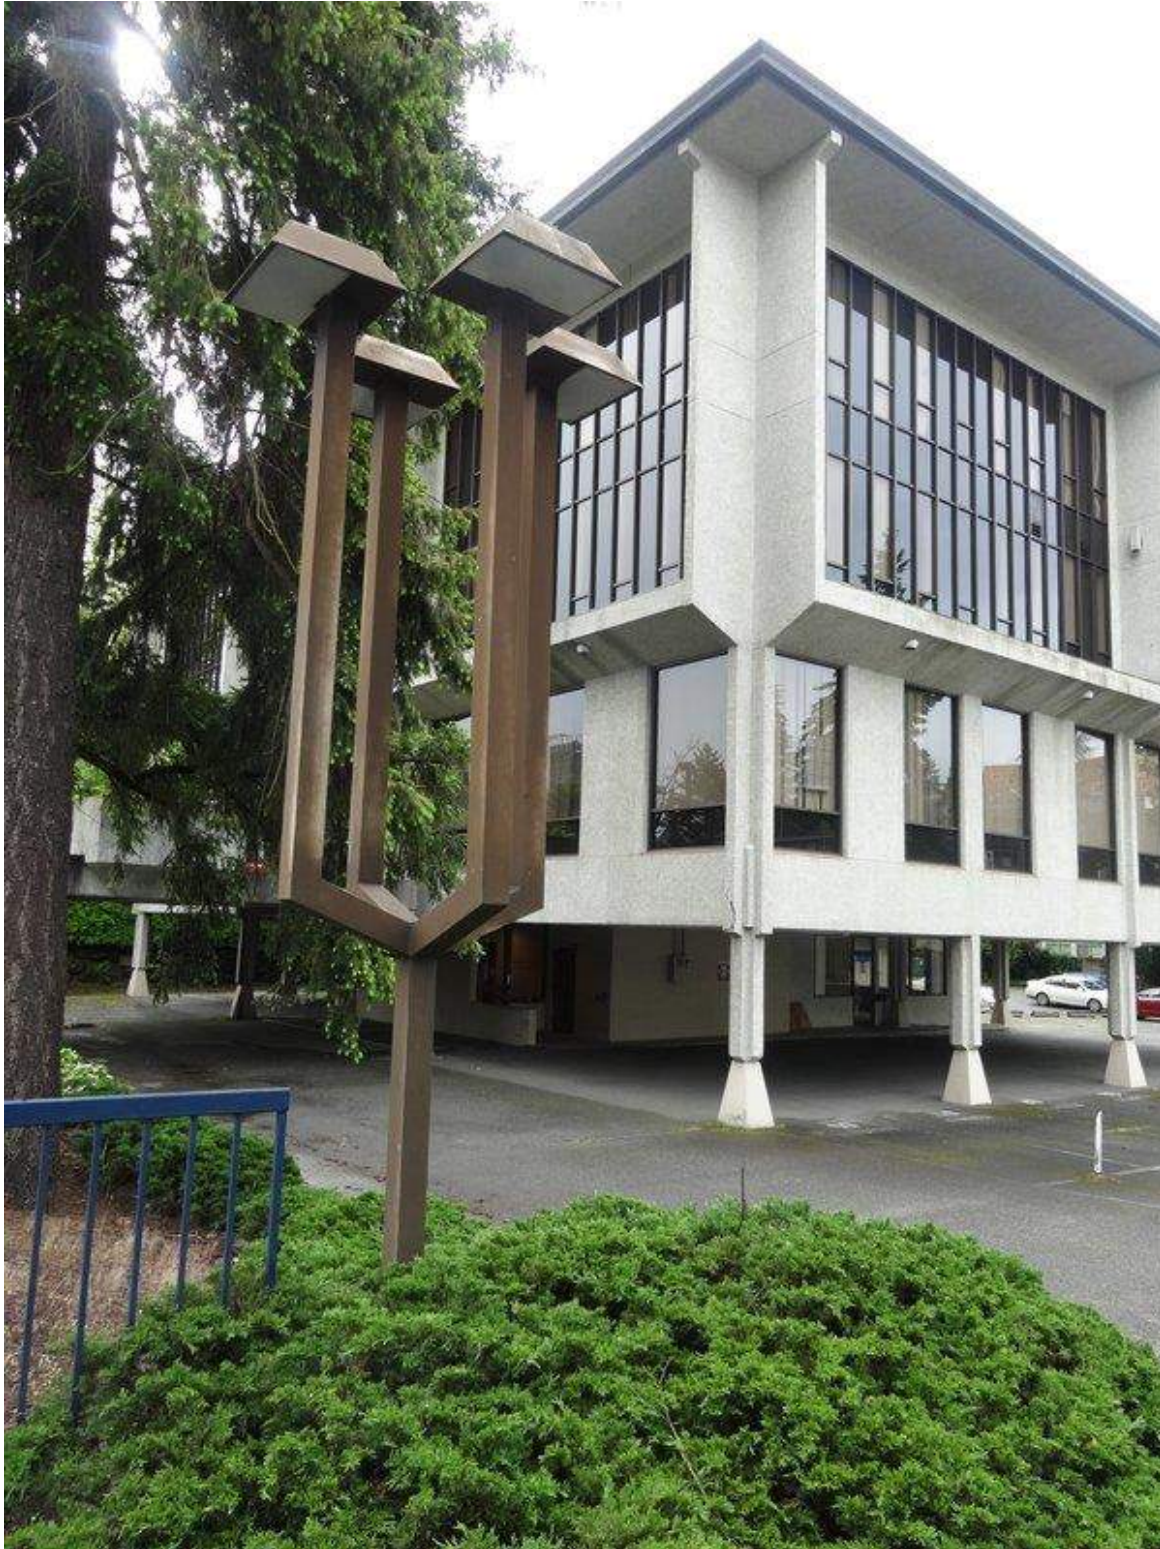
PHOTOGRAPH 16. Surrey Building. Lighting fixture at north driveway and northwest corner of building in the background. Camera facing southeast.

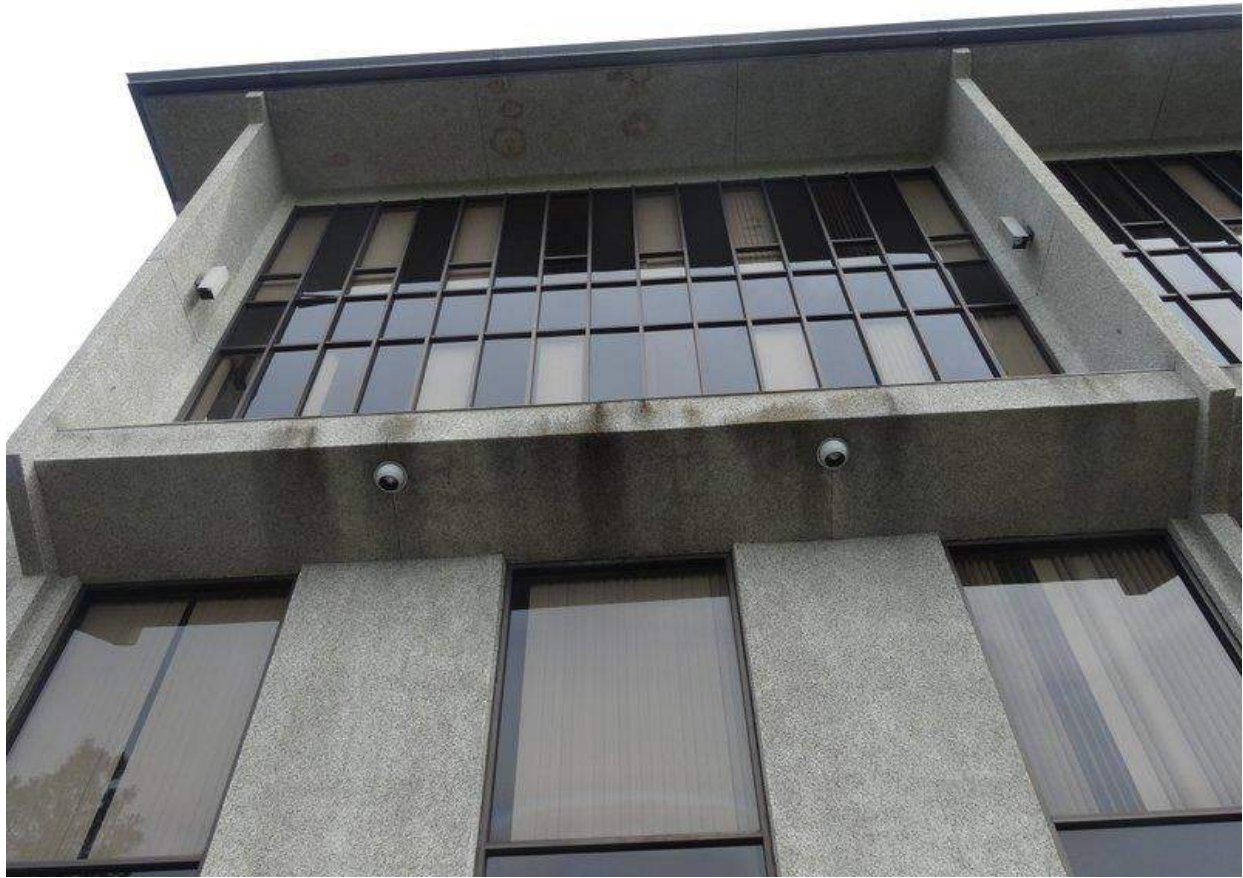
PHOTOGRAPH 17. Surrey Building. Upper west bay on south façade. Camera facing north.

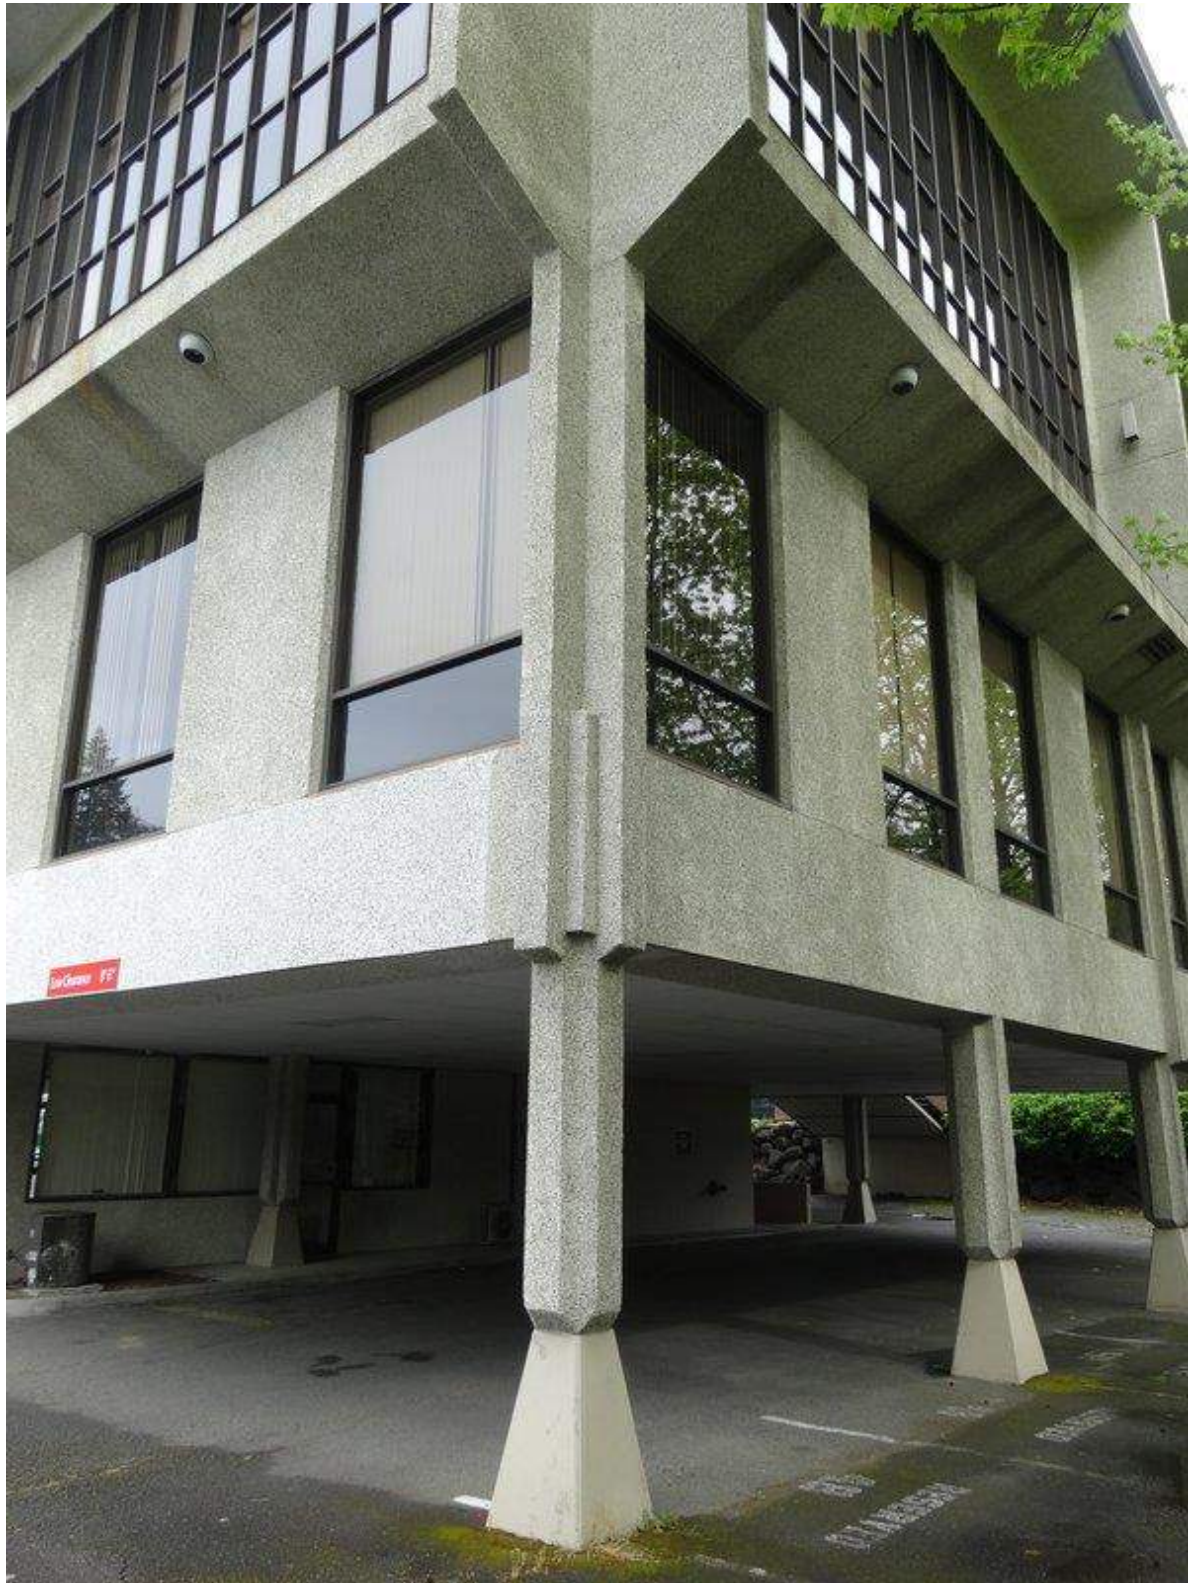
PHOTOGRAPH 18. Surrey Building. Southeast corner of building. Camera facing northwest.

- PHOTO 18. Southeast corner of building. Camera facing northwest.
- PHOTO 19. Southeast corner detail, typical. Camera facing northwest.
- PHOTO 20. Southeast corner base detail, typical. Camera facing northwest.

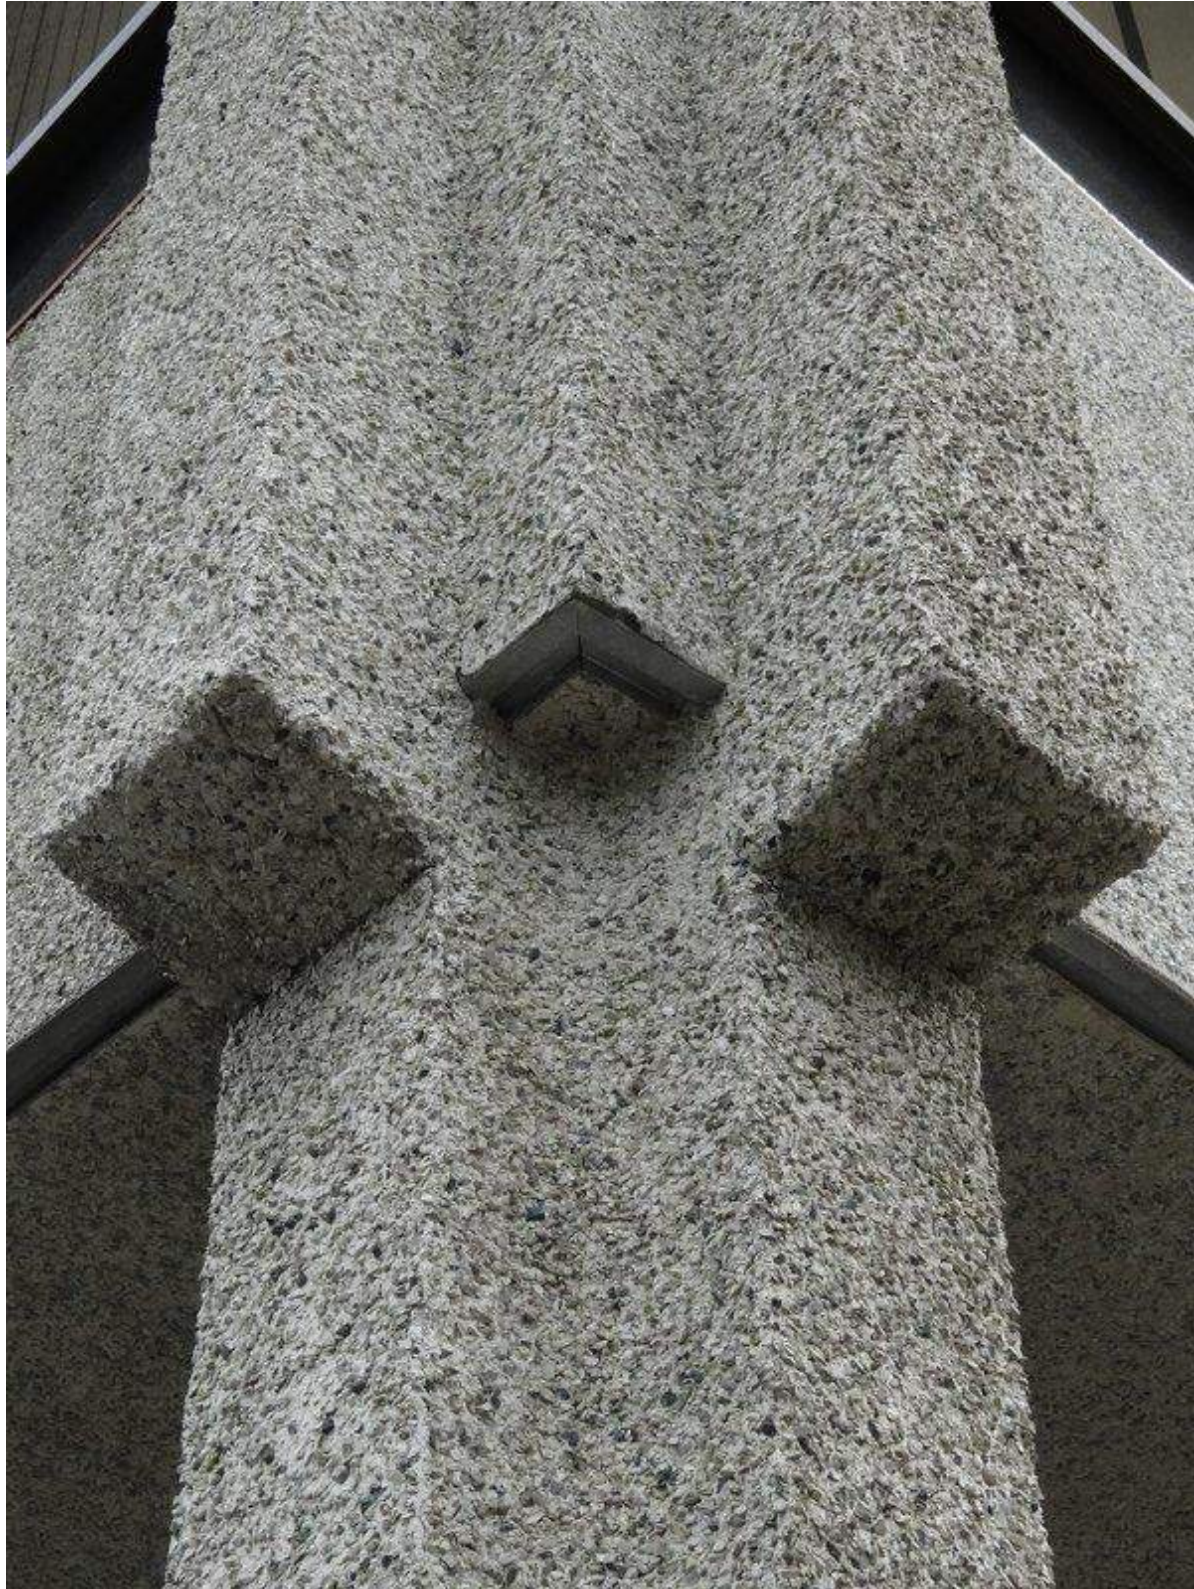
PHOTOGRAPH 19. Surrey Building. Southeast corner detail, typical. Camera facing northwest.

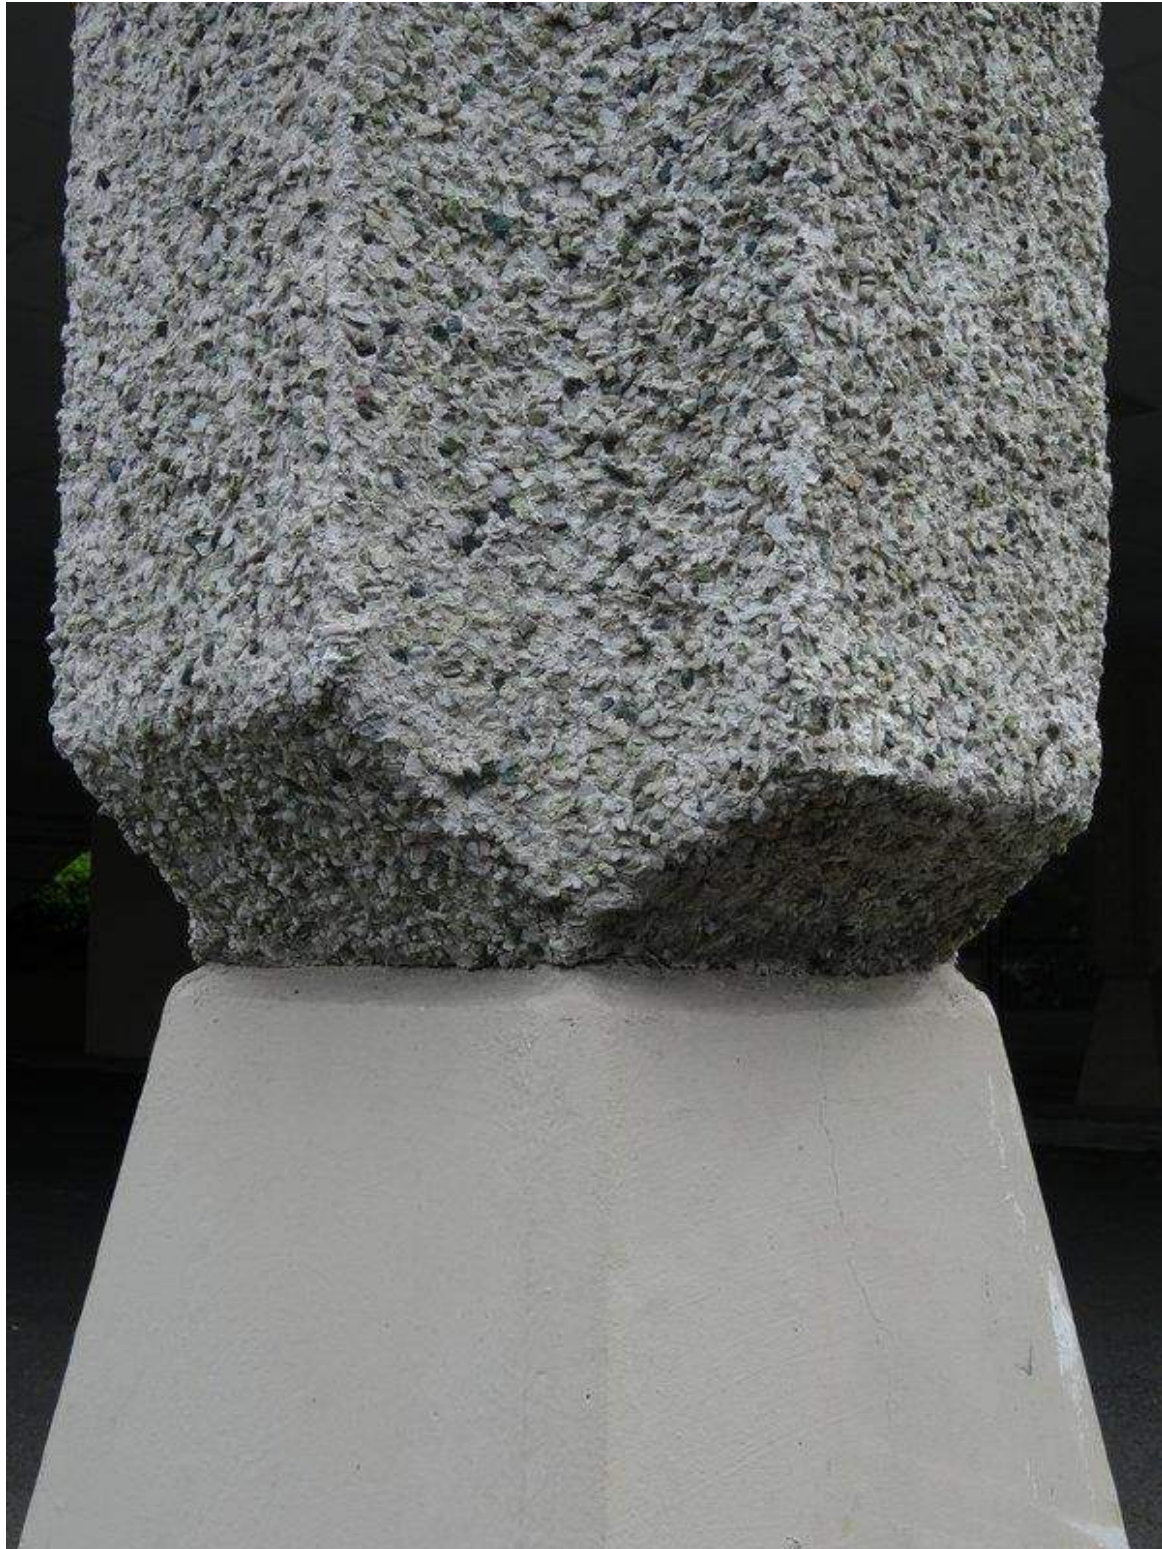
PHOTOGRAPH 20. Surrey Building. Southeast corner base detail, typical. Camera facing northwest.

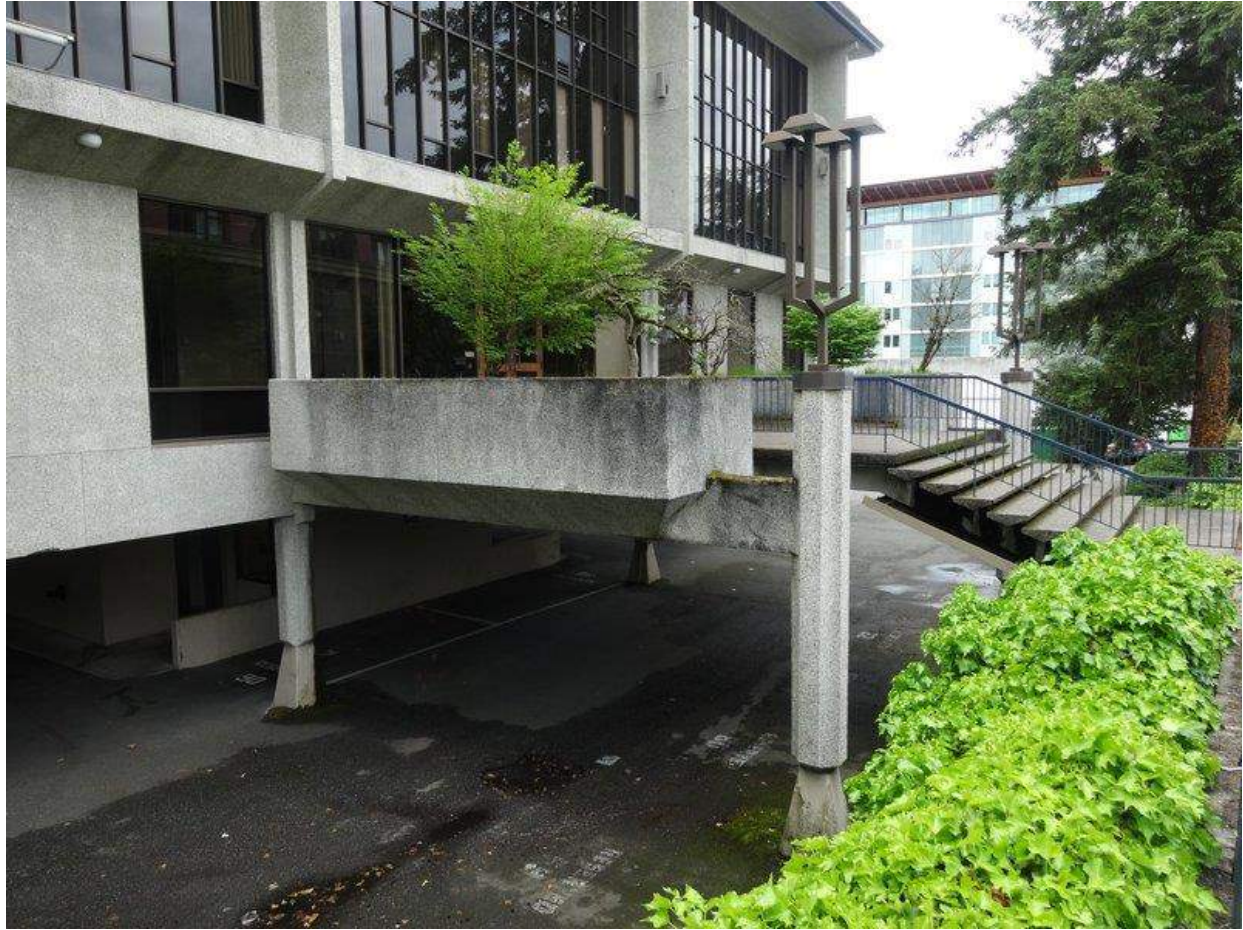
PHOTOGRAPH 21. Surrey Building. View from sidewalk of staircase and bridge to primary entrance. Camera facing southwest.

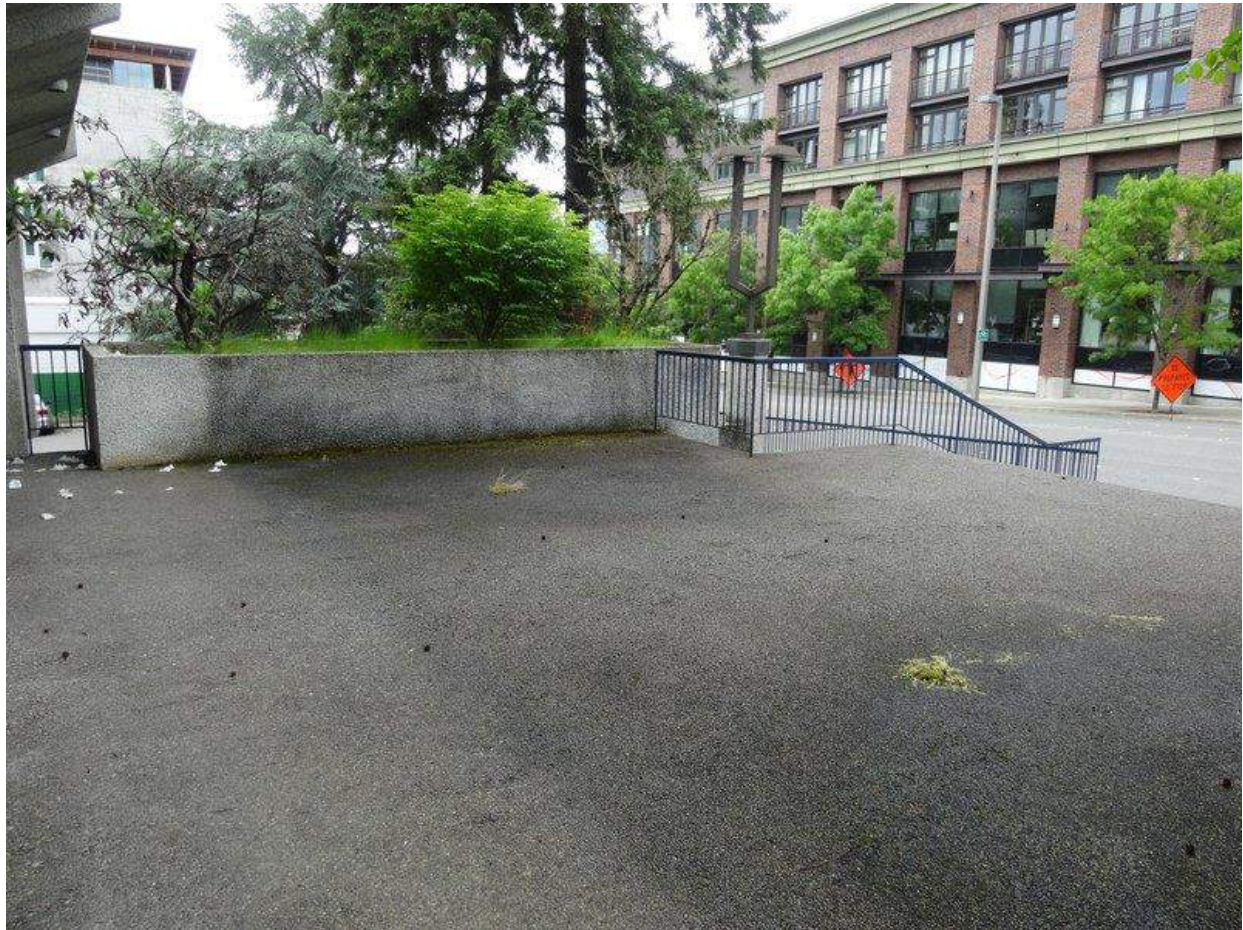
PHOTOGRAPH 22. Surrey Building. Entry bridge with planter at left and Main Street in the background at right. Camera facing northwest.

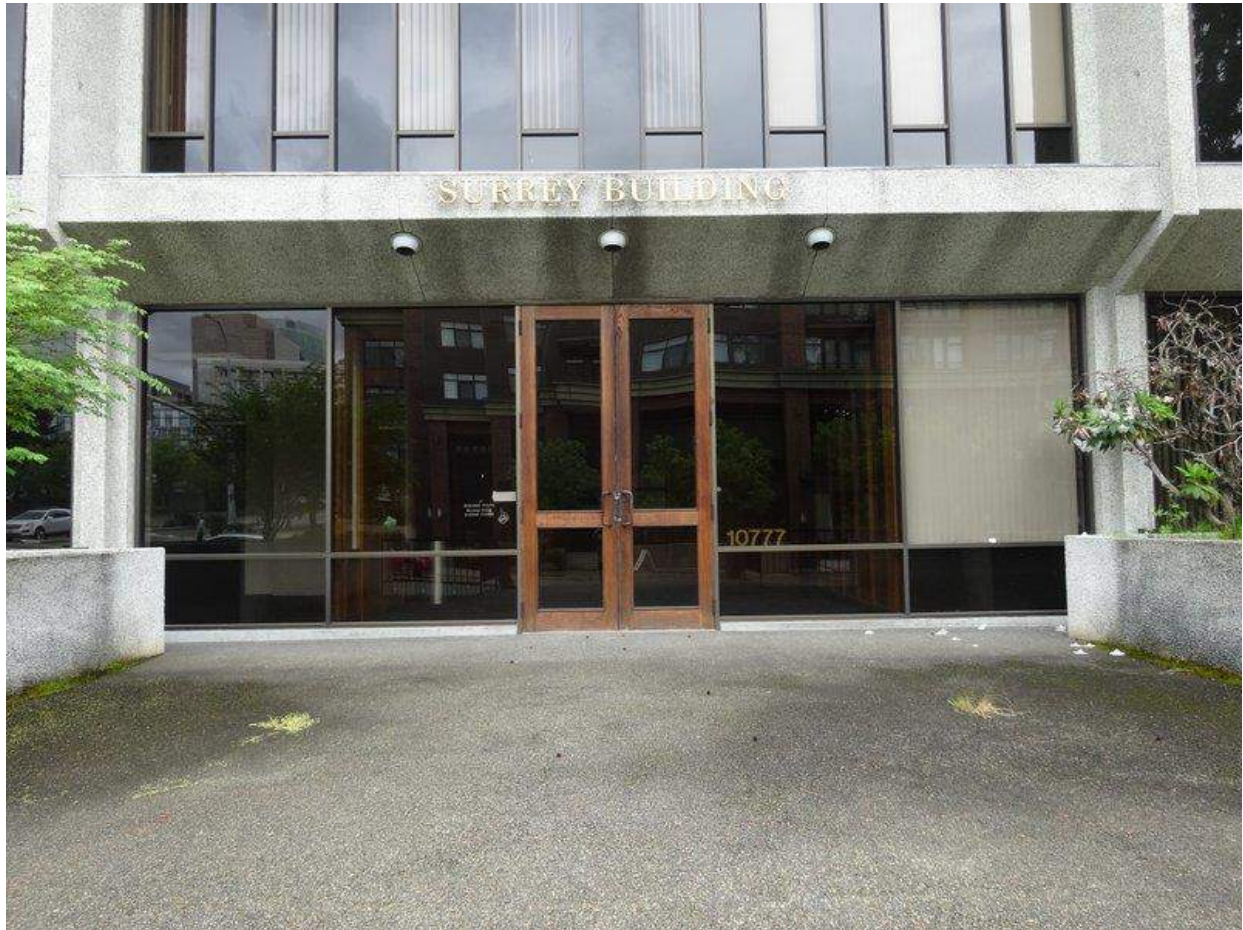
PHOTOGRAPH 23. Surrey Building. Primary entrance on the north façade. Camera facing south.

- PHOTO 23. Primary entrance on the north façade. Camera facing south.
- PHOTO 24. First floor lobby inside the primary entrance. Camera facing northeast.

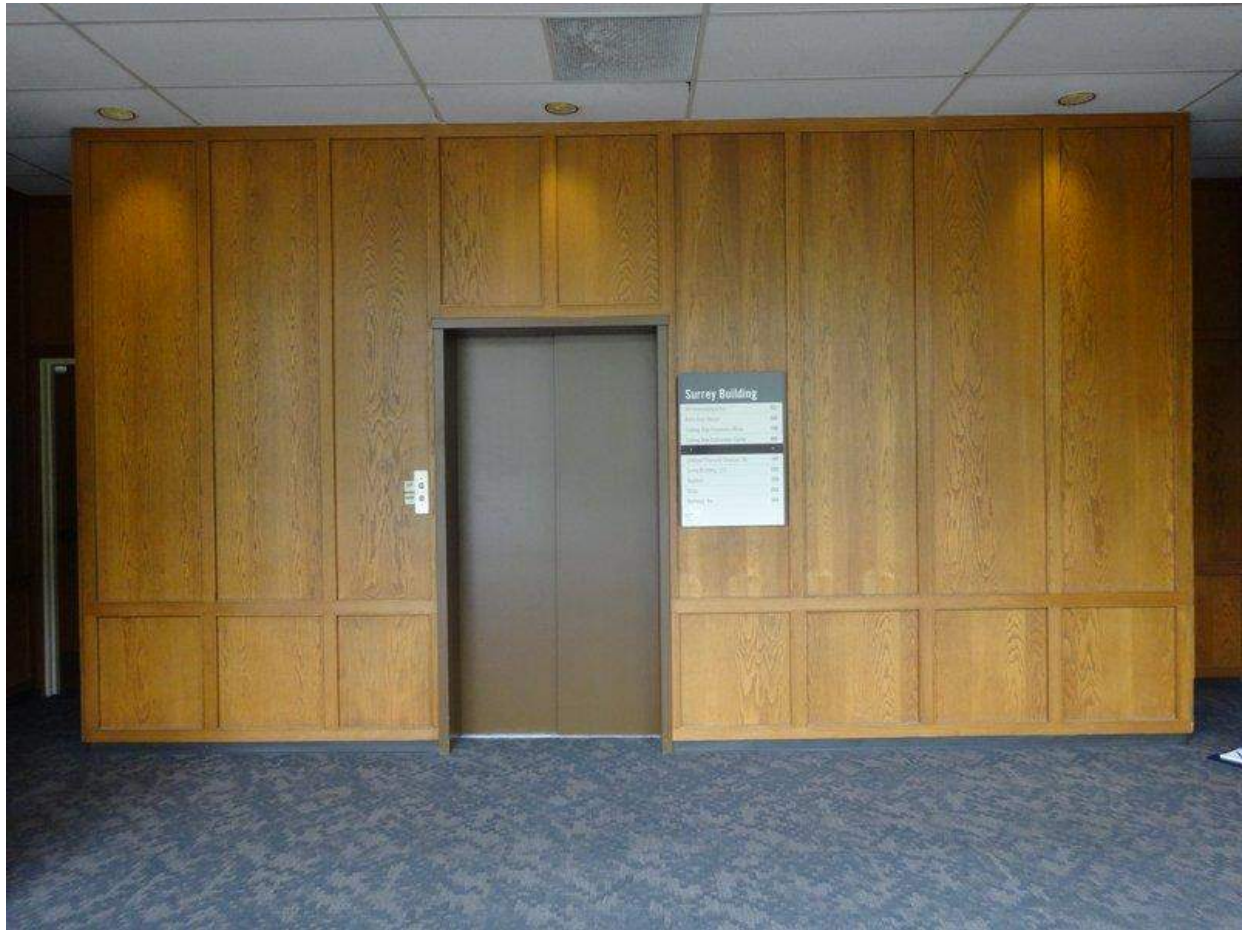
PHOTOGRAPH 26. Surrey Building, first floor lobby. The building's one elevator is located directly opposite the primary entrance. The building has two staircases. Access to the east staircase is through the door pictured at the far left. Not pictured is a men's restroom, also at left, and a women's restroom at the right.

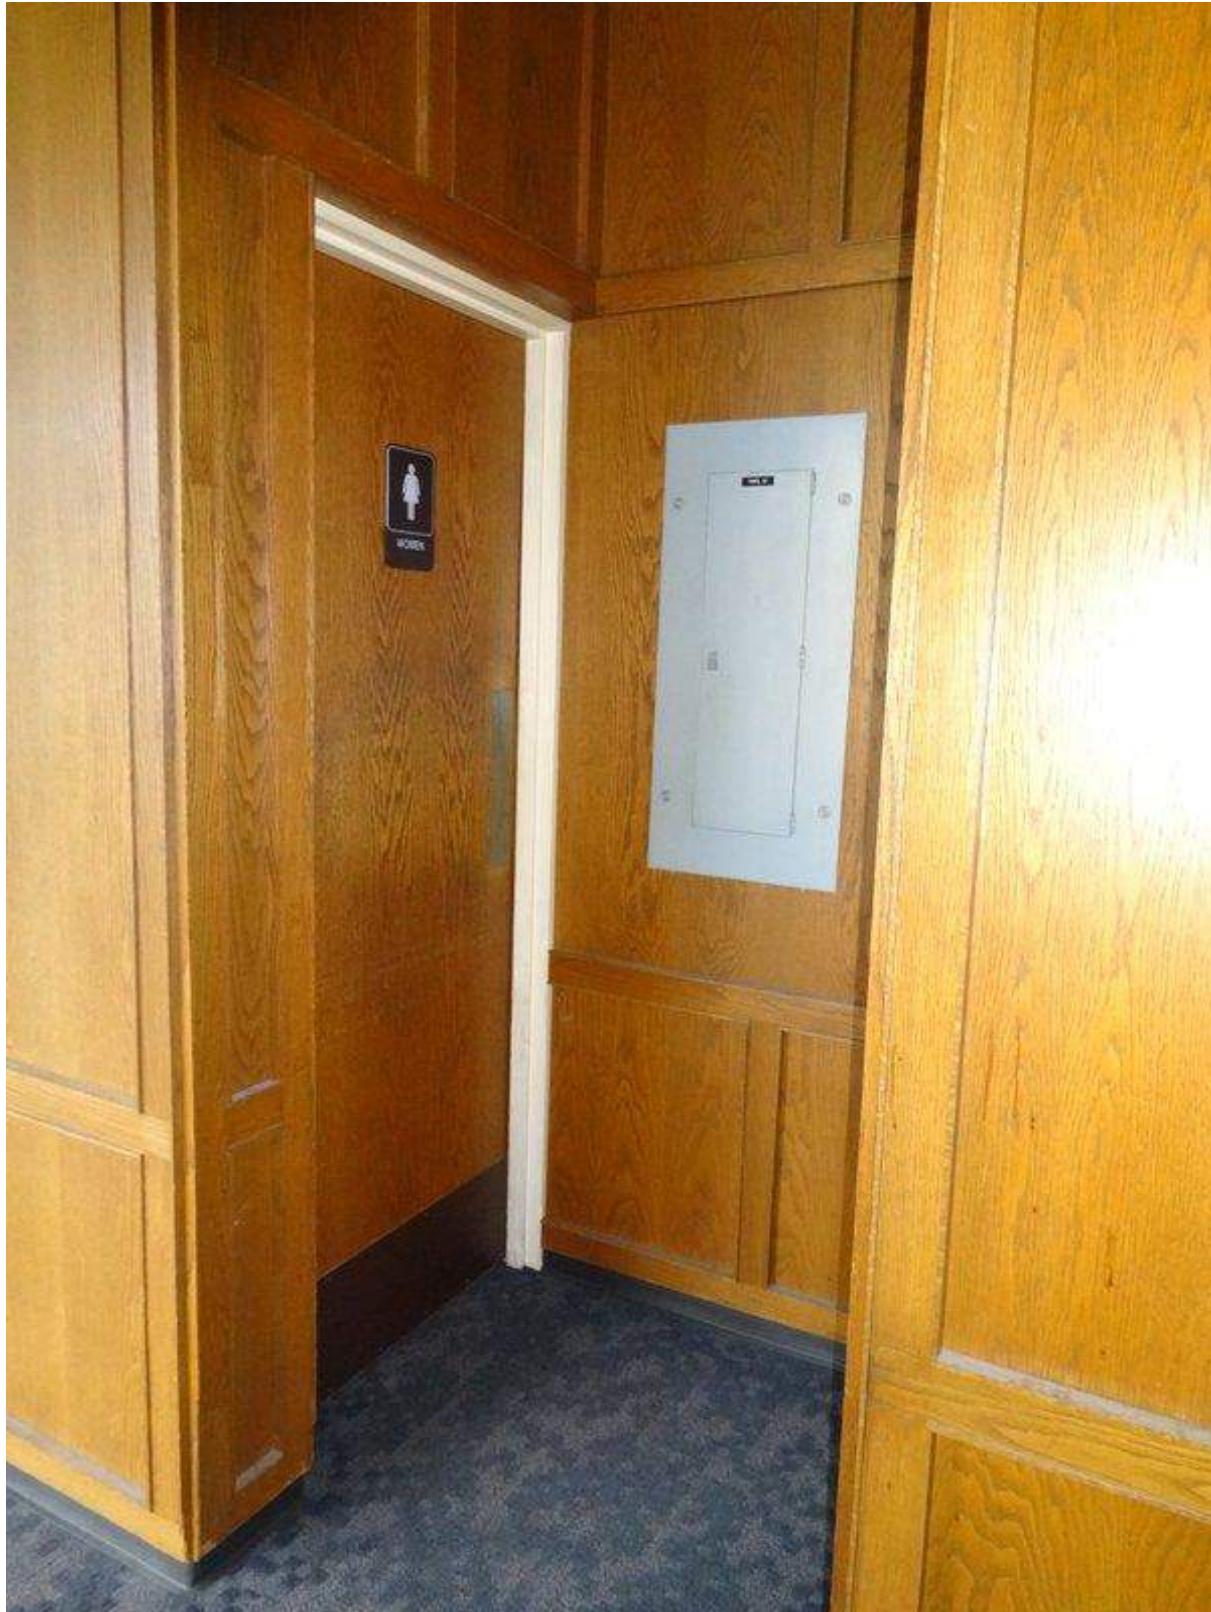
PHOTOGRAPH 27. Surrey Building, first floor women's restroom. Camera facing southeast.

- PHOTO 27. First floor women's restroom. Camera facing southeast.
- PHOTO 28. First floor women's restroom. This is typical of all the building's restrooms. Camera facing south.

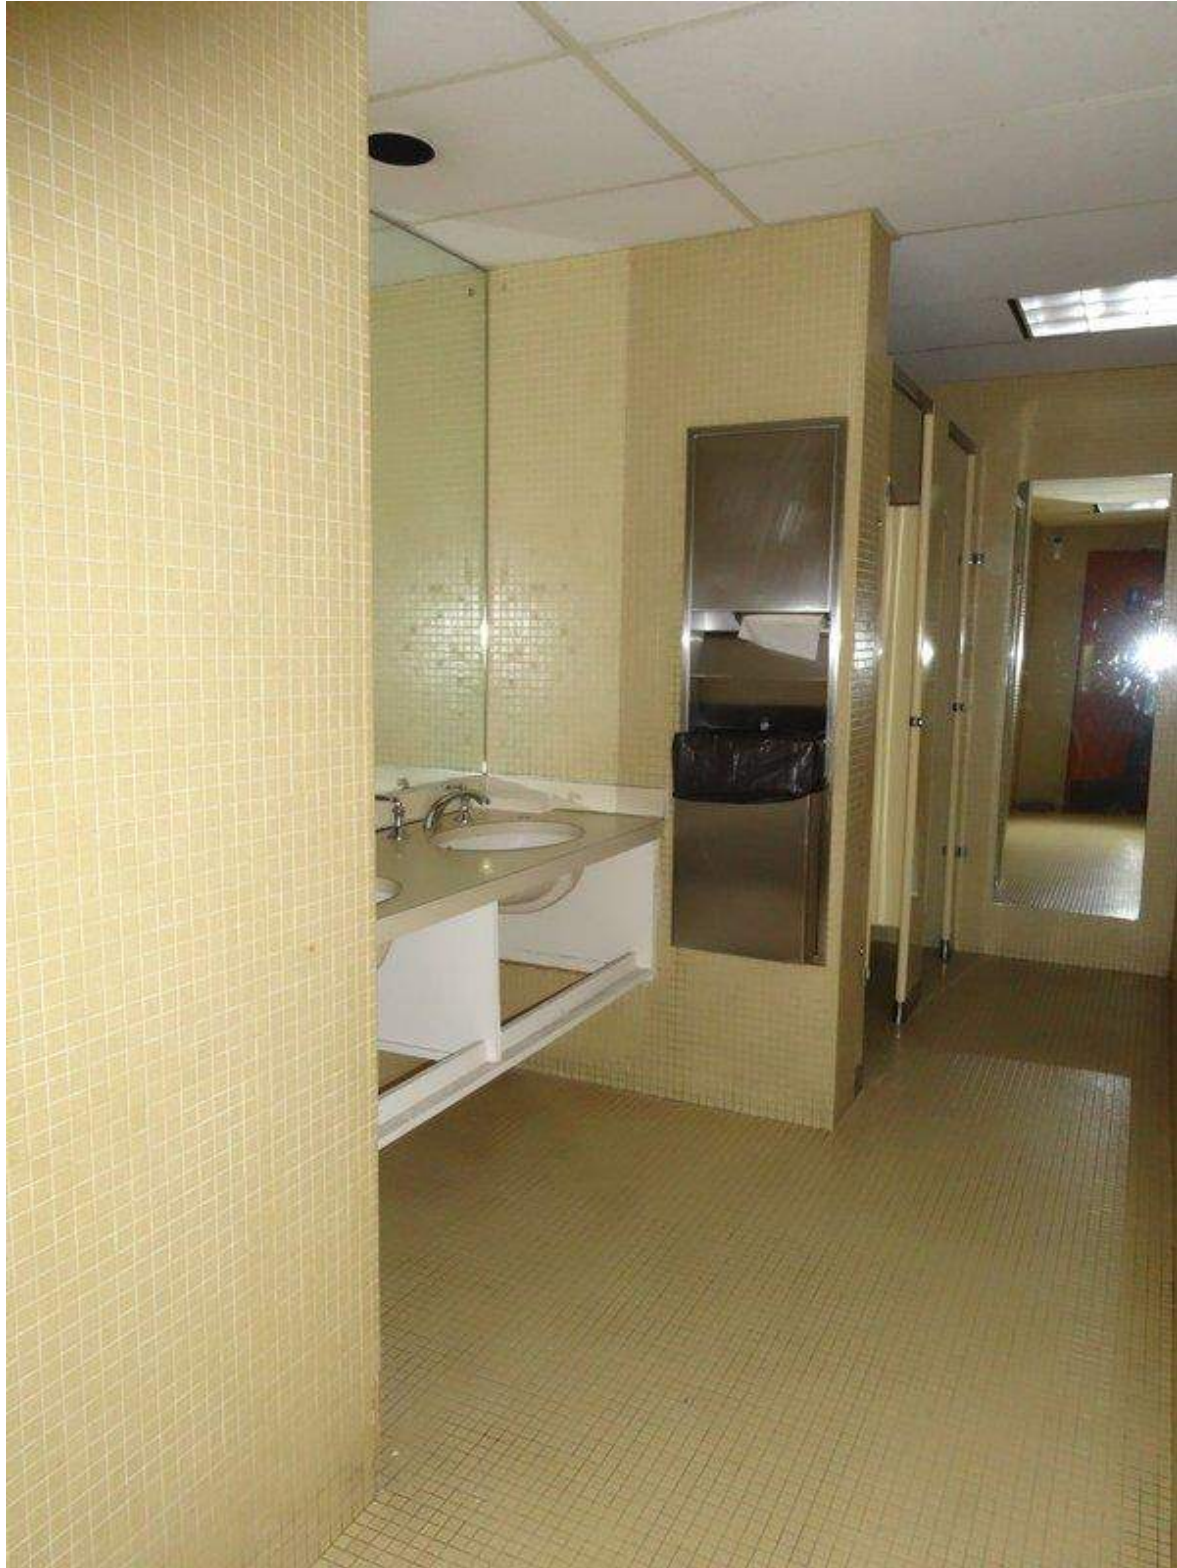
PHOTOGRAPH 28. Surrey Building, first floor women's restroom. This is typical of all the building's restrooms. Camera facing south.

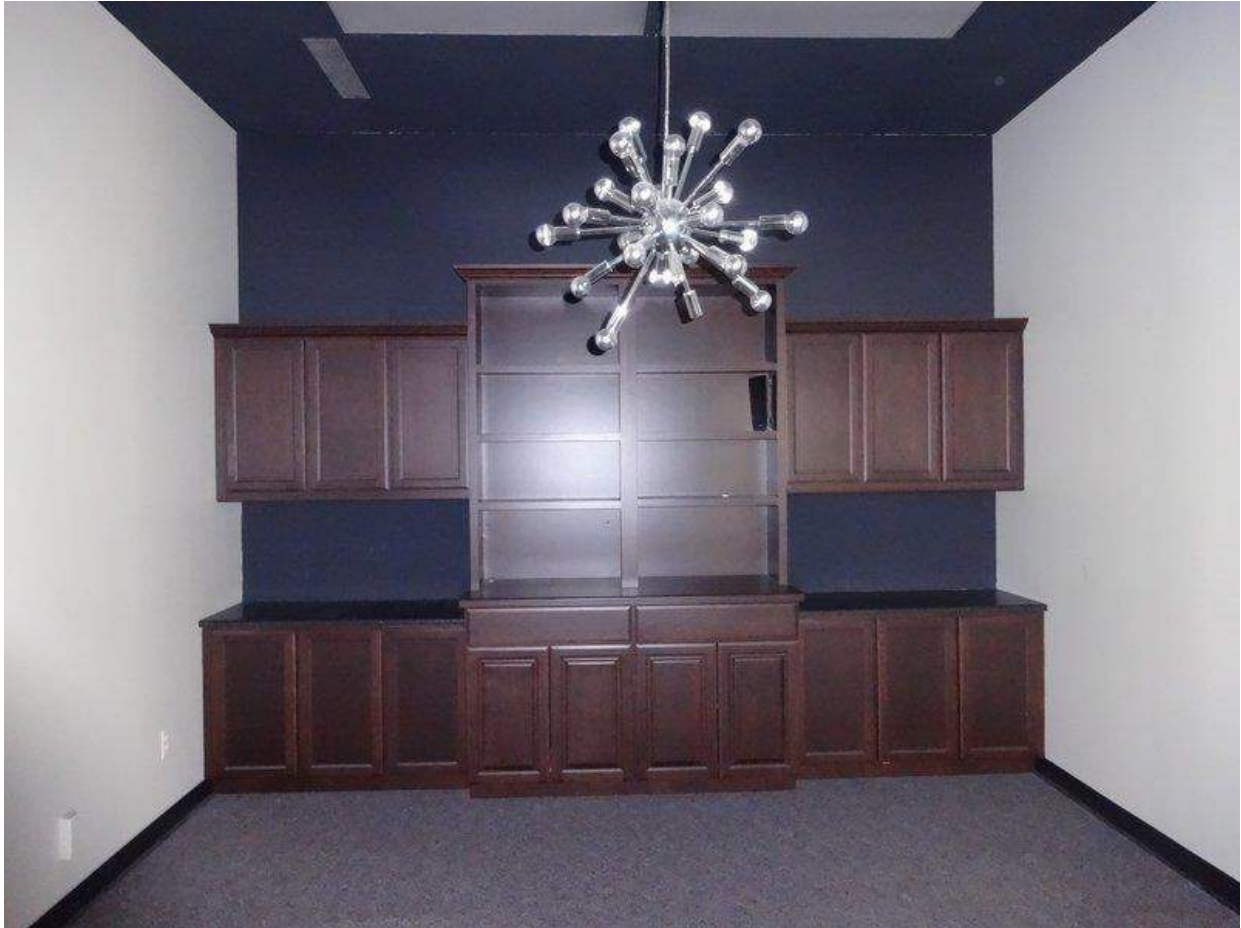
PHOTOGRAPH 33. Surrey Building, first floor. This is in the northwest corner of office suites. The light fixture and finishes are not original. Camera facing south.

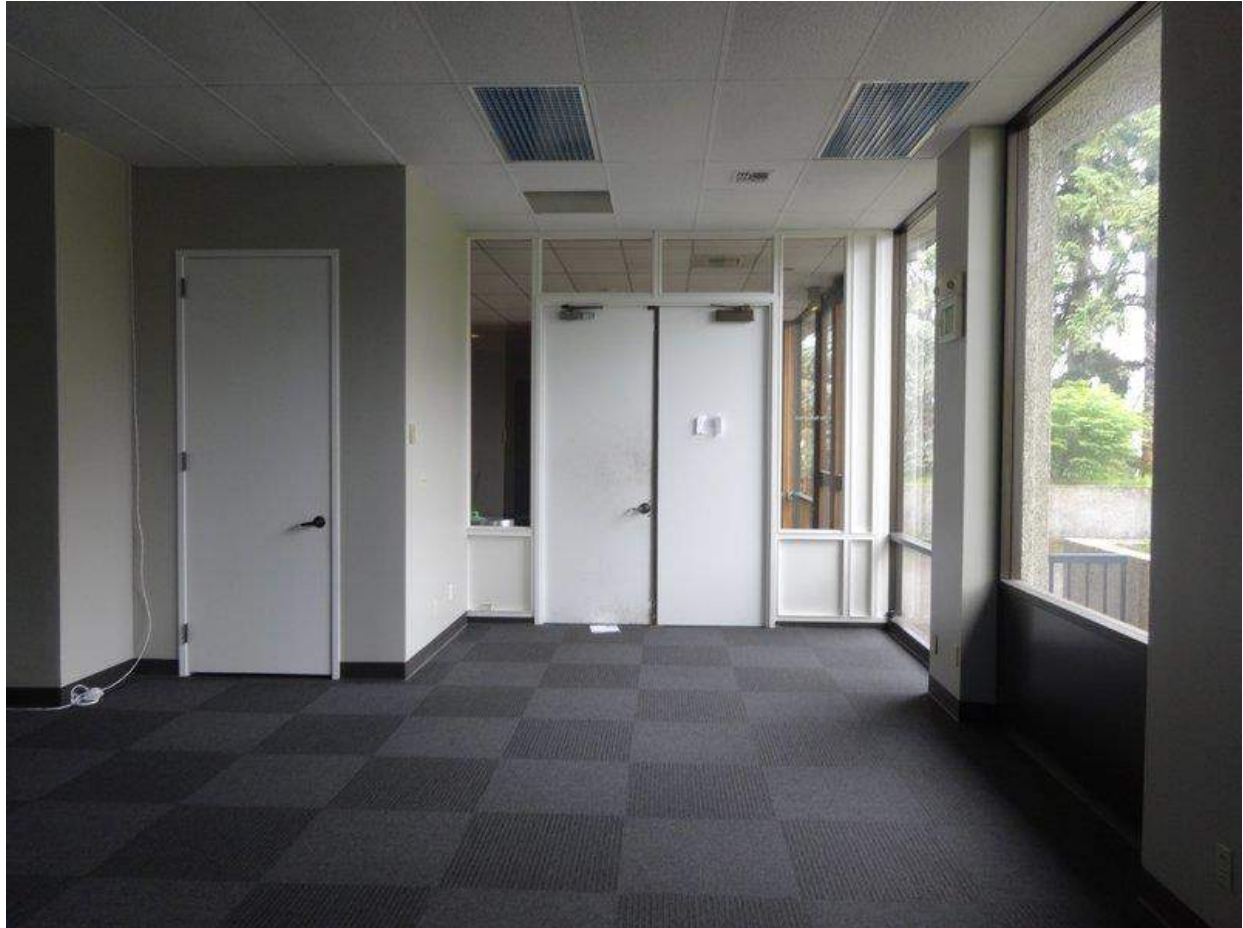
PHOTOGRAPH 34. Surrey Building, first floor. Entry to office suite on the east side of the lobby. The area wraps around the building forming an irregular U-shaped space. Camera facing west.

- PHOTO 34. First floor. Entry to office suite on the east side of the lobby. The area wraps around the building forming an irregular U-shaped space. Camera facing west.

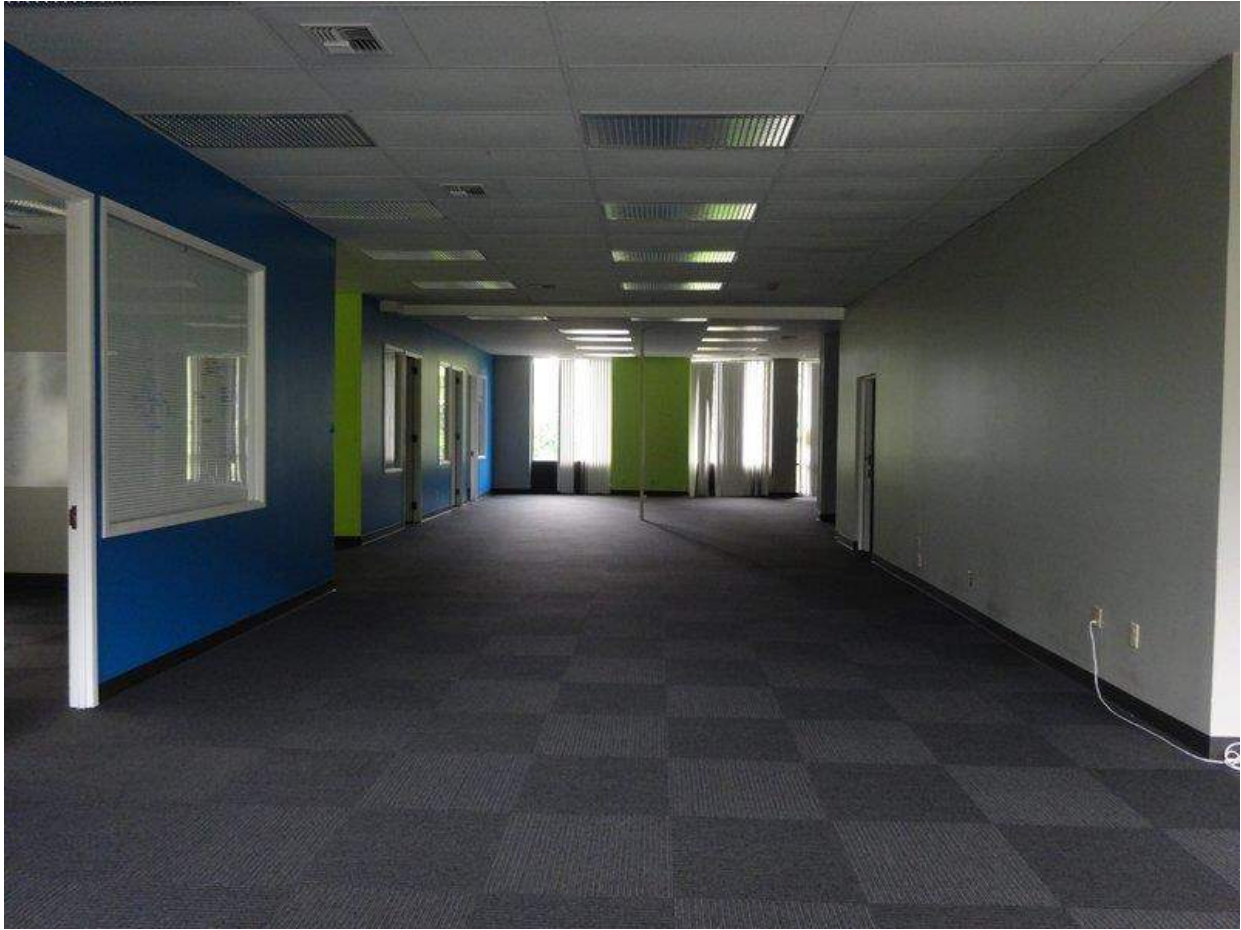
PHOTOGRAPH 35. Surrey Building, first floor. This is the portion of the office suite that occupies the east side of the first floor. This image shows the full width of the building, from north to south. The finishes and office configuration are not original. Camera facing south.

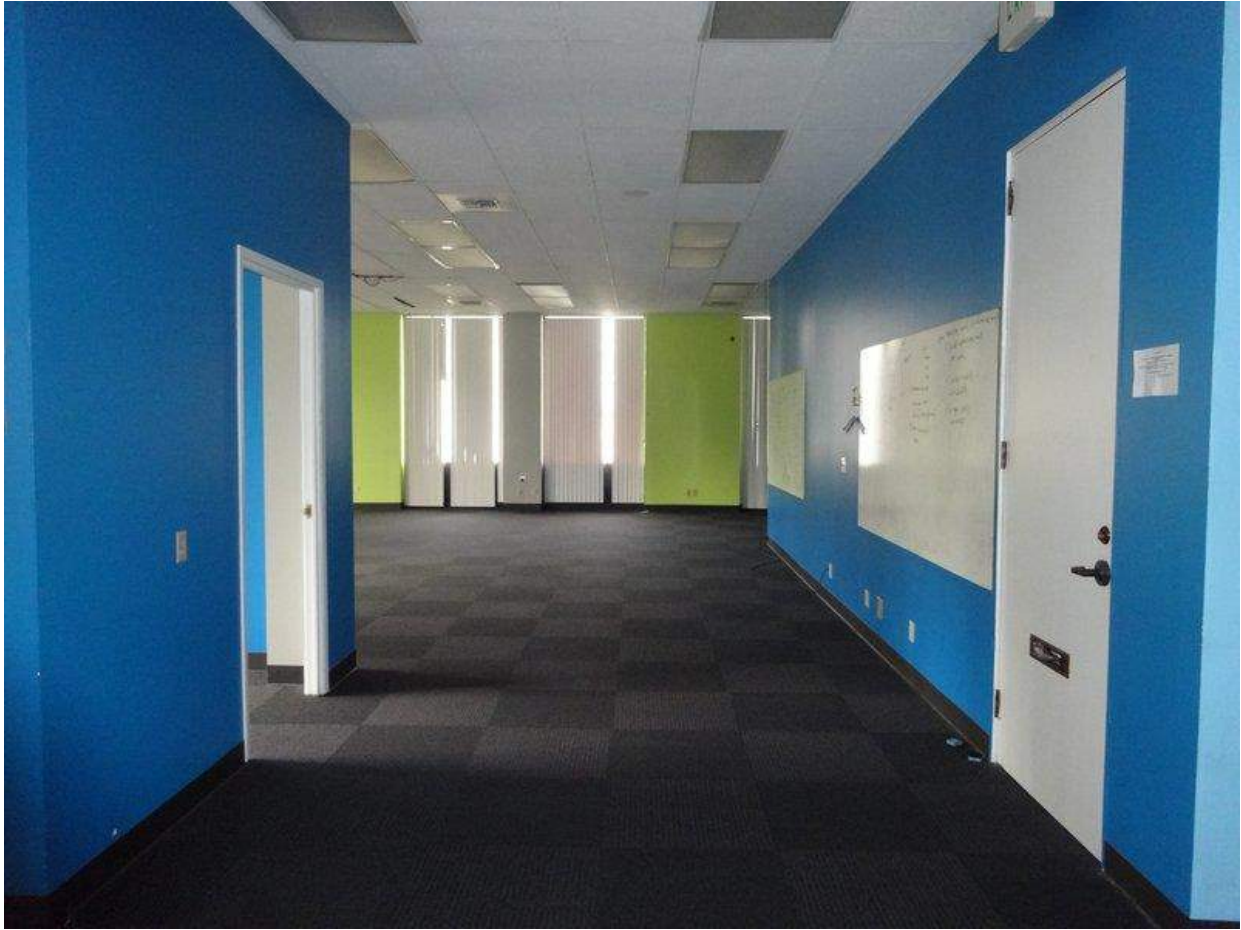
PHOTOGRAPH 36. Surrey Building, first floor. This is the portion of the office suite that occupies the south side of the first floor. This image shows nearly the full width of the building, from east to west. The finishes and office configuration are not original. Camera facing west.
