DAHP Level II Mitigation Report

Surrey Building

10777 Main Street
Bellevue, Washington
King County

2018-03-01597

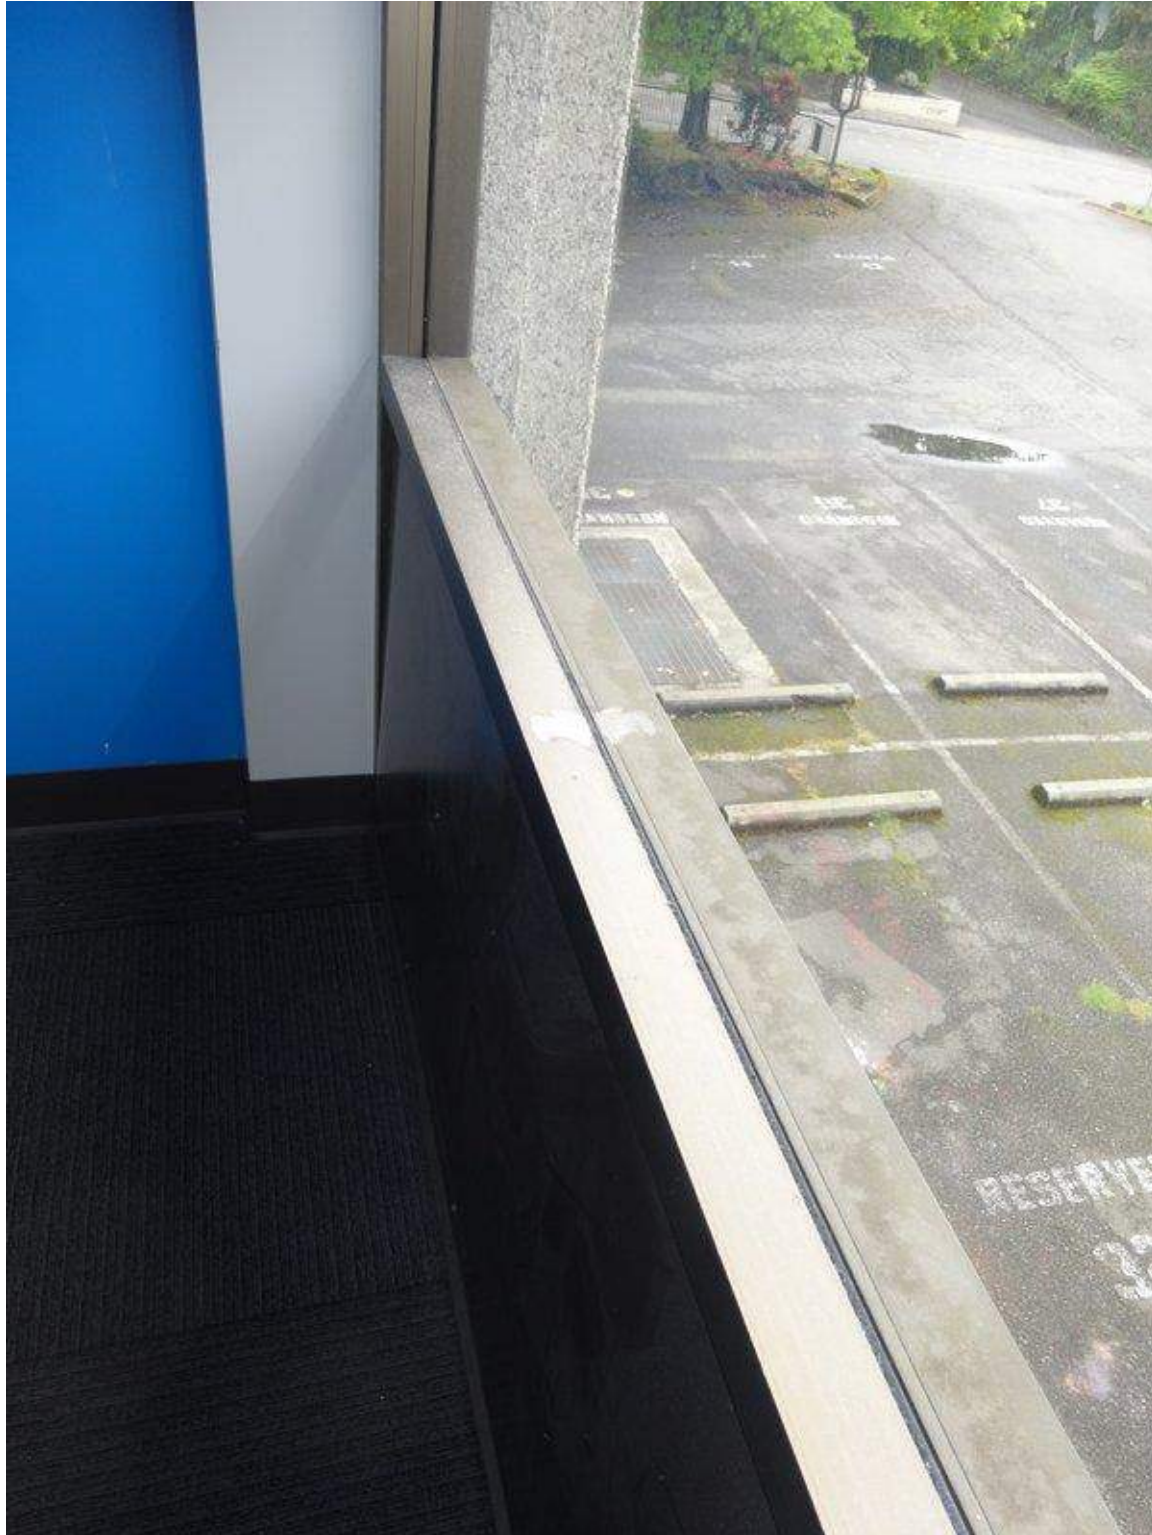
PHOTOGRAPH 37. Surrey Building, first floor. Detail of a window along the south wall. Camera facing east.

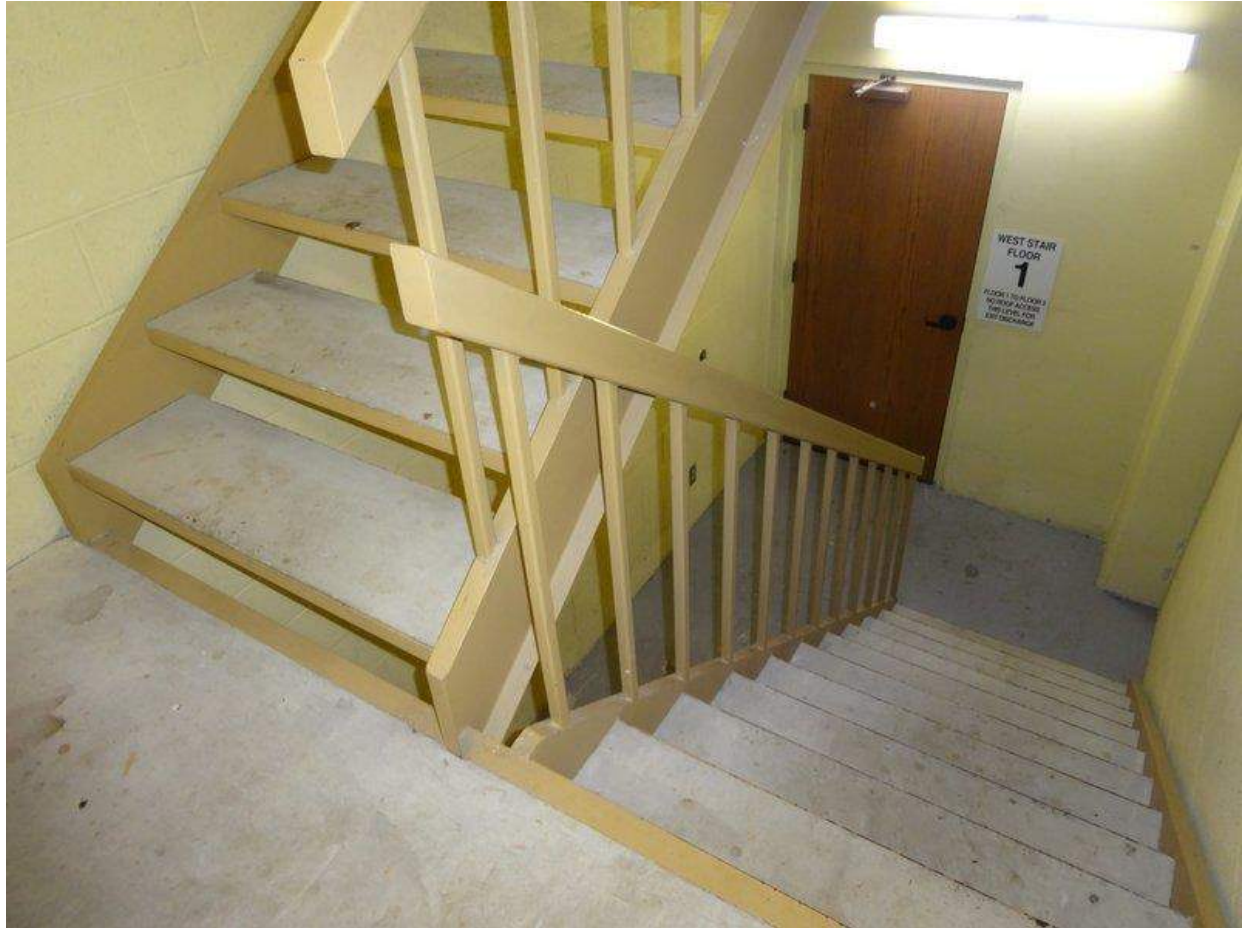
PHOTOGRAPH 38. Surrey Building, west staircase. This is one of two interior staircases that are located on either side of the elevator shaft. This west staircase begins on the first floor and accesses each floor at the southwest portion the building. Camera facing south.

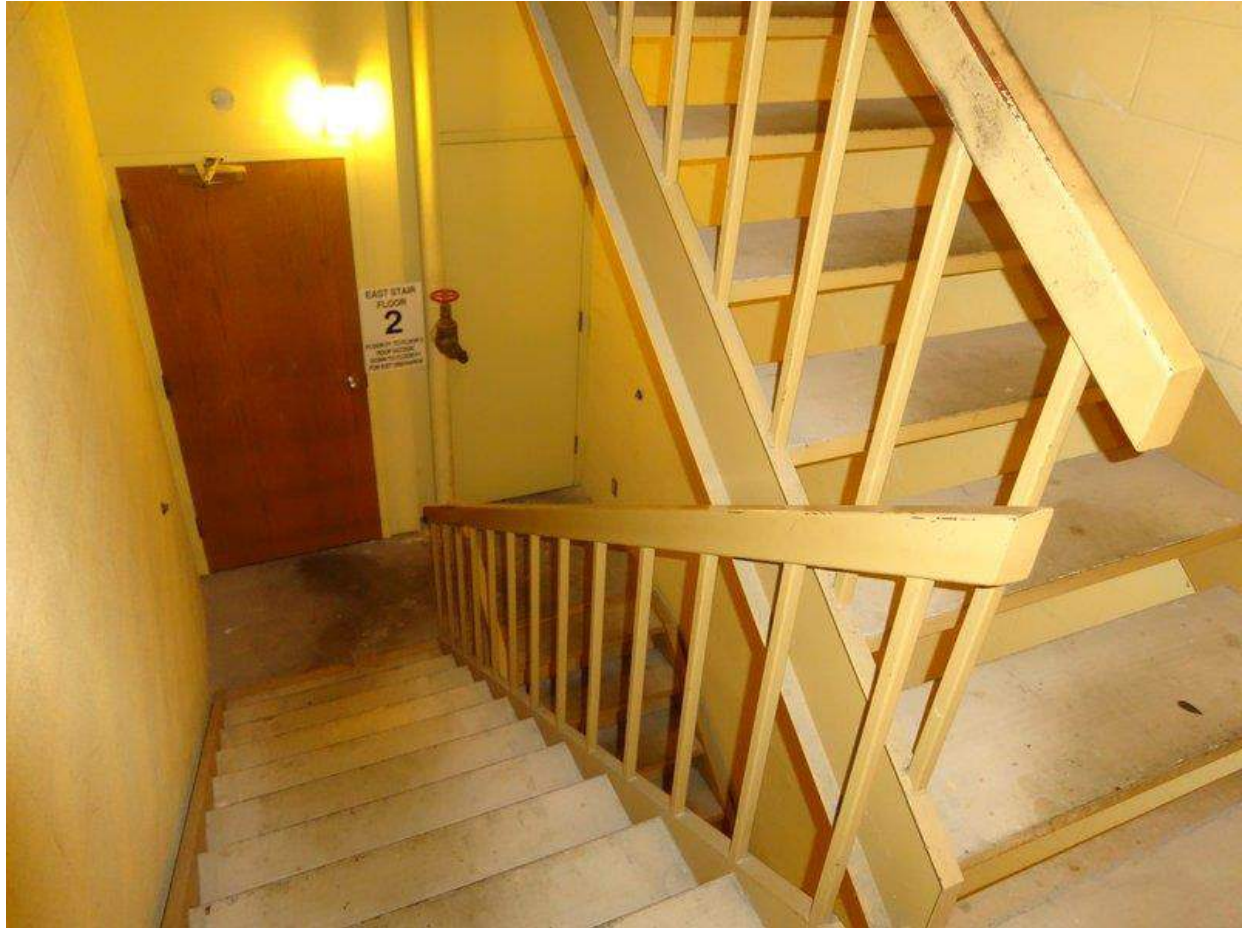
PHOTOGRAPH 39. Surrey Building, east staircase. This is one of two interior staircases that are located on either side of the elevator shaft. This east staircase begins on the ground floor and accesses each floor at the northeast portion the building. Camera facing north.

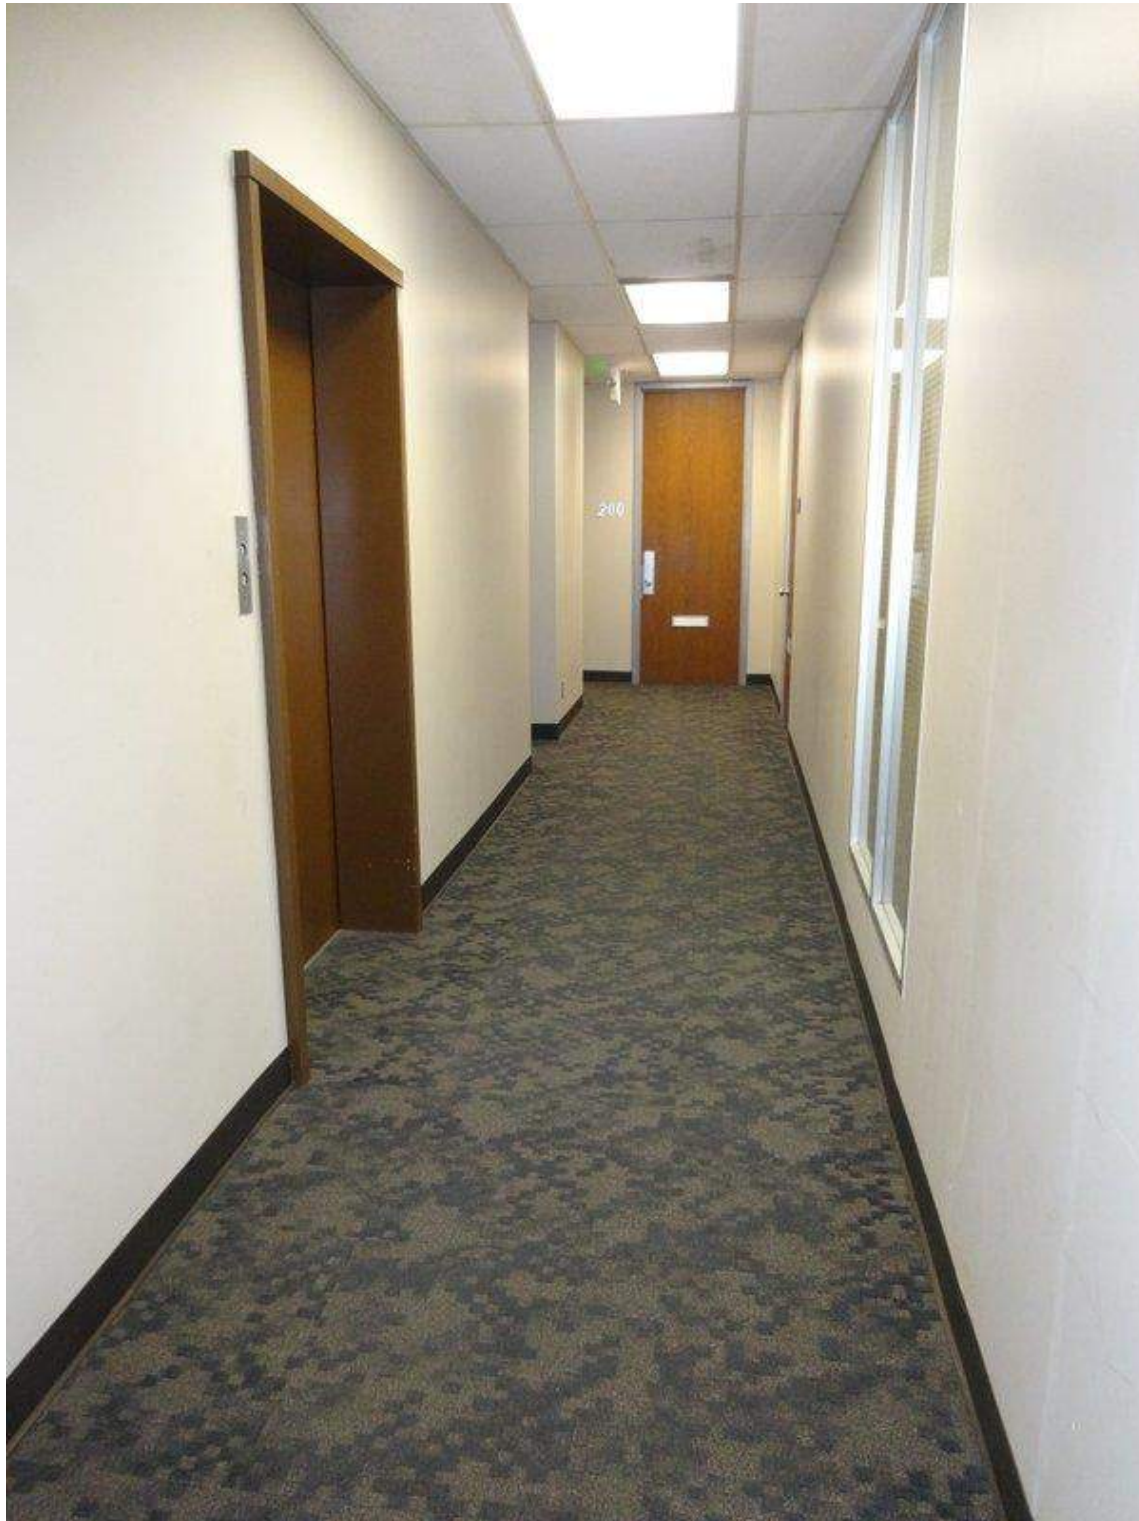
PHOTOGRAPH 40. Surrey Building, second floor. This is the east-west corridor, with the elevator at left and office suites at center and right. The hallway is 60" wide. Note the interior window at right, which also is shown in photograph 42. Camera facing west.

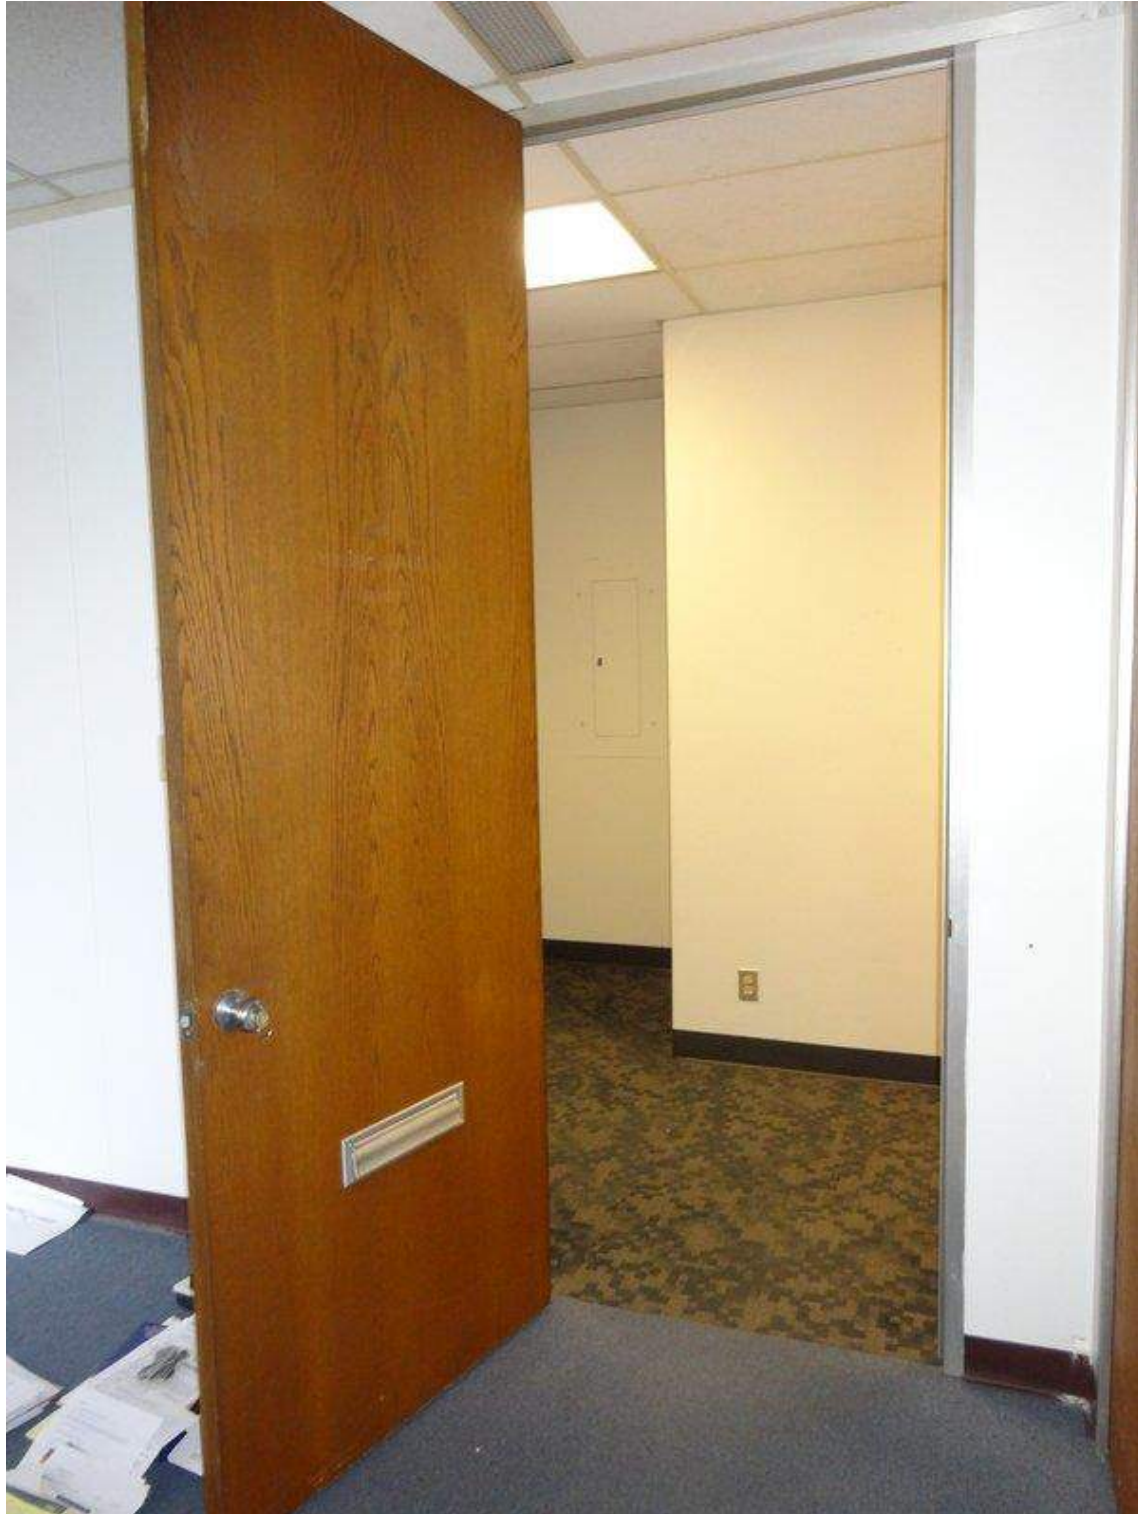
PHOTOGRAPH 41. Surrey Building, second floor. Entry into the office suite located along the north side of the building. This is a typical door, measuring 101" x 35", and has metal framing. Camera facing south.

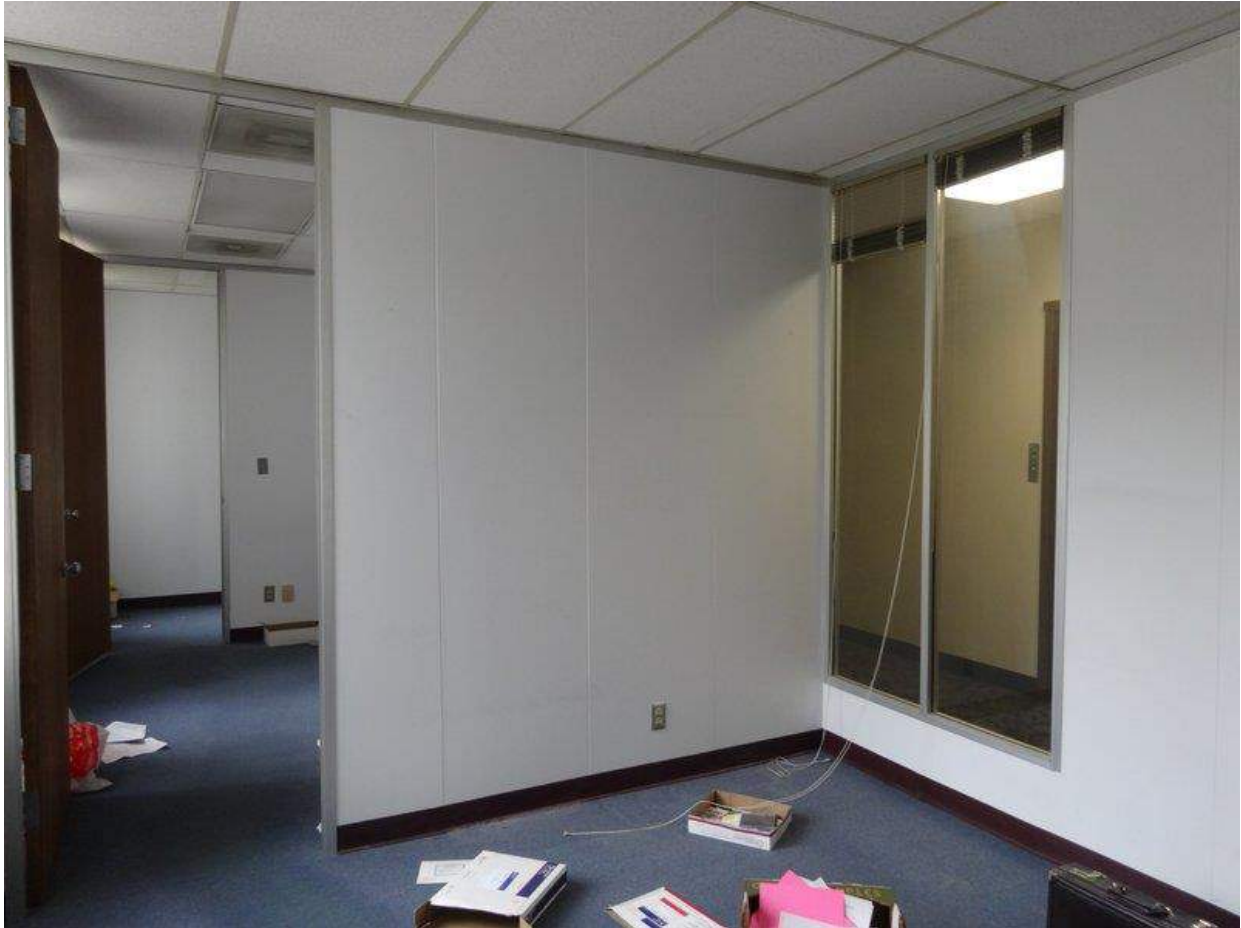
PHOTOGRAPH 42. Surrey Building, second floor. This is the suite of offices along the north side of the building. Note the metal door framing and scored walls, which are found throughout the second floor and appear to be original. The window looks into the hallway by the elevator. Camera facing southeast.

- PHOTO 42. Second floor. This is the suite of offices along the north side of the building. Note the metal door framing and scored walls, which are found throughout the second

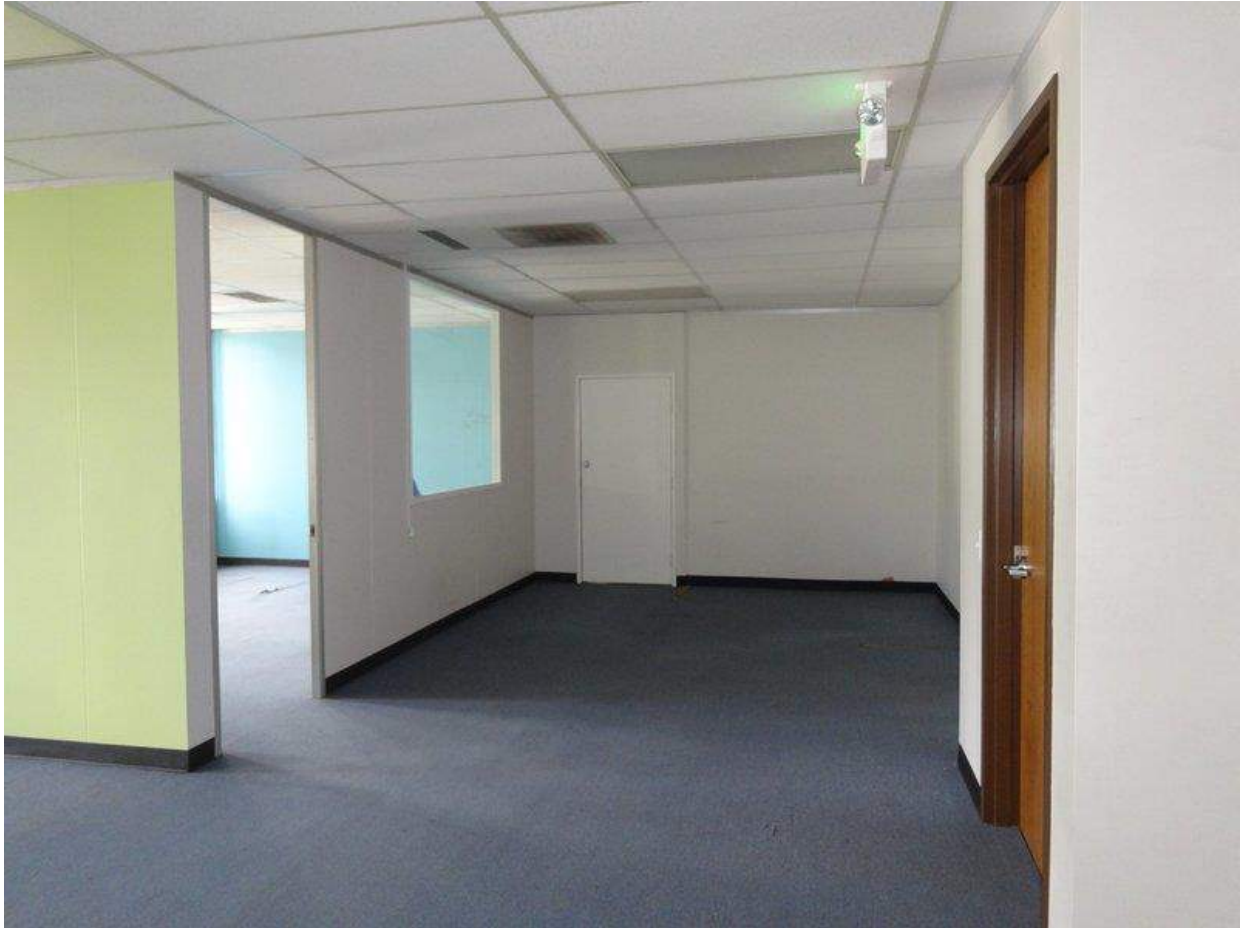
PHOTOGRAPH 43. Surrey Building, second floor. This area is part of a grouping of office suites along the west and south portions of the building. Note the scored walls and metal door framing. Camera facing north.

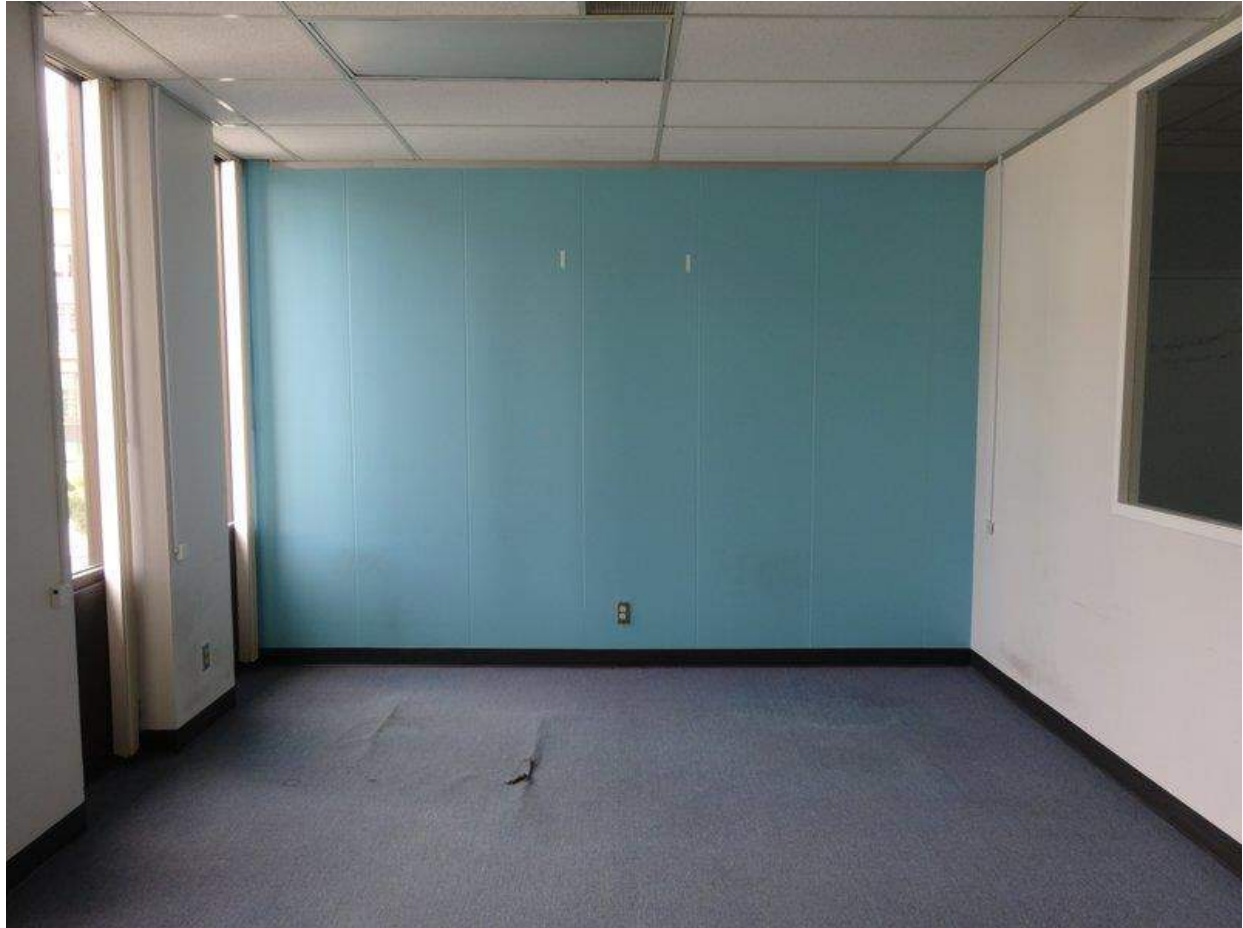
PHOTOGRAPH 44. Surrey Building, second floor. This office is along the west wall of the building (at left) and is part of a grouping of office suites along the west and south portions of the building. Note the scored walls. Camera facing north.

- PHOTO 44. Second floor. This office is along the west wall of the building (at left) and is part of a grouping of office suites along the west and south portions of the building. Note the scored walls. Camera facing north.

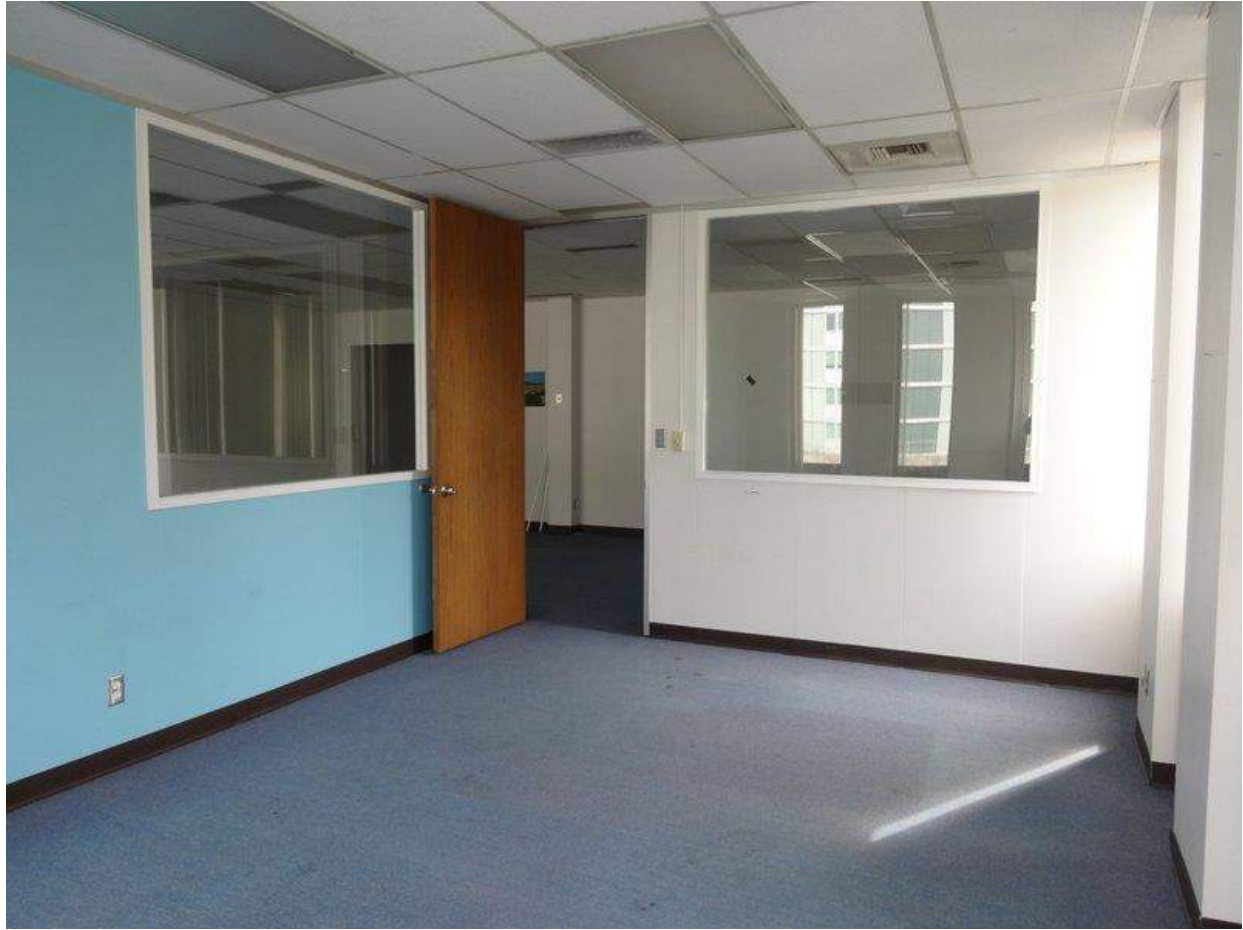
PHOTOGRAPH 45. Surrey Building, second floor. This office is in the southwest corner of the building and is part of a grouping of office suites along the west and south portions of the building. Note the scored walls and metal door framing. Camera facing northeast.

- PHOTO 45. Second floor. This office is in the southwest corner of the building and is part of a grouping of office suites along the west and south portions of the building. Note the scored walls and metal door framing. Camera facing northeast.

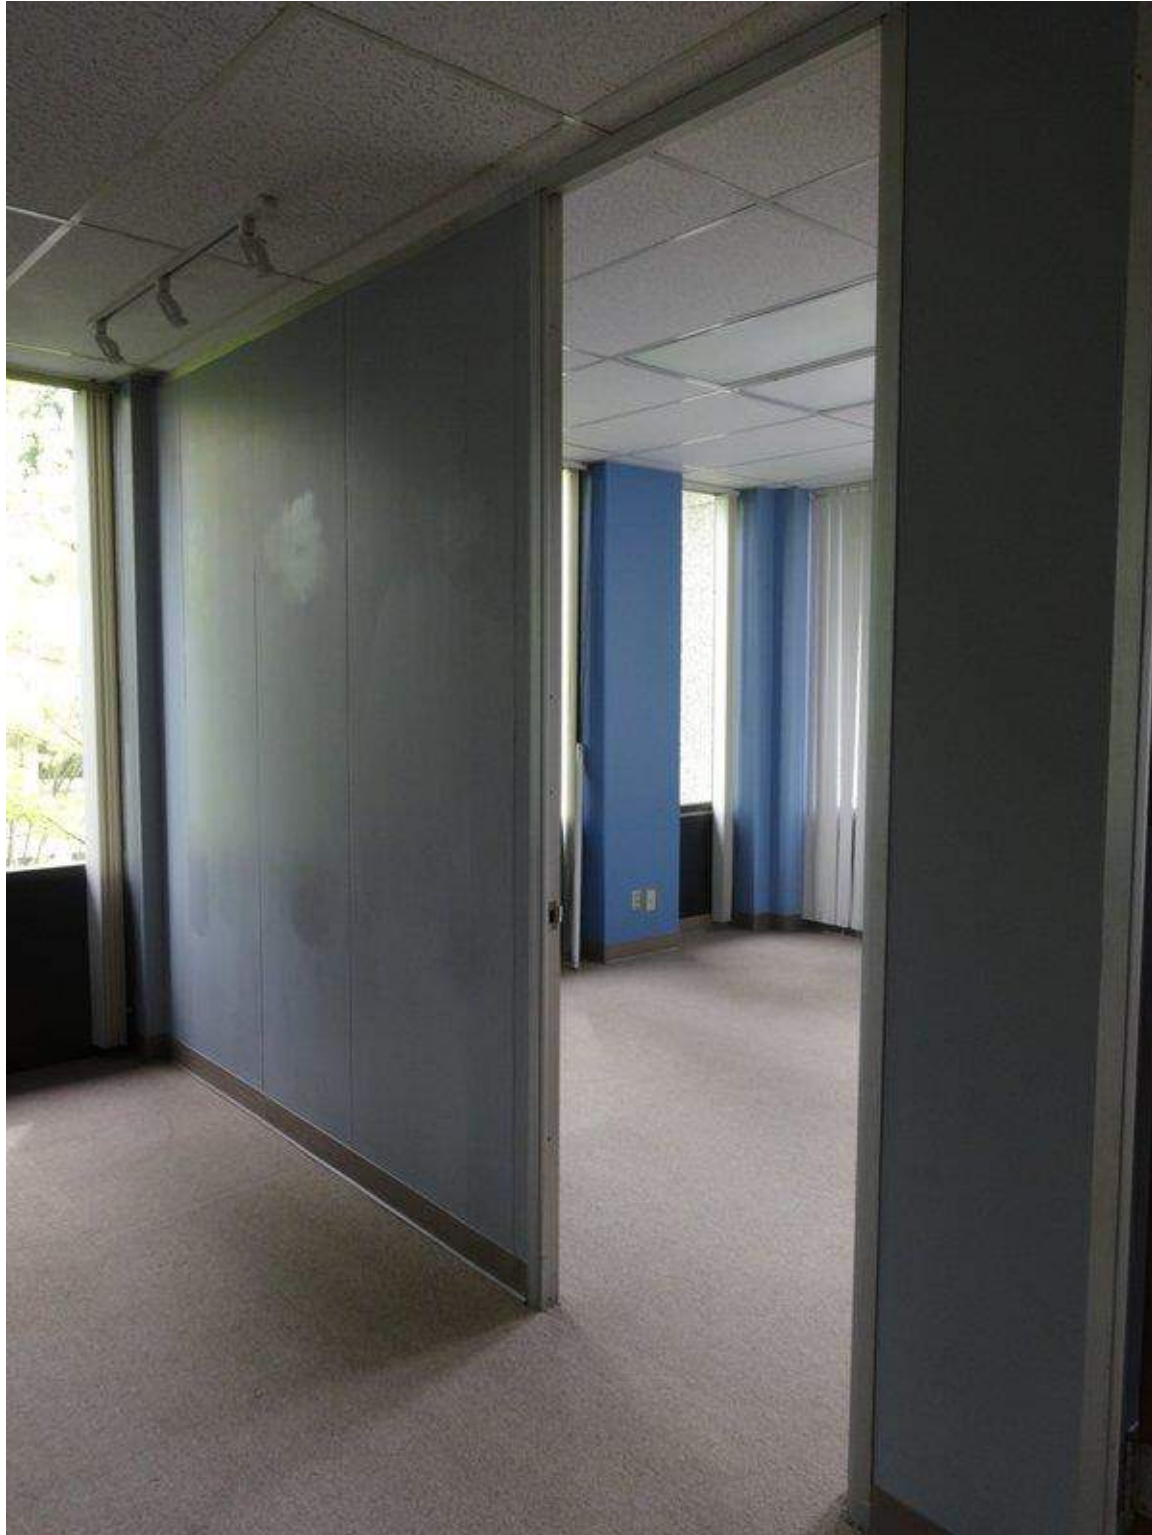
PHOTOGRAPH 46. Surrey Building, second floor. This area is part of an office suite that occupies the south and east portions of the second floor. This is the southeast corner office with scored walls and a metal-frame door. Camera facing southeast.

- PHOTO 46. Second floor. This area is part of an office suite that occupies the south and east portions of the second floor. This is the southeast corner office with scored walls and a metal-frame door. Camera facing southeast.

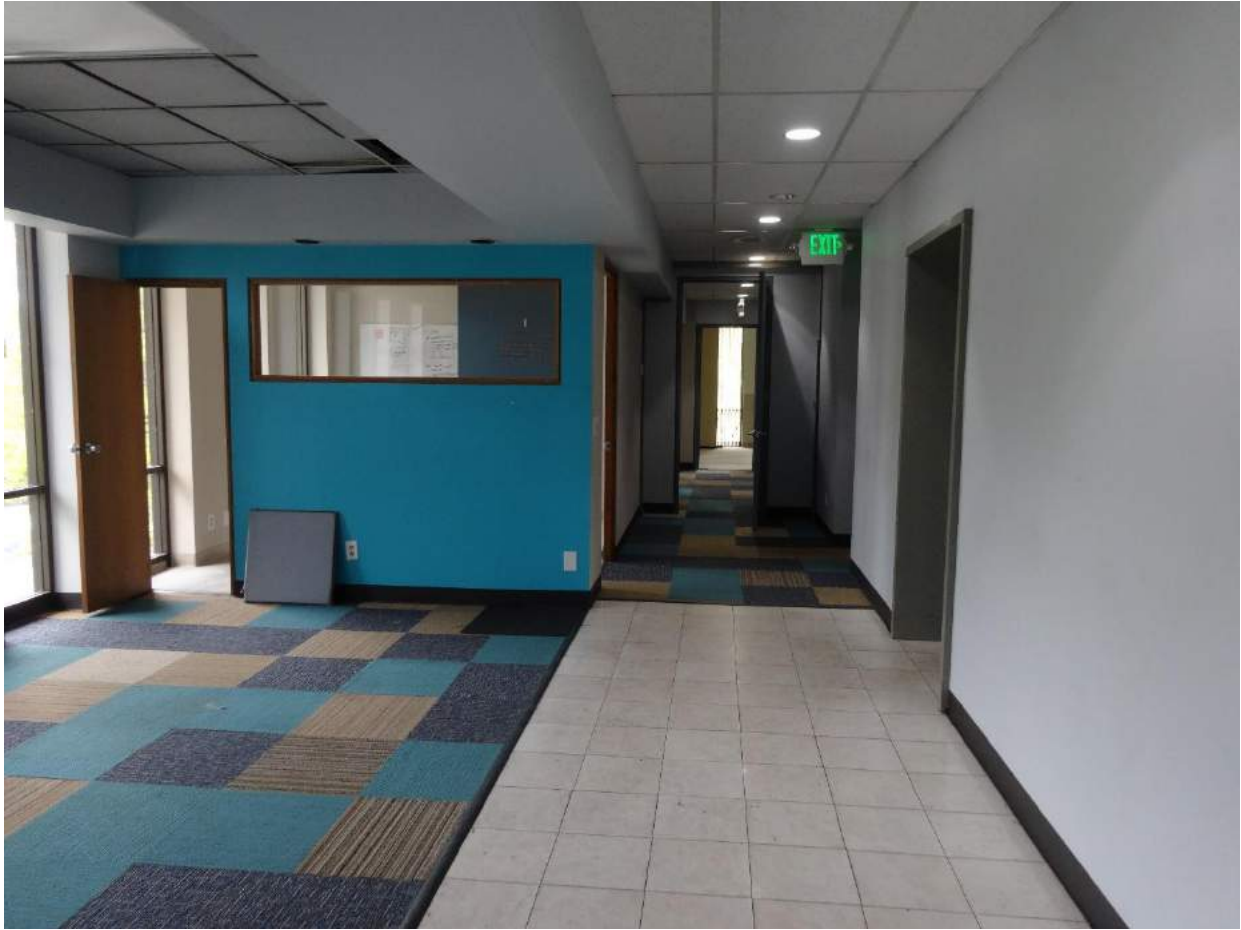
PHOTOGRAPH 47. Surrey Building, third floor. This is the lobby area and east-west corridor on the third floor. The elevator is at the right. Most recently, the third floor has functioned as one large suite of offices and the finishes, although dated, appear newer than what was on the second floor. Camera facing east.

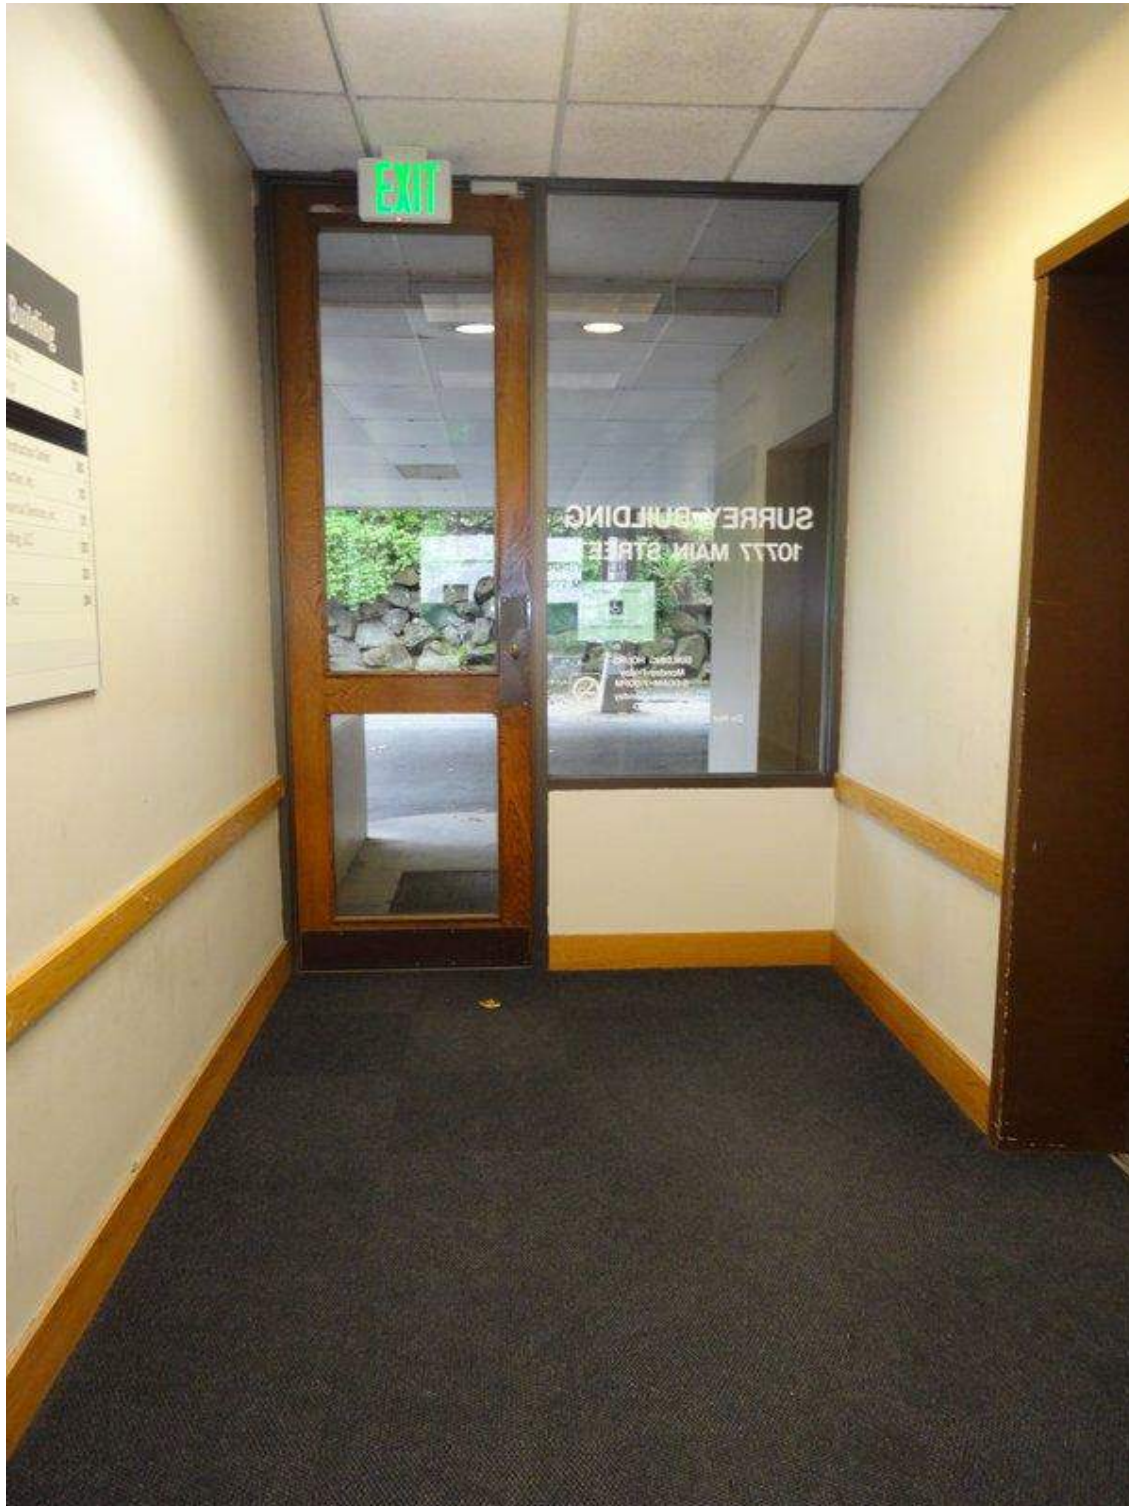
PHOTOGRAPH 51. Surrey Building, ground floor. This is the lobby area on the ground floor with the elevator at right. The east stairs exit outside the lobby in the doorway at right. Camera facing east.

- PHOTO 51. Ground floor. This is the lobby area on the ground floor with the elevator at right. The east stairs exit outside the lobby in the doorway at right. Camera facing east.

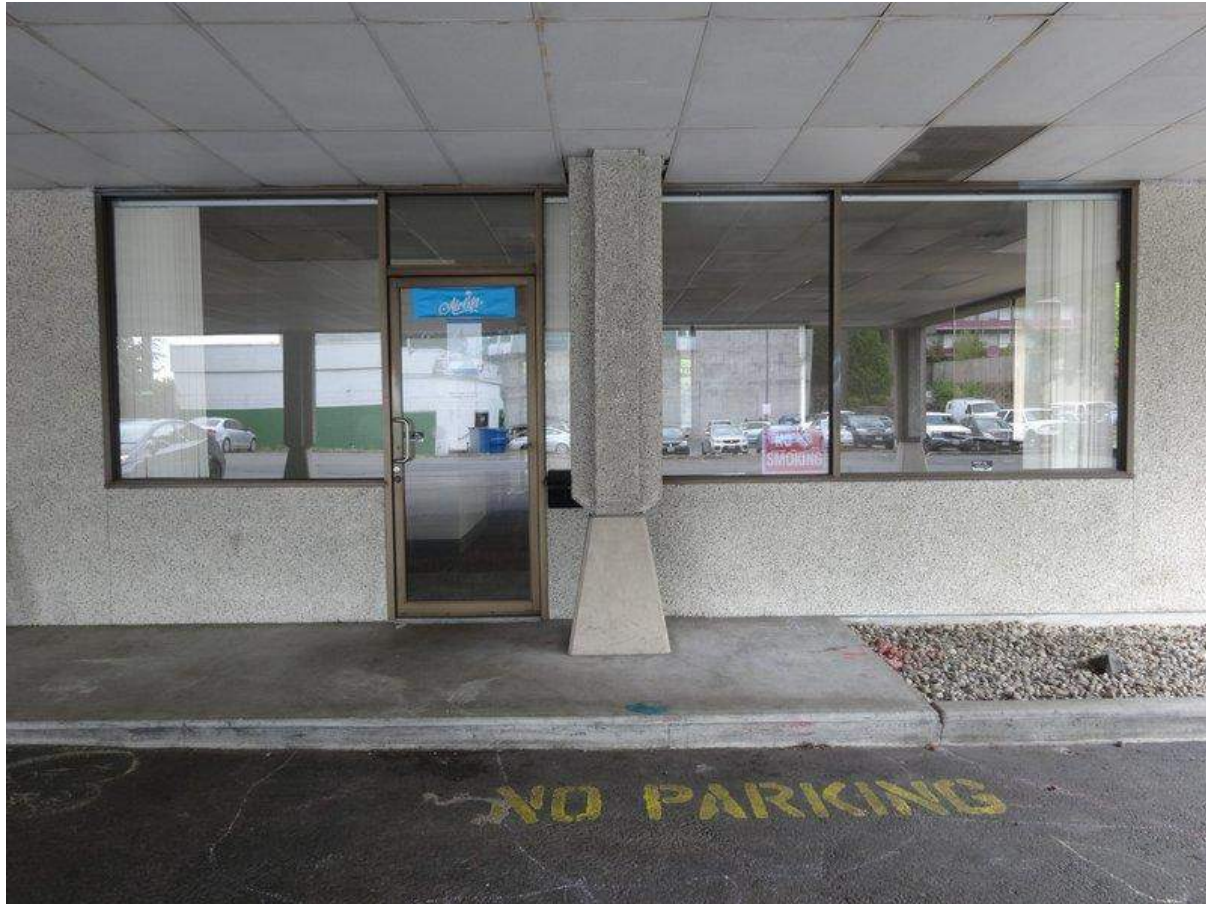
PHOTOGRAPH 52. Surrey Building, ground floor. This is the west entrance to the ground floor office space. Camera facing east.

- PHOTO 52. Ground floor. This is the west entrance to the ground floor office space. Camera facing east.
- PHOTO 53. Ground floor interior. This is the ground floor office space with the east entry on the opposite wall. Camera facing east.

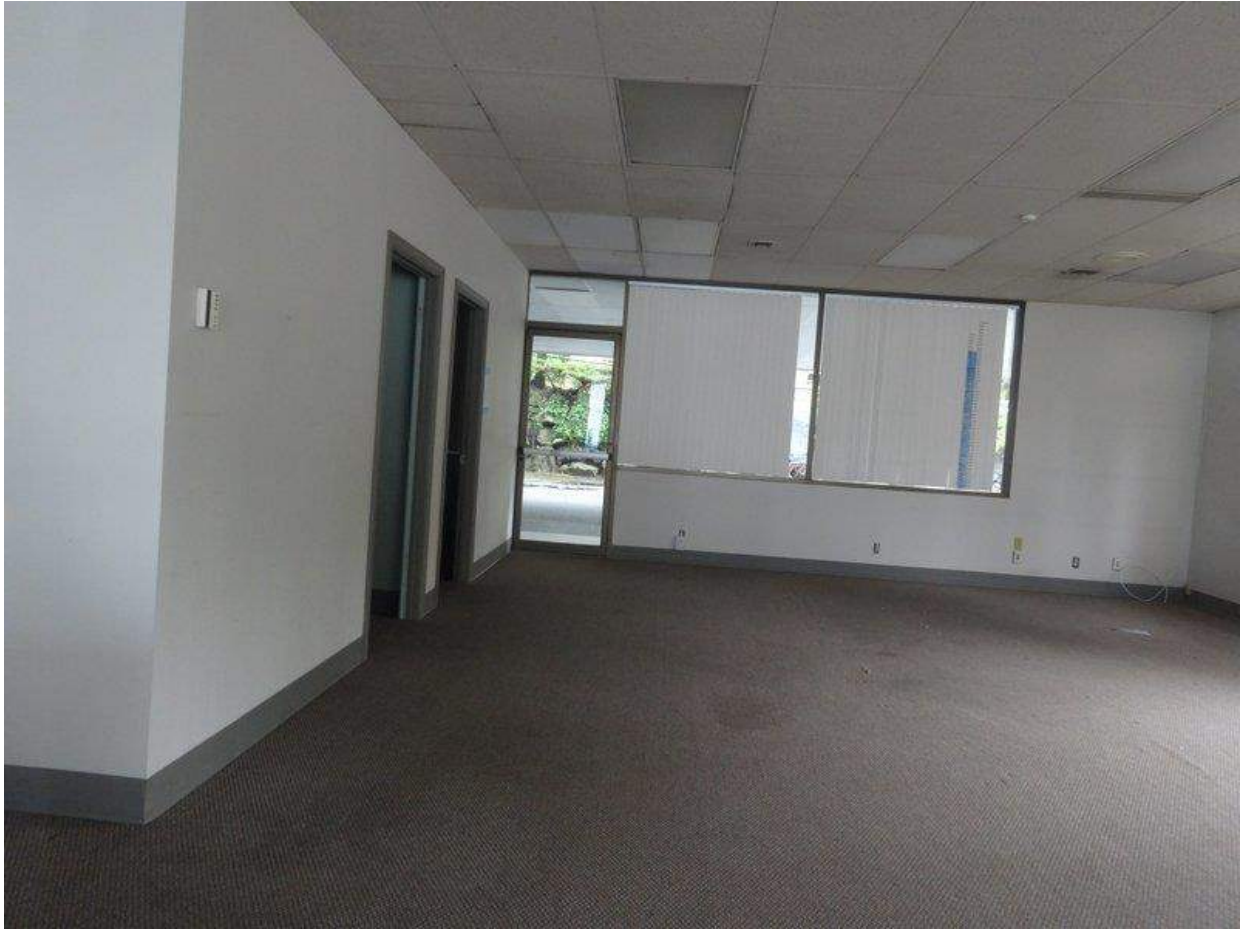
PHOTOGRAPH 53. Surrey Building, ground floor interior. This is the ground floor office space with the east entry on the opposite wall. Camera facing east.
