**Name:** Dr. Scott and Imogene Woodin House  
(Common, present or historic)

**Street Address:** 5801 Corson Avenue South, Seattle

# Landmark Nomination Report

## Dr. Scott and Imogene Woodin House 5801 Corson Avenue South Seattle, King County, Washington

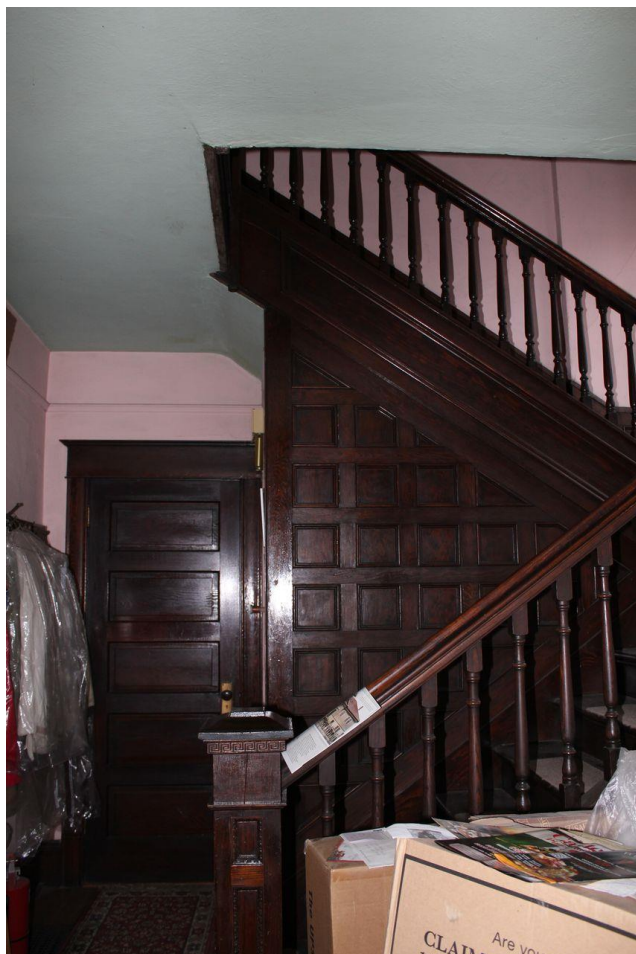
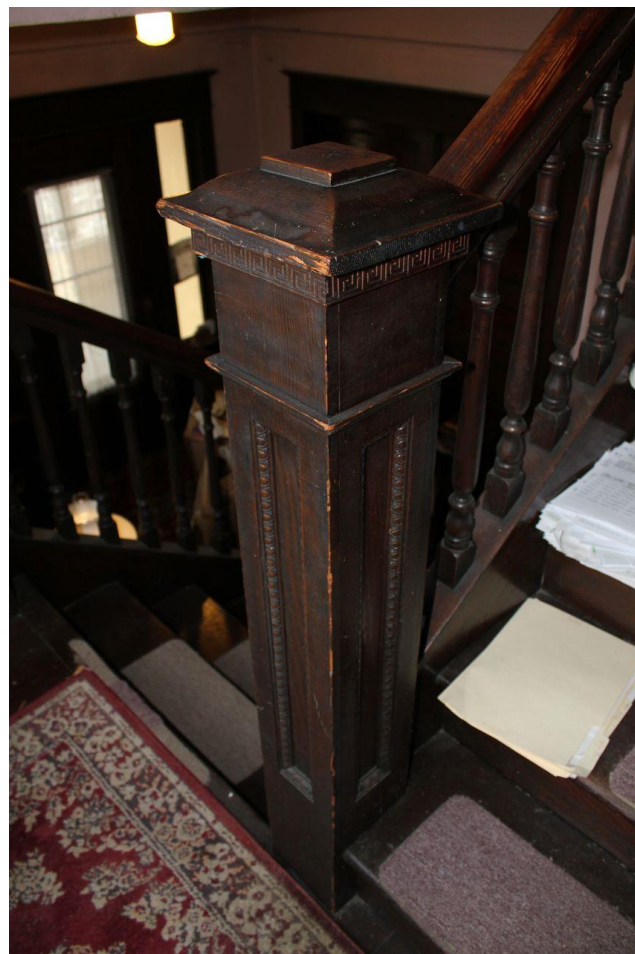
- B15. (Left photo) Interior, view of the kitchen door (left) and main staircase to the 2nd floor
- B16. (Right photo) Interior, view of newel post on main staircase between 1st and 2nd floors

The u-shaped staircase to the second floor dominates the **entry hall**, with its paneled dark wood treatment and wainscoting (figures B14-B17). The balustrade features turned balusters capped by a smooth well-worn handrail. There are three newel posts, at the base, landing, and top of the staircase, each with a square base, a paneled shaft embellished with an egg-and-dart motif, and a square cap with fretwork. A single light fixture hangs in the entryway, and natural light illuminates the space from the front door, a small, leaded-glass window on the north wall, and tall paired windows at the staircase landing. Opposite the front door, beyond the base of the stairs, is a five-panel door that leads to the kitchen. The entry hall's south wall features five-panel pocket doors through which is the living room.

The u-shaped staircase in the entry hall provides the only access to the **second floor** (figures B15-B17). The staircase terminates in a square center hall, which accesses all of the second-floor rooms (figures B18-B19). In all, there are eight five-panel doors in the hall. **Bedrooms** with built-in closets are situated in the four corners of the house. (The east corner bedroom, above the front porch, was Dr. Woodin's private practice examination room. No photos or accounts of the exam room's appearance survive and today the space appears very much like the other bedrooms.) A small **nursery** with a closet is centered on the south wall opposite the staircase. A **bathroom** with a wall-mounted porcelain sink, toilet, clawfoot tub, and built-in medicine cabinet is located next to the staircase. A door centered on the west wall accesses a **hall closet**. A door centered on the east wall of the hall leads to an **enclosed attic staircase**. The attic space is unfinished.

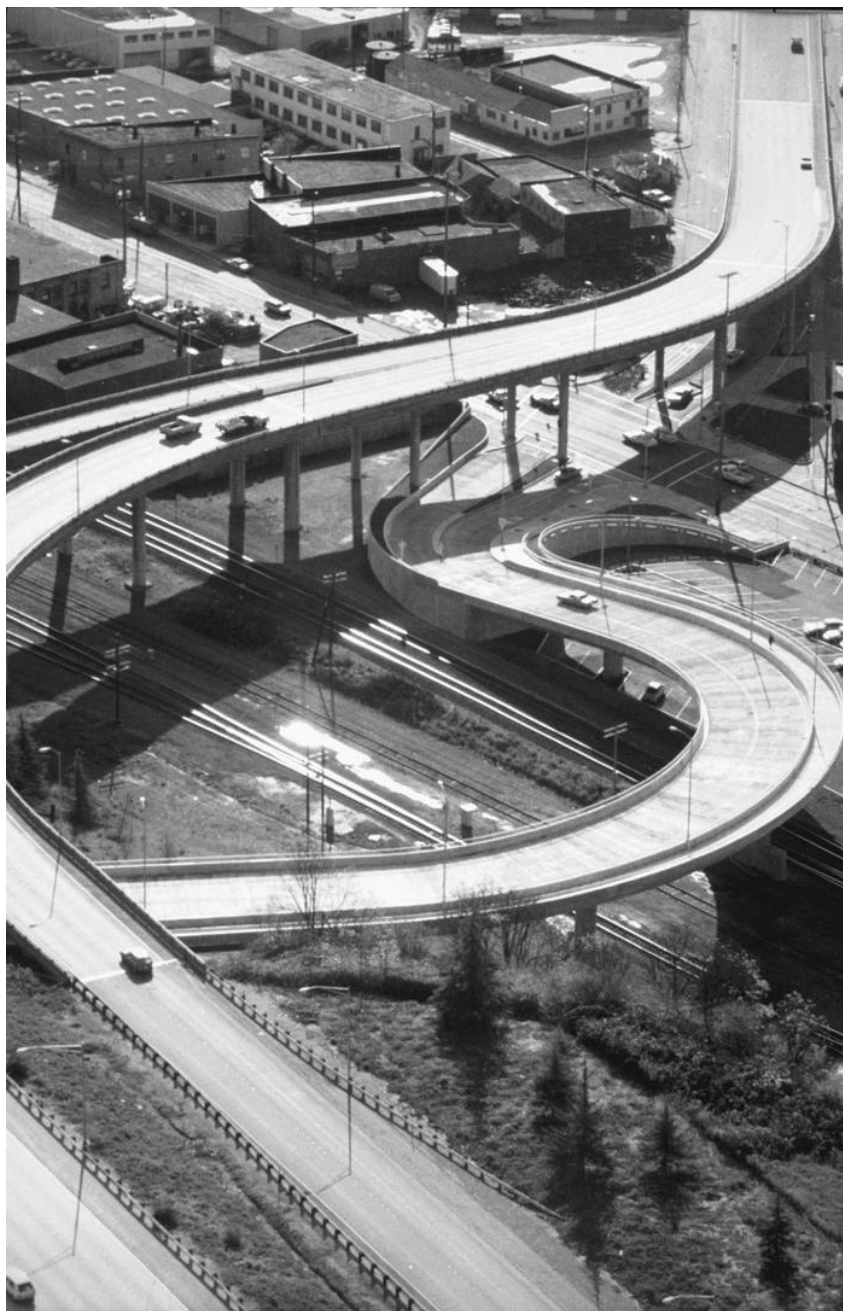
- C10. Interstate 5 Exit at Corson Avenue South, ca. 1967. The Woodin House is not shown but is just out of sight at the top right. Source: Seattle Municipal Archives

Georgetown emerged from the war as a rapidly changing community overtaken by industrial development, and “as early as 1923, the entire area of Georgetown was identified as an industrial zone although area residents managed to force rezoning of the residential areas by 1942.”<sup>13</sup> Following WWII, most wartime workers and their families moved on, and the Duwamish Bend housing project had closed by 1954. Once-thriving businesses shuttered, the movie theater and library closed, and the King County Hospital building was closed and torn down in 1956, the same year Seattle’s Comprehensive Plan called for “phasing out” the remaining residential areas in Georgetown.<sup>14</sup> The completion of Interstate 5 through the area in 1962 significantly altered the landscape and local transportation network, creating physical barriers and cutting off the old community with that of south Beacon Hill. The Corson Avenue South exit off Interstate 5 brought traffic from the elevated highway into Georgetown toward East Marginal Way S and Highway 99 (figure C10).

Woodin residence in the 1960s when the development of Interstate 5 forced the relocation of the house to make way for the Corson Avenue South exit ramp (figure C10). The ramp was built on top of the old four-lane Corson Avenue South, taking approximately 28 feet along the east part of the property. The house was moved west approximately 25 feet onto a new concrete foundation in 1965-67.<sup>39</sup>
