Landmark Registration Form

Historic Name: Highland Dairy Farm

Other names/site number: Bassett Farm; Bassetti's Crooked Arbor Gardens

Street Address: 18420 NE 165th Street, Woodinville, WA 98072

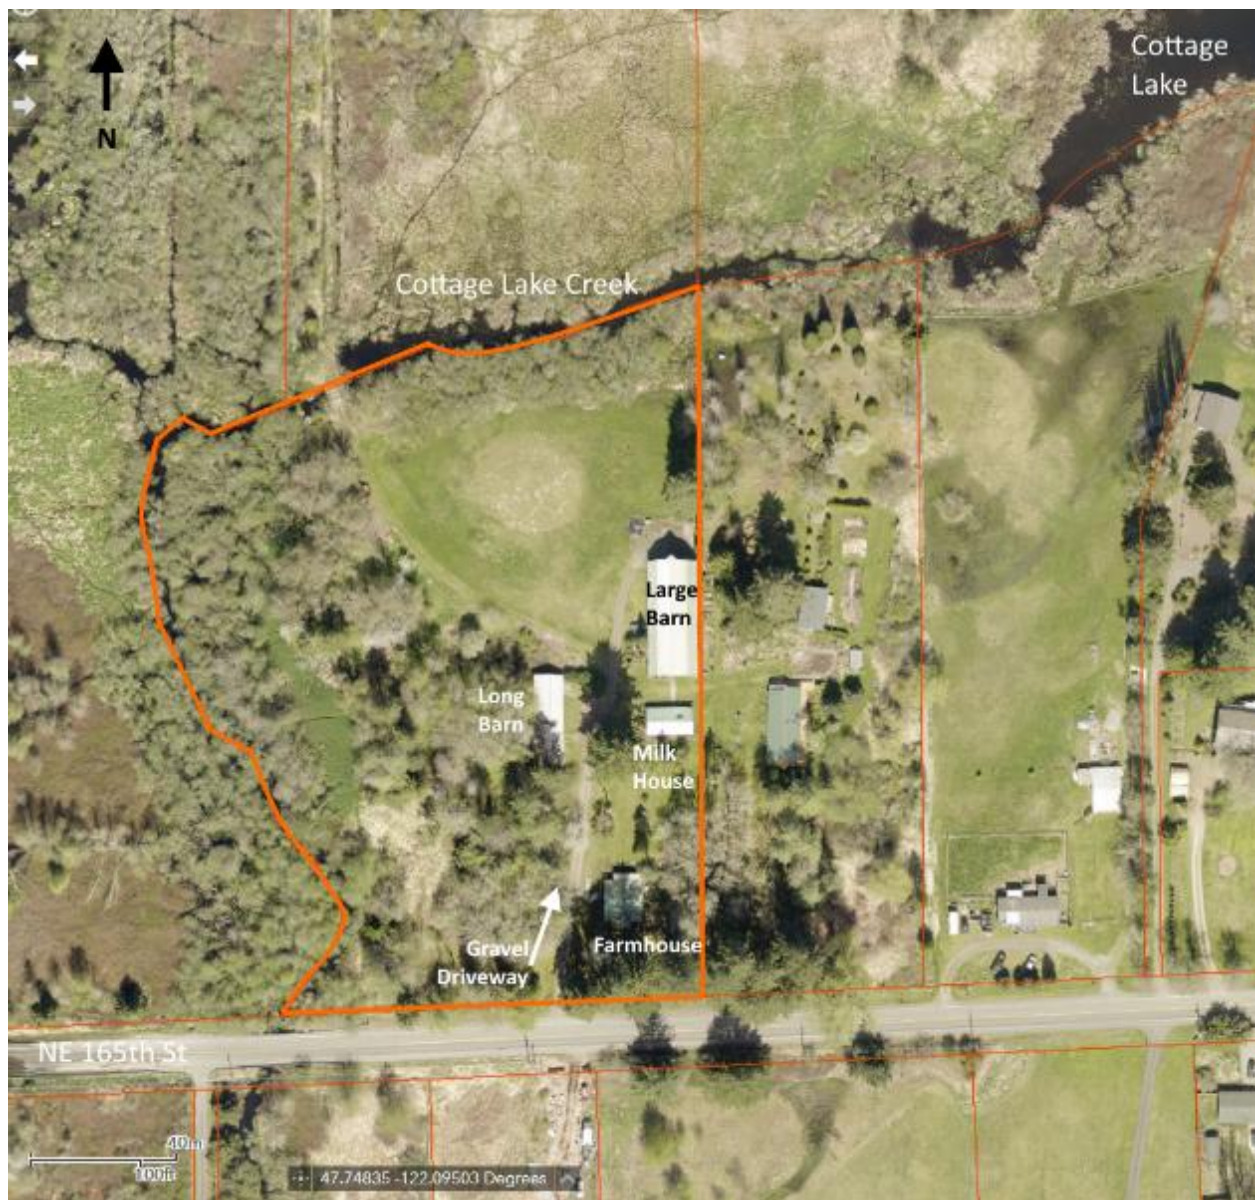
Aerial image of the nominated property, with the parcel boundary and resources noted. King County iMap.

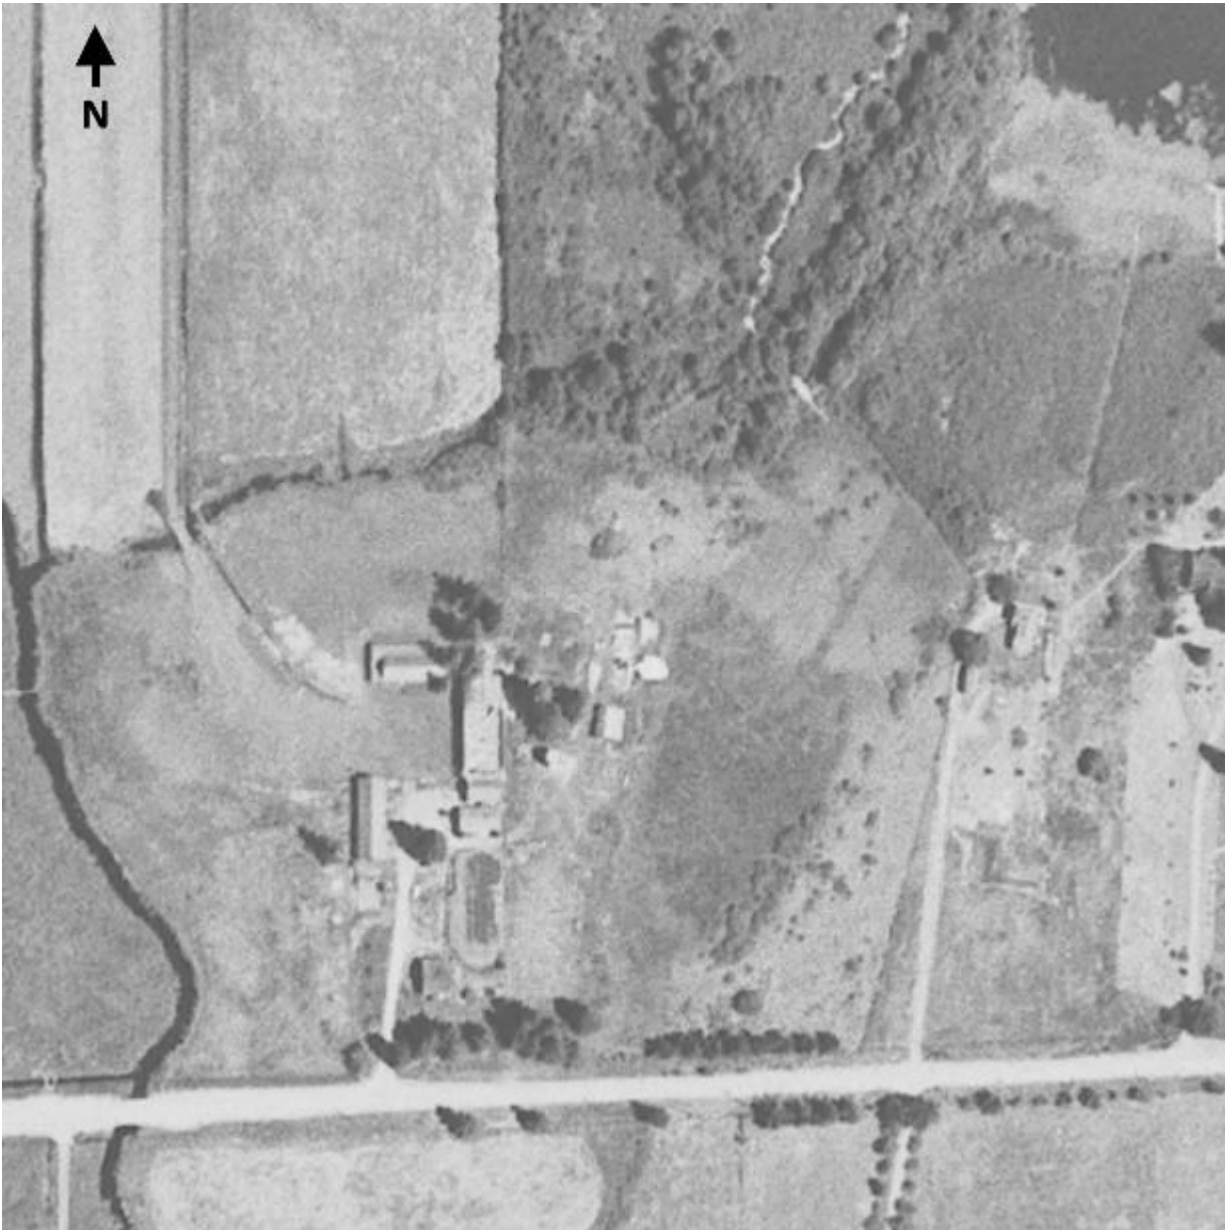
Figure A9. Aerial image, 1952. Source: HistoricAerials.com.

This image shows the gambrel-roof barn was in place by 1952.

² An aerial image confirms the barn was in place by 1952 (figure A9). A 2004 newspaper article suggests the barn was constructed in 1946. Debra Prinzing, "At Bassetti's, Growth Has Been a Good Thing," *The Daily Herald* [Everett, WA] (Home & Garden section), Jun. 10, 2004, pp. 8-12.

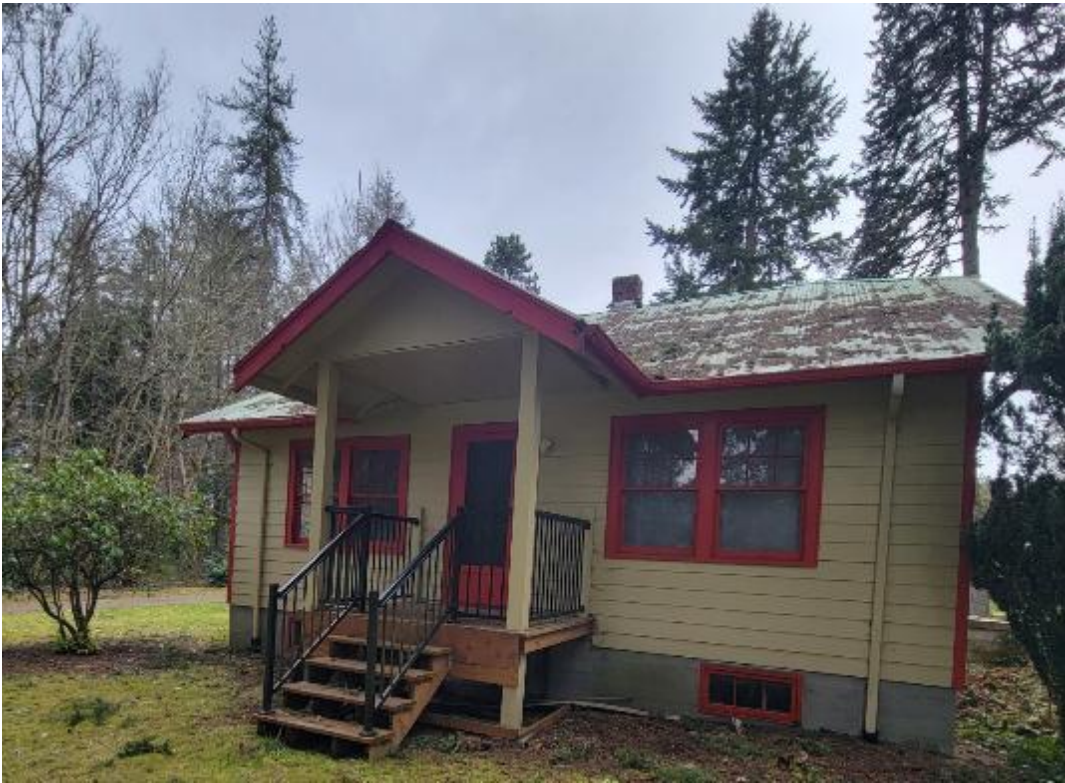
Figure B1. Farmhouse, primary south side with the main entrance, camera facing northwest (photo by Leanette Bassetti, March 2025)

Built in 1938, this one-and-a-half-story bungalow with a clipped gable roof has a nearly square footprint that measures approximately 30' by 32'. A gabled entry porch (8' by 5') projects from the center of the primary, south-facing elevation. A rear enclosed porch (10' by 20') with a flat roof spans nearly the full width of the north side.

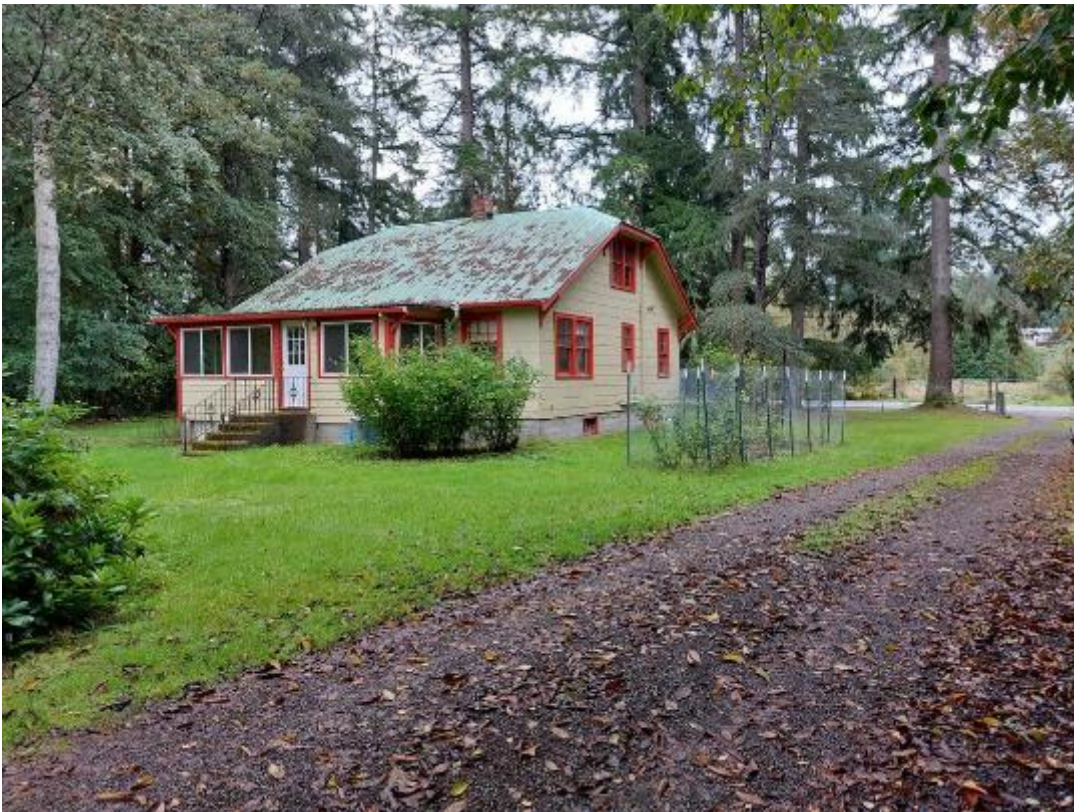
Figure B3. East side of farmhouse; camera facing west

The roof cladding is corrugated metal, and a brick chimney rises from the center peak. The chimney is no longer functional. The bracketed eaves feature wide bargeboards and open soffits with exposed rafter tails. The primary elevation and rear porch are clad in wood weatherboard siding, while the side and rear elevations are clad in asbestos shakes, which were in place by 1945 (figure C2). Wood windows are primarily double-hung wood sashes grouped in pairs with a six-over-one configuration. Other sash configurations include four-over-one and one-over-one. The rear porch has metal slider windows. The wood windows and multi-light wood door at the entry are original. The farmhouse originally featured a post-and-pier foundation (figures C1 and C2) but it now rests on a board-formed poured concrete foundation that rises approximately 2' above grade. There are foundation-level wood windows with vertical muntins on the south, east, and west sides. A covered well is located along the east side at the north corner. An open-air basement entry is located at the east end of the rear porch.

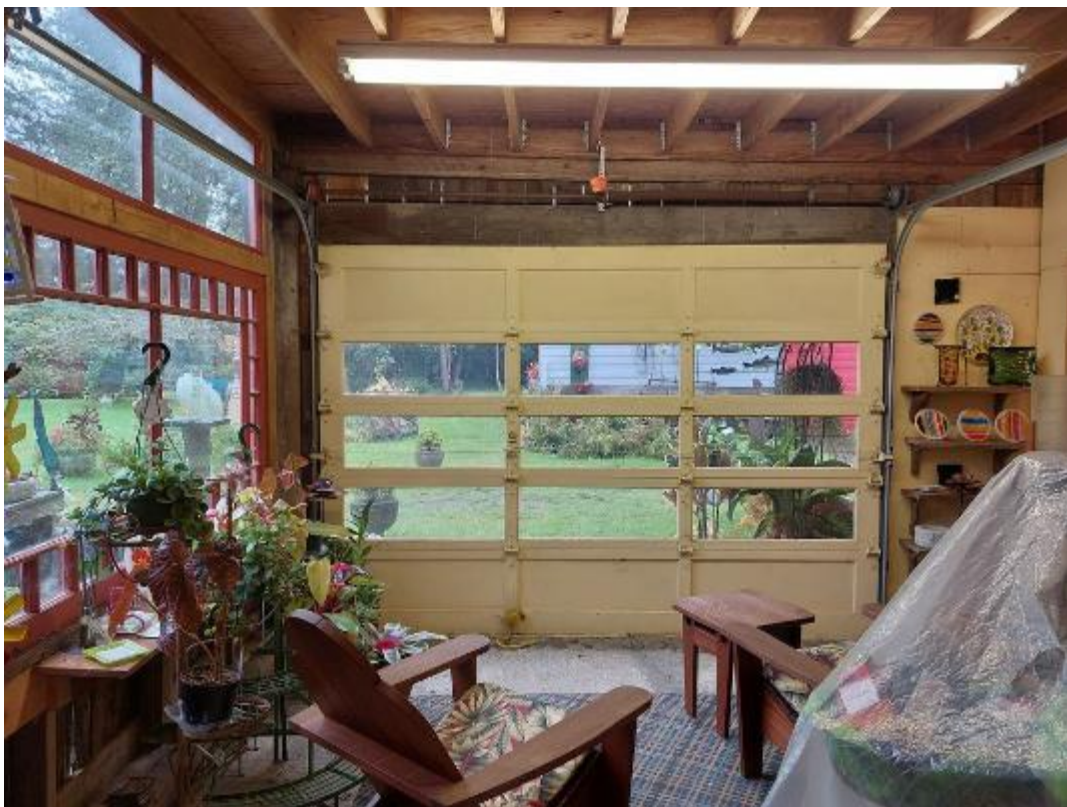
Figure B9. Interior of large barn at the southeast corner, camera facing south; today this space is used as Bassetti's Crooked Arbor Garden Galleries and is open to the public in the spring and summer

The ground-floor interior is spatially organized by three aisles created by the original heavy timber framing. These aisles run nearly the full length of the barn. A central feed alley is flanked by two milking outer aisles. It is likely the dairy cows faced the inner alley to feed and were held in place by wood dividers or stanchions that are no longer present. Two still-visible manure gutters that are filled in with concrete run the length of the outer milking aisles.

- In the 1980s, the first-story areas that remained open and unfinished were enclosed with exterior windows, roll-up garage doors, and interior wall framing (figures B8 through B11, C7, and C9).

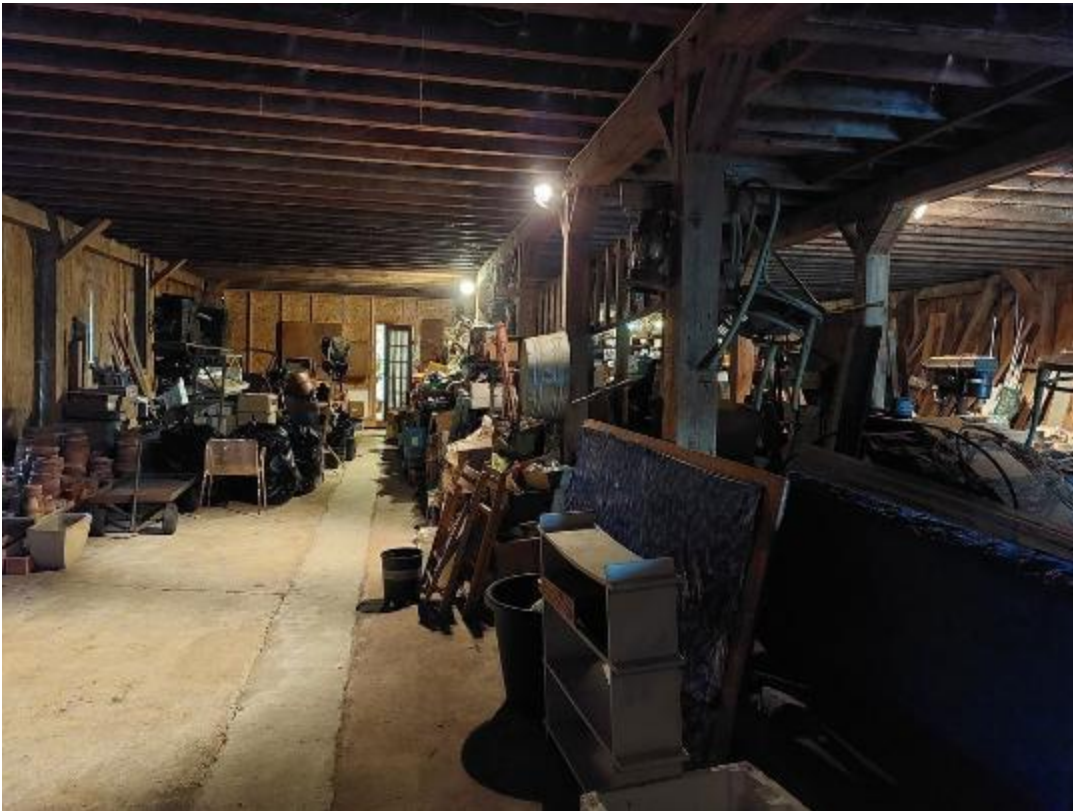
Figure B11. Interior of large barn's former milking area, camera facing south
Note: the long, narrow manure gutters are filled in with concrete

- The two manure gutters along the outer milking aisles were filled in with concrete at an unknown date.

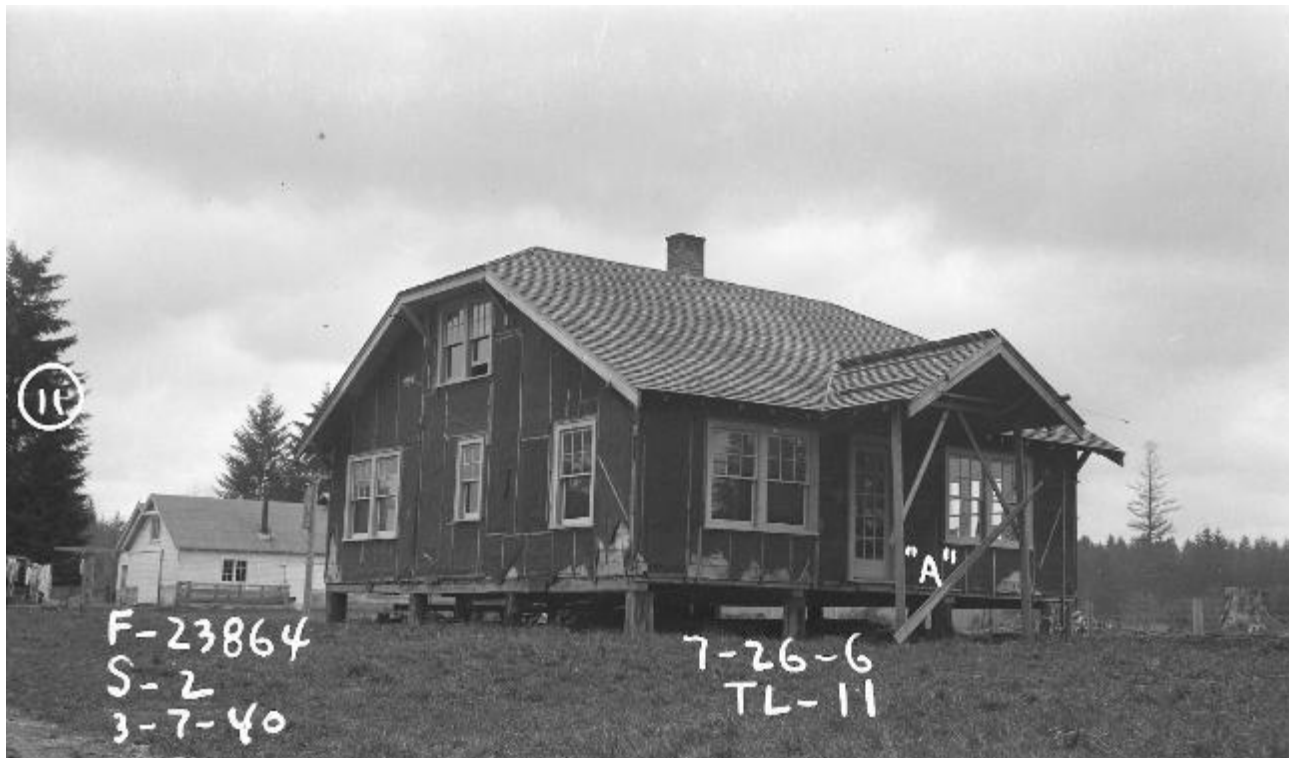
Figure C1. Farmhouse, 1940. Source: King County Assessor's Property Record Card.

- It was constructed in 1938 and remained unfinished for at least a few years. It did not receive exterior cladding until about 1945 when asbestos shingles were applied (figures C1 and C2).
- It originally had a post-and-pier foundation with no basement. By 1981, it had a poured concrete foundation and a basement accessed from the exterior (King County Assessor).
- A screened rear porch was in place by 1981 (King County Assessor). It was totally replaced in 2021.
- It originally had a wood-shingle roof. A corrugated metal roof was added sometime after 1981.
- Wood siding was applied to the south-facing primary elevation sometime after 1981.
- Interior finishes and features were largely stripped in 2024 due to water damage.

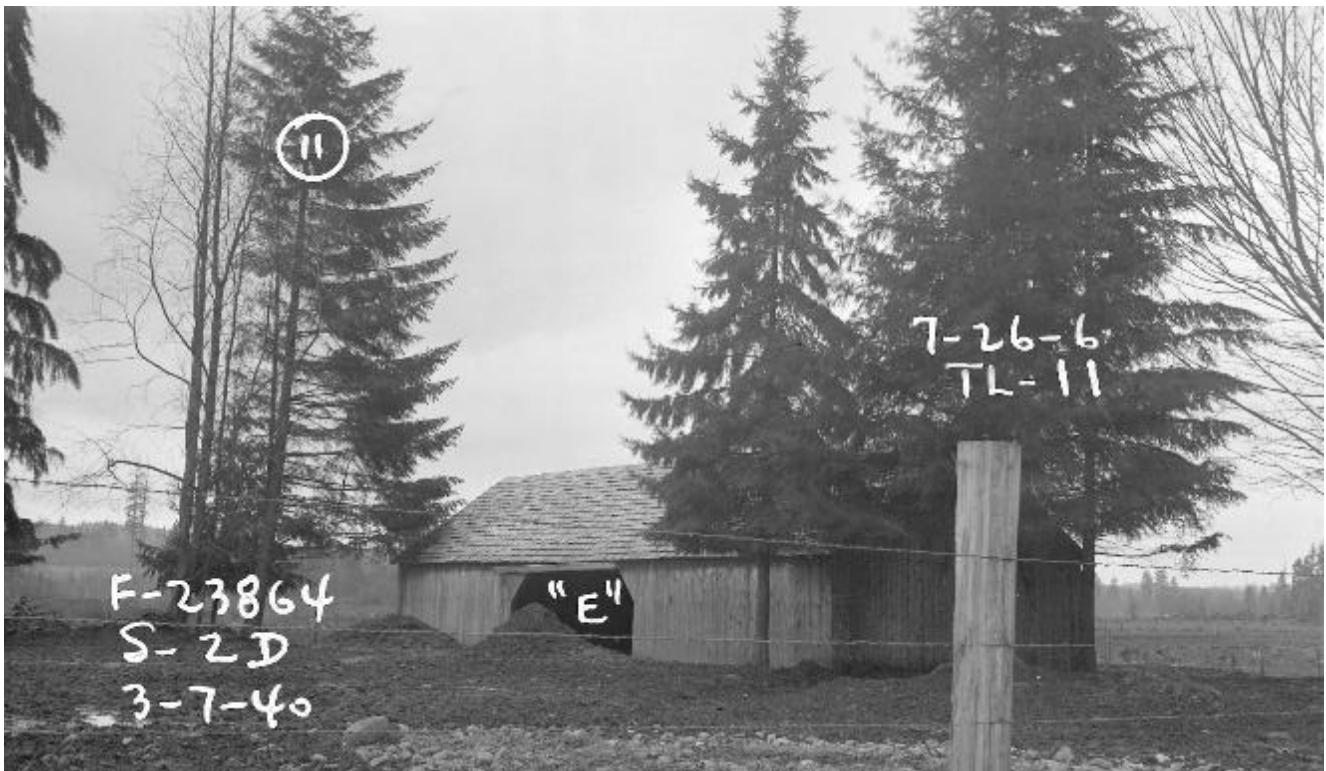
Figure C7. Large barn, 1968. Source: King County Assessor's Property Record Card.

- When it was built in the post-WWII years, it was minimally connected on the south side to a 1934 milk barn that has since been demolished (figure C7). Because of this, most of the changes to the large barn are to the south end.

- In the late 1980s, the second-story openings at the south and north ends were covered with translucent fiberglass panels (figures B6, B8, C7, and C9).

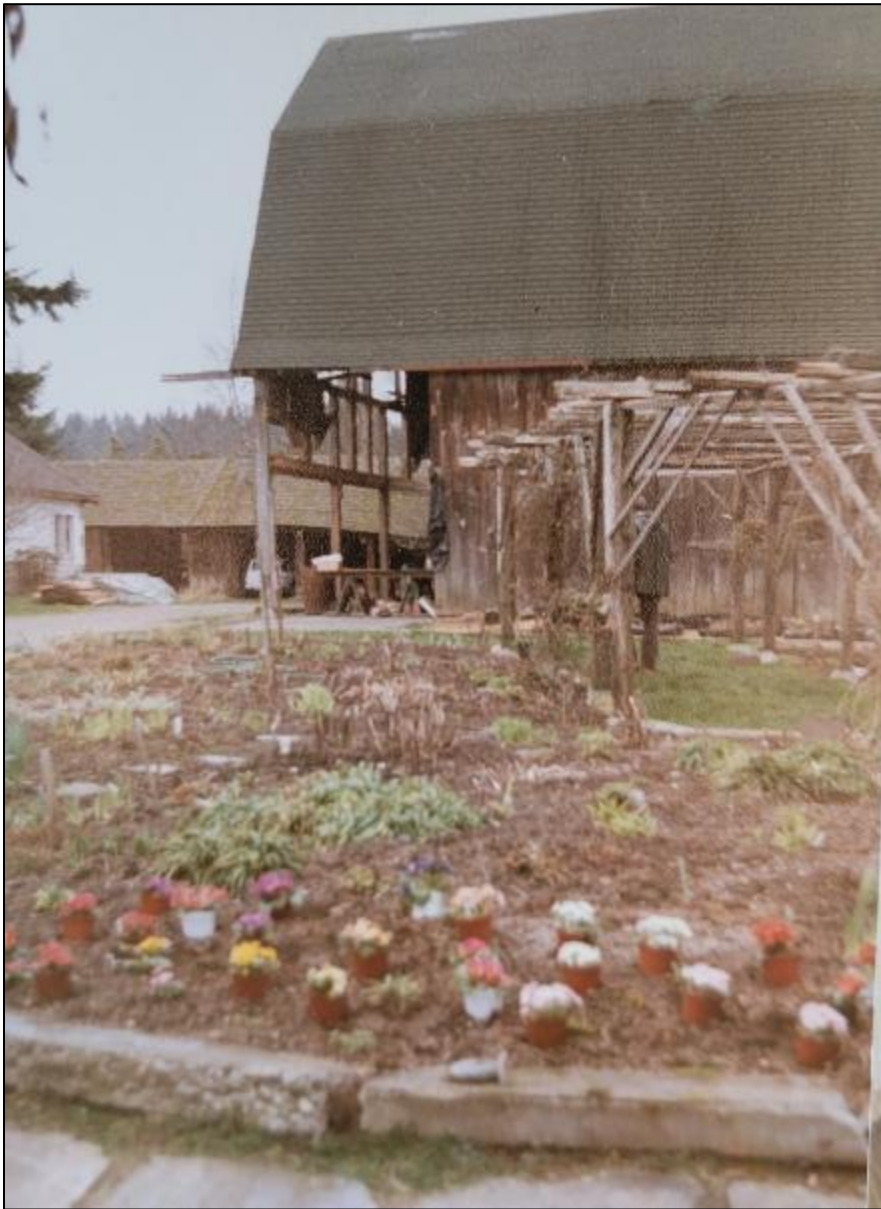
Figure C9. South end of the Large Barn before it was enclosed and the upper-level floor extended to the end wall, 1985. Source: Leanette Bassetti.
